SUBJECT: Southern California Edison Company's Response to Notice of Non-Performance NON_CAD_SCE_SIS_20250813_0918

Finding: Failure to complete missing connector cover replacement

Notice	Deficiency #	Structures
NON_CAD_SCE_SIS_20250813_0918	1	2105947E

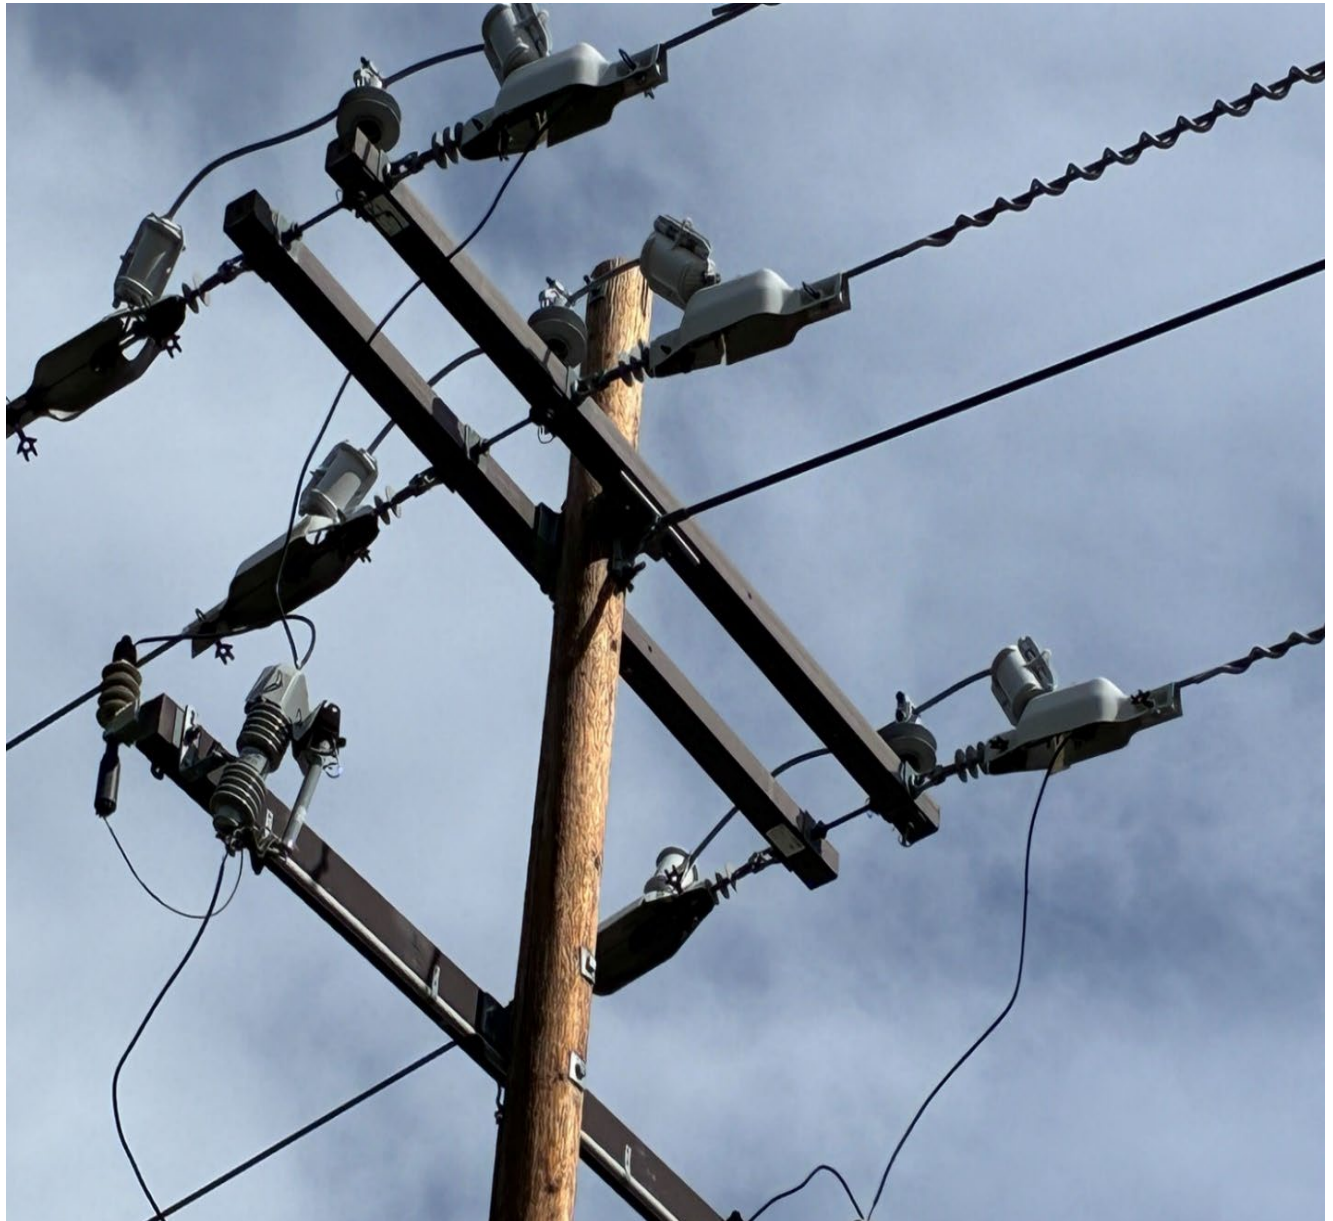
Energy Safety's Notice states that in implementing 2025 WMP initiative 8.1.3.1 - Distribution High Fire Risk-Informed (HFRI) Inspections and Remediations (IN-1.1), SCE failed to complete the remediation of a missing connector cover on Pole ID 2105947E, Grid Hardening ID 413332973-2105947E at coordinates 33.805394, -117.409172.

SCE confirms that the wildlife connector cover on structure ID 2105947E was remediated on February 20, 2025. During a subsequent inspection in response to this Notice, SCE's Field Operations team identified that the previously installed wildlife connector cover had become dislodged likely due to environmental exposure or other external factors. On October 29, 2025, SCE personnel installed a wildlife connector

cover on structure 2105947E once again. Please find the photo evidence below of the most recently completed wildlife connector cover remediation.
