NOTICE OF NON-PERFORMANCE

On June 17, 2025, Energy Safety conducted an inspection of SCE's WMP initiatives in the vicinity of the city of Porterville, California. The inspection report is enclosed herewith. Energy Safety found the following deficiency:

INSPECTION REPORT

Exhibit A: Photo Log Structure ID: 4022820E

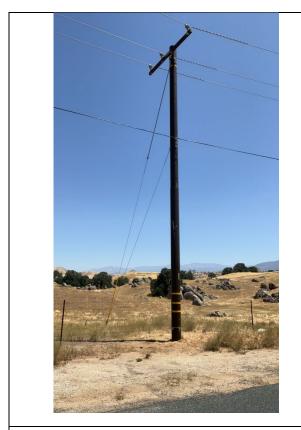
Glmg1: Overall Structure

On Pole ID 4022820E, Grid Hardening ID 409837801-4022820E at 27707-27707 Deer Creek Dr, Porterville, CA, 93257, USA, 35.98584646688619, -118.9218473827965, the inspector observed that no wildlife covers were installed. The inspector's observation is documented in Deficiency 1 photographs, which are attached to this report. Photo number IA1Img1 depicts that no wildlife covers are installed. Per information provided by SCE to the Compliance Inbox on April 3, 2025, at 12:15 pm, the remediation was completed.

- 1. Southern California Edison Company's 2024 WMP 8.1.3.1 Distribution Detailed Inspections and Remediations work identified that the remediation of wildlife covers was completed at this location.
- 2. The wildlife covers were not installed.

Deficiency 1. Energy Safety observed that in implementing 2024 WMP initiative 8.1.3.1 - Distribution High Fire Risk-Informed (HFRI) Inspections and Remediations (IN-1.1), SCE failed to complete the remediation of installing wildlife covers on Pole ID 4022820E, Grid Hardening ID 409837801-4022820E at 35.98584646688619, -118.9218473827965. Energy Safety considers this non-performance to be in the Minor risk category. SCE must complete a corrective action for this deficiency by 12 months from date of this notice.
