NOTICE OF NON-PERFORMANCE

INSPECTION REPORT

Electrical Corporation:	Southern California Edison Company
Report Number:	CAD_SCE_AXS_20250904_1406
Inspector:	Alexander Scott
WMP Year Inspected:	2025
Quarterly Data Report (QDR) Referenced:	Quarter 1 (Q1)
Inspection Selection:	Energy Safety viewed the contents of the Q1 QDR and performed an analysis that resulted in the selection of the WMP initiatives and locations referenced in this report.
Relevant WMP Initiative(s):	8.1.3.1 - Distribution Detailed Inspections and Remediations (IN-1.1)
Date of inspection:	September 4, 2025
City and/or County of Inspection:	Palos Verdes Peninsula, Los Angeles County
Inspection Purpose:	Assess the accuracy of Southern California Edison Company's QDR data, completeness of its work, compliance with WMP requirements, and compliance with its protocols.

Deficiency #	Structure ID	Grid Hardening ID	Lat/Long	HFTD	Initiative Number	Severity	Deficiency Description
Deficiency 1	1232599E	412153145-1232599E	33.796000, -118.357955	Tier 2	8.1.3.1 - Distribution High Fire Risk-Informed (HFRI) Inspections and Remediations	Minor	Failure to complete the tightening of a guy wire

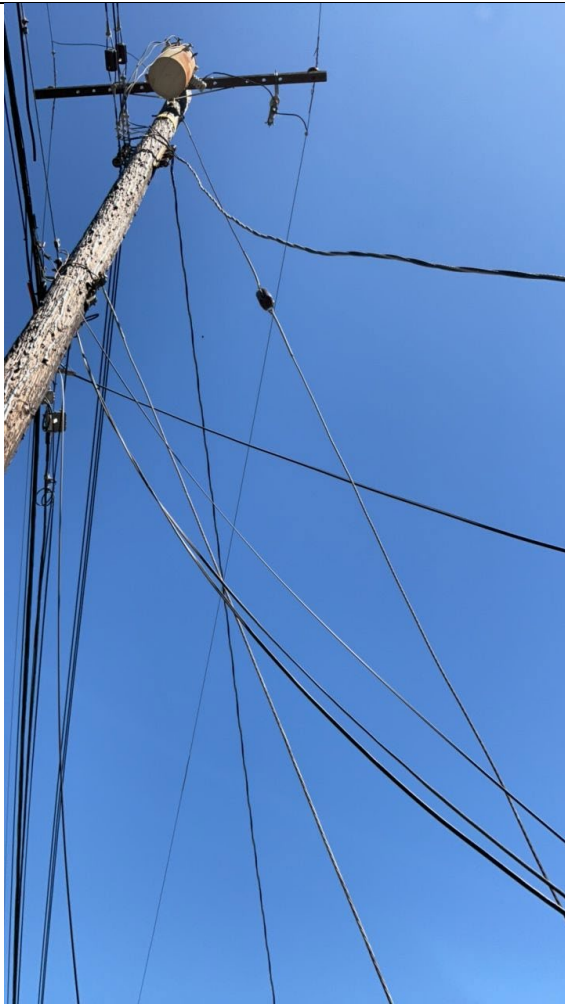
On Pole ID 1232599E, Grid Hardening ID 412153145-1232599E at 4245 Via Alondra, Palos Verdes Peninsula, CA, 90274, USA, 33.796000, -118.357955, the inspector observed that the down guy wires are loose. The inspector's observation is documented in Deficiency 1 photographs, which are attached to this report. Photo IA1Img1, IA1Img2, IA1Img3 and IA1Img4 depict loose guy wires. Per information provided by SCE to the Compliance Inbox on July 1, 2025, at 4:09 pm, the remediation work to tighten the guy wire was completed.

1. Southern California Edison Company's 2025 WMP initiative number 8.1.3.1 Distribution Detailed Inspections and Remediation work identified that tightening of the guy wire was completed at this location.
2. The guy wires were loose.

IA1Img1: View showing both down guy wires are loose

Deficiency 1. Energy Safety observed that in implementing 2025 WMP initiative 8.1.3.1 - Distribution High Fire Risk-Informed (HFRI) Inspections and Remediations (IN-1.1) SCE failed to complete the corrective action of tightening a down guy wire on Pole ID1232599E, Grid Hardening ID 412153145-1232599E at coordinates 33.796000, -118.357955. Energy Safety considers this non-performance to be in the Minor risk category. SCE must complete a corrective action for this deficiency by 12 months from date of this notice.

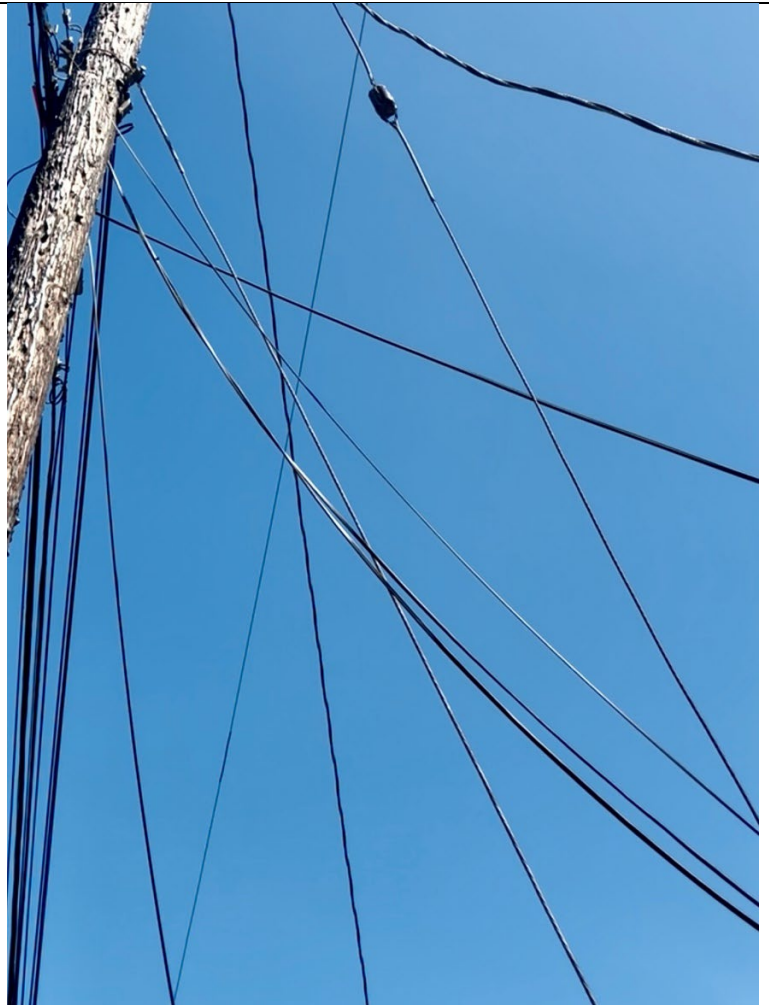
IA1Img2: View showing small bends in down guy, caused by slack

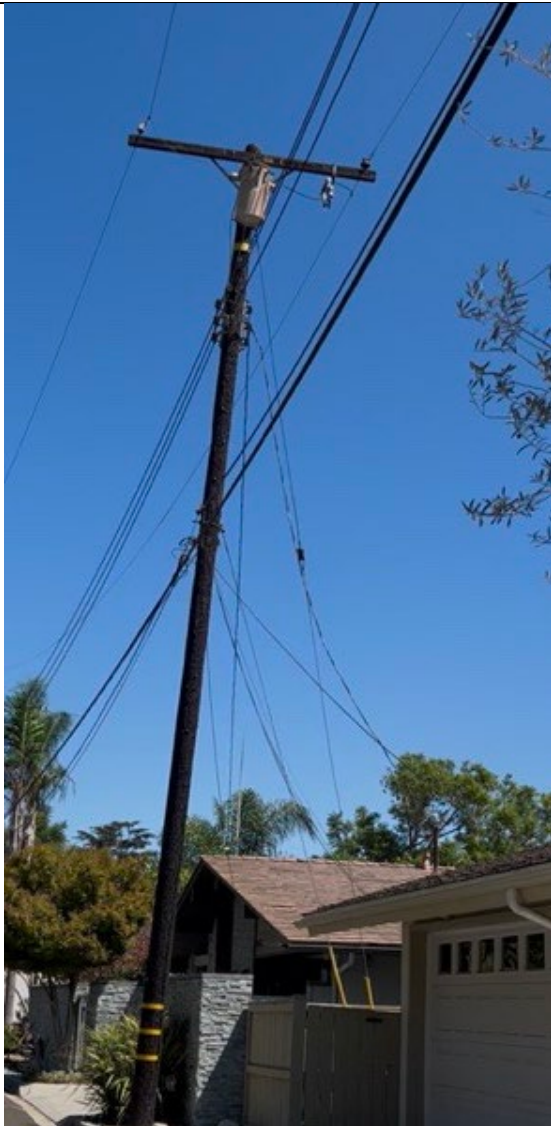
IA1Img3: View showing loose down guy

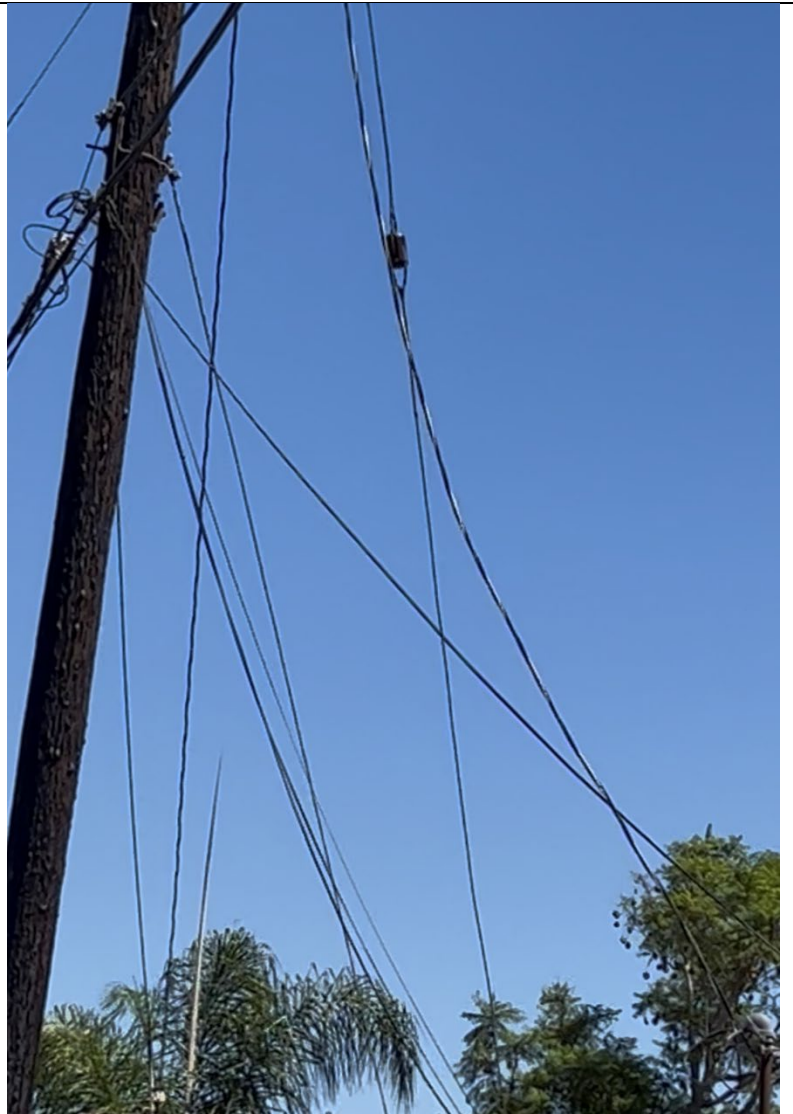
IA1Img4: View showing loose down guy
