NOTICE OF NON-PERFORMANCE

INSPECTION REPORT

Electrical Corporation:	Bear Valley Electric Service, Inc.
Report Number:	CAD_BVES_KSF_20250820_1100
Inspector:	Keyshawn Ford
WMP Year Inspected:	2024
Quarterly Data Report (QDR) Referenced:	Quarter 3 (Q3)
Inspection Selection:	Energy Safety viewed the contents of the Q3 QDR and performed an analysis that resulted in the selection of the WMP initiatives and locations referenced in this report.
Relevant WMP Initiative(s):	8.1.2.3 - Evacuation Route Hardening Pilot & Program
Date of inspection:	August 20, 2025
City and/or County of Inspection:	Big Bear Lake, San Bernardino County
Inspection Purpose:	Assess the accuracy of BVES's QDR data, completeness of its work, compliance with WMP requirements, and compliance with its protocols.

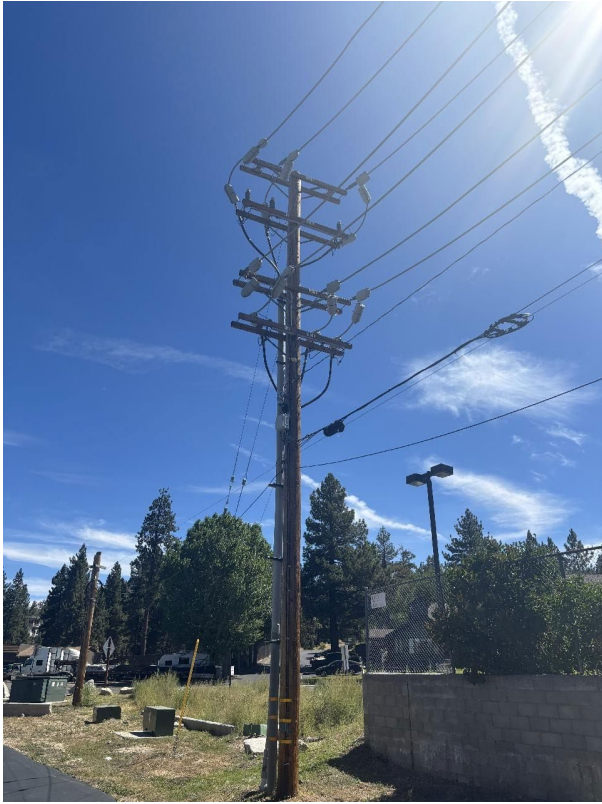
On Pole ID 13045BV, Grid Hardening ID FW_50, at Mile 51.1 State Rte 18 S, Big Bear Lake, CA, 92315, USA, 34.2498027777272, -116.88383055559, the inspector observed that while a new wooden pole was installed, it was not fire wrapped. The inspector's observation is documented in Deficiency 1 photographs, which are attached to this report. Photo numbers G1mg1, G1mg2, IA11mg1 and IA11mg2 depict incomplete installation of fire-resistant pole wrap.

1. A new wooden pole was installed at the inspection location.
2. The new wooden pole did not have fire-resistant pole wrap installed.

IA1Img1: View of new pole with no fire-resistant wrapping

Deficiency 1. Energy Safety observed that in implementing 2024 WMP initiative 8.1.2.3 - Evacuation Route Hardening Pilot & Program, BVES failed to install fire-resistant wrap on Pole ID 13045BV, Grid Hardening ID FW_50 at coordinates 34.249795094722636, -116.8838249883977. Energy Safety considers this non-performance to be in the Minor risk category. BVES must complete a corrective action for this deficiency by 12 months from date of this notice.

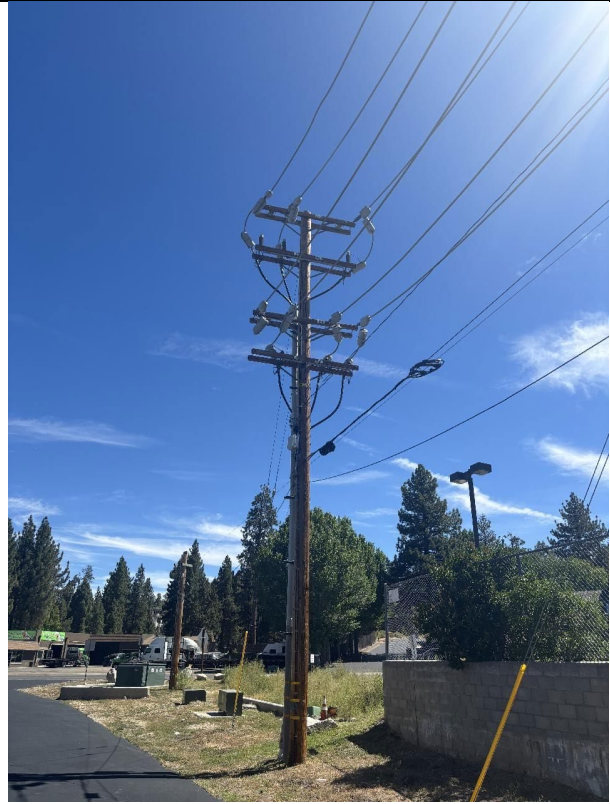
IA1Img2: View of new pole with no fire-resistant wrapping
