NOTICE OF NON-PERFORMANCE

INSPECTION REPORT

Electrical Corporation:	Southern California Edison Company
Report Number:	CAD_SCE_AXS_20250904_1343
Inspector:	Alexander Scott
WMP Year Inspected:	2025
Quarterly Data Report (QDR) Referenced:	Quarter 1 (Q1)
Inspection Selection:	Energy Safety viewed the contents of the Q1 QDR and performed an analysis that resulted in the selection of the WMP initiatives and locations referenced in this report.
Relevant WMP Initiative(s):	8.1.3.1 - Distribution Detailed Inspections and Remediations (IN-1.1)
Date of inspection:	September 04, 2025
City and/or County of Inspection:	Palos Verdes Peninsula, Los Angeles County
Inspection Purpose:	Assess the accuracy of Southern California Edison Company's QDR data, completeness of its work, compliance with WMP requirements, and compliance with its protocols.

Deficiency #	Structure ID	Grid Hardening ID	Lat/Long	HFTD	Initiative Number	Severity	Deficiency Description
Deficiency 1	1232593E	412152966-1232593E	33.796231, -118.360156	Tier 2	8.1.3.1 - Distribution High Fire Risk-Informed (HFRI) Inspections and Remediations	Minor	Failure to complete the tightening of guy wire

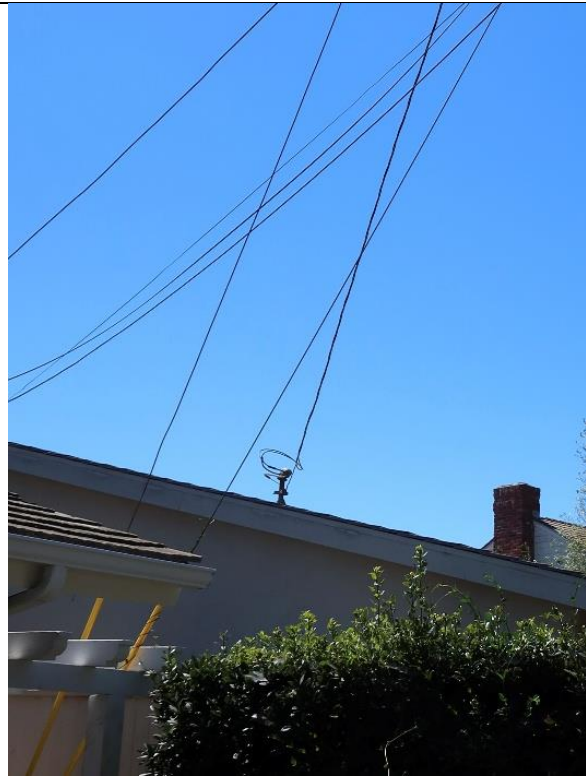
On Pole ID 1232593E, Grid Hardening ID 412152966-1232593E at 4200-4236 Via Alondra, Palos Verdes Peninsula, CA, 90274, USA, 33.796231, -118.360156, the inspector observed that the down guy wires were loose. The inspector's observation is documented in Deficiency 1 photographs, which are attached to this report. Photo numbers IA1Img1 and IA1Img2 depict loose guy wires. Per information provided by SCE to the Compliance Inbox on July 1, 2025, at 4:09 pm, the remediation work was completed.

1. Southern California Edison Company's 2025 WMP initiative number 8.1.3.1 Distribution Detailed Inspections and Remediations work identified that tightening of the guy wire was completed at this location.
2. The guy wires were loose.

IA1Img1: View showing not tightened guy wires

Deficiency 1. Energy Safety observed that in implementing 2025 WMP initiative 8.1.3.1 - Distribution High Fire Risk-Informed (HFRI) Inspections and Remediations (IN-1.1), SCE failed to complete the remediation of tightening a guy wire on Pole ID 1232593E, Grid Hardening ID 412152966-1232593E at coordinates 33.796231, -118.360156. Energy Safety considers this non-performance to be in the Minor risk category. SCE must complete a corrective action for this deficiency by 12 months from date of this notice.
