**December 29, 2025**

**BY ENERGY SAFETY E-FILING**

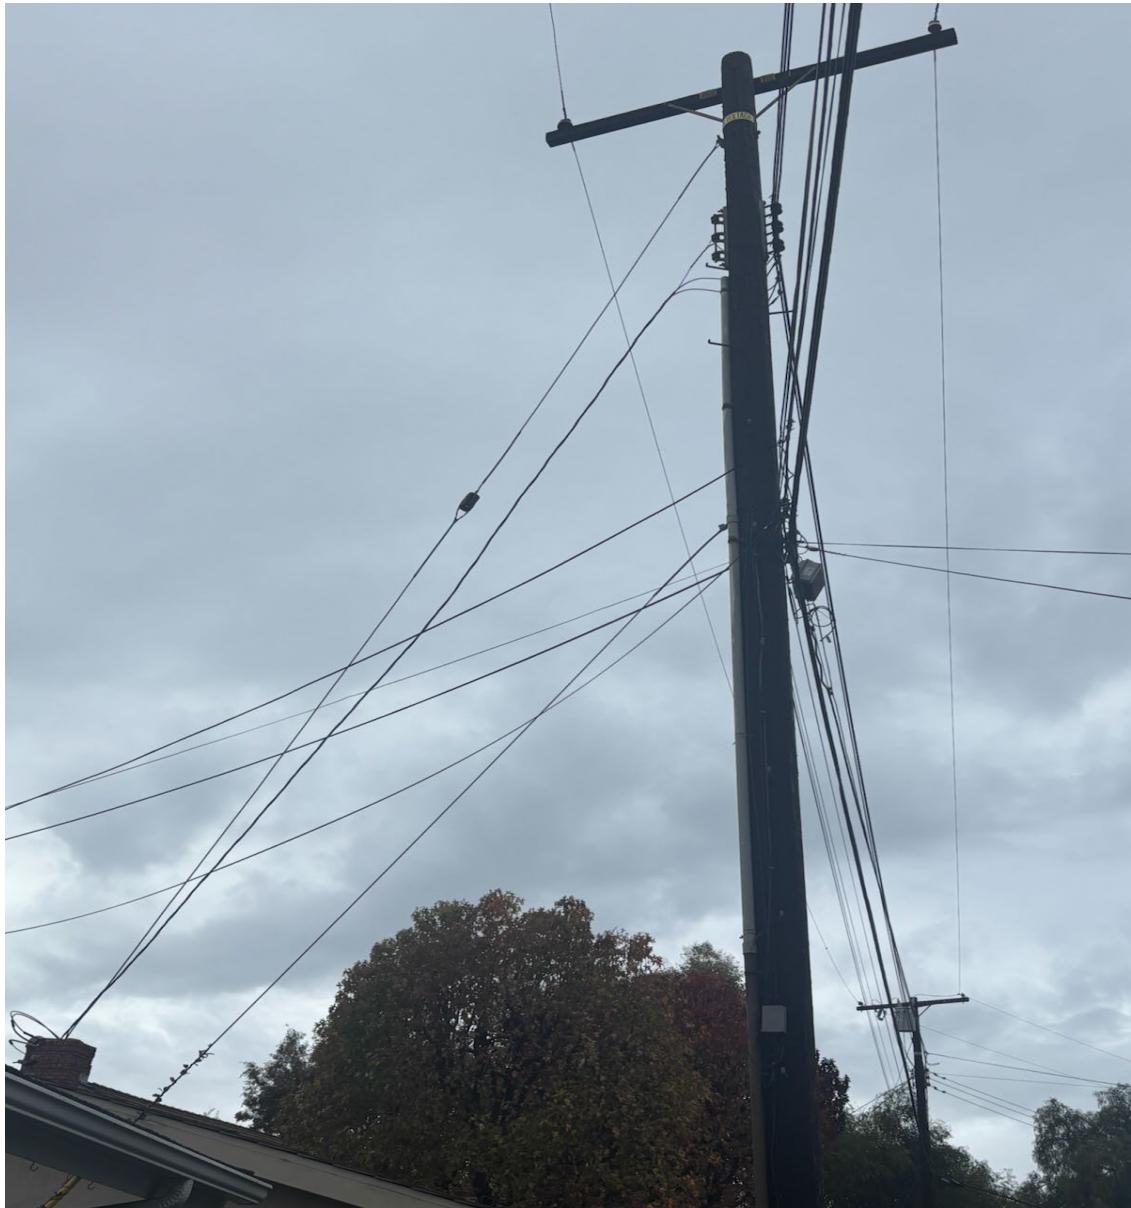
evidence below from SCE's December 26, 2025 inspection, documenting the guy wire in its secured condition.<sup>2</sup>
