February 3, 2025

Brandon Tolentino
Vice President, Wildfire and Business Resiliency
Southern California Edison Company
2244 Walnut Grove Ave
Rosemead, CA 91770

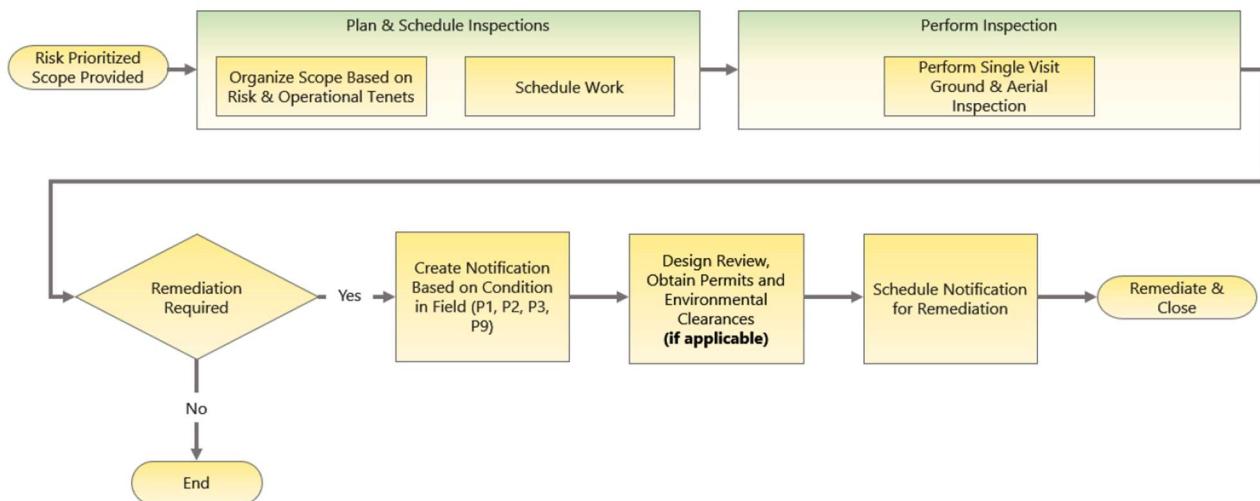
⁵ Southern California Edison Company, "2023-25 Wildfire Mitigation Plan," October 26, 2023, p. 284. [Online]. Available: <https://efiling.energysafety.ca.gov/eFiling/Getfile.aspx?fileid=55866&shareable=true>

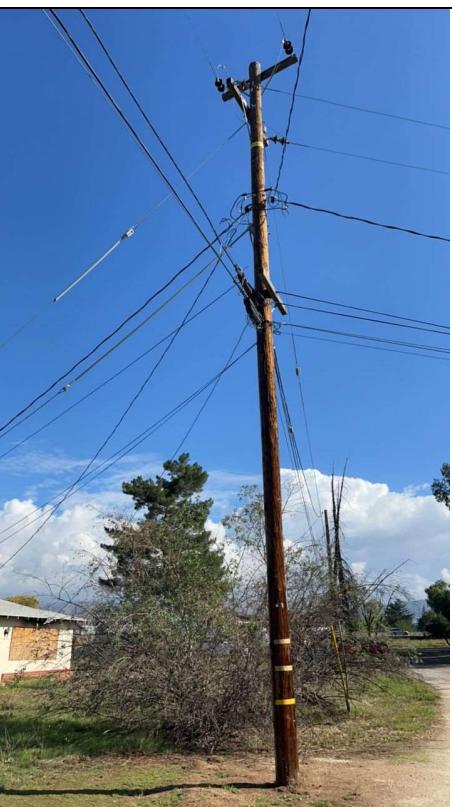
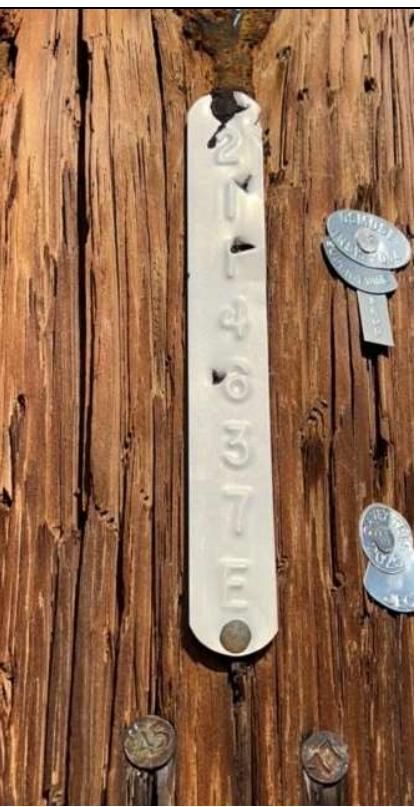
GImg1: Overall Structure	GImg2: Structure ID
