February 24, 2022

NOD\_SCE\_ATJ\_20211130-01

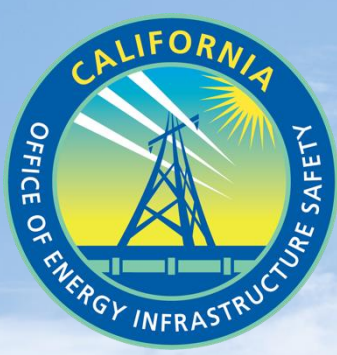
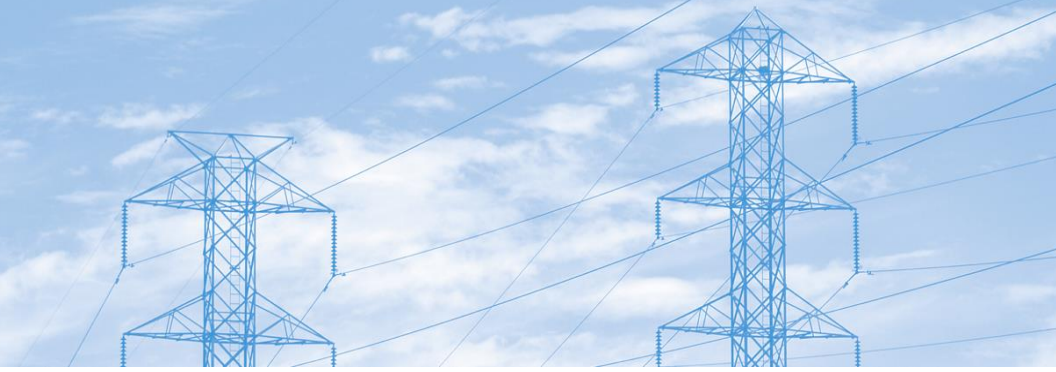
3 below. Issues discovered during these inspections are categorized as defects and are accompanied by a notice of defect (NOD).

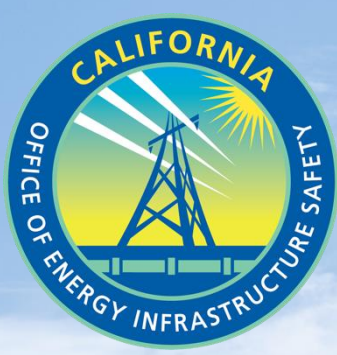
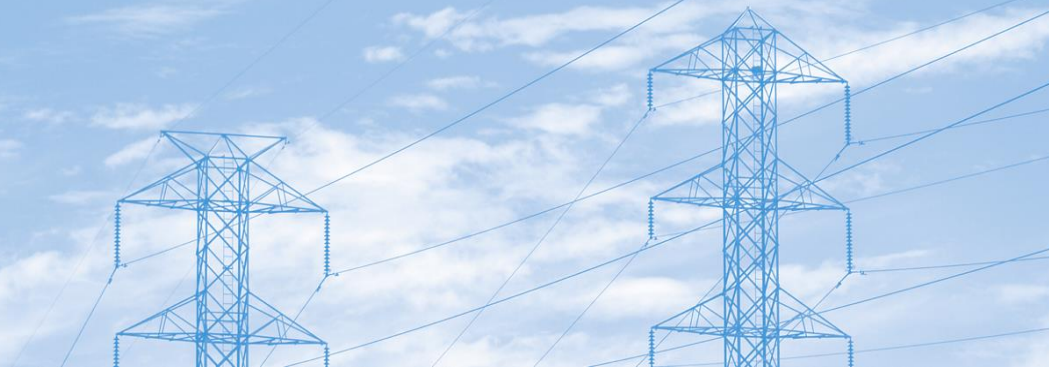
**Table 1. Risk Category and Correction Timelines**

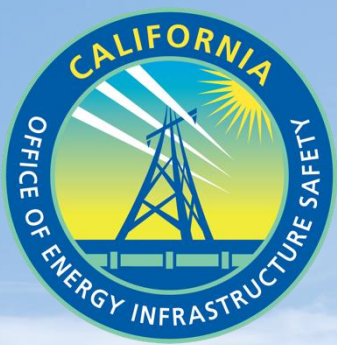
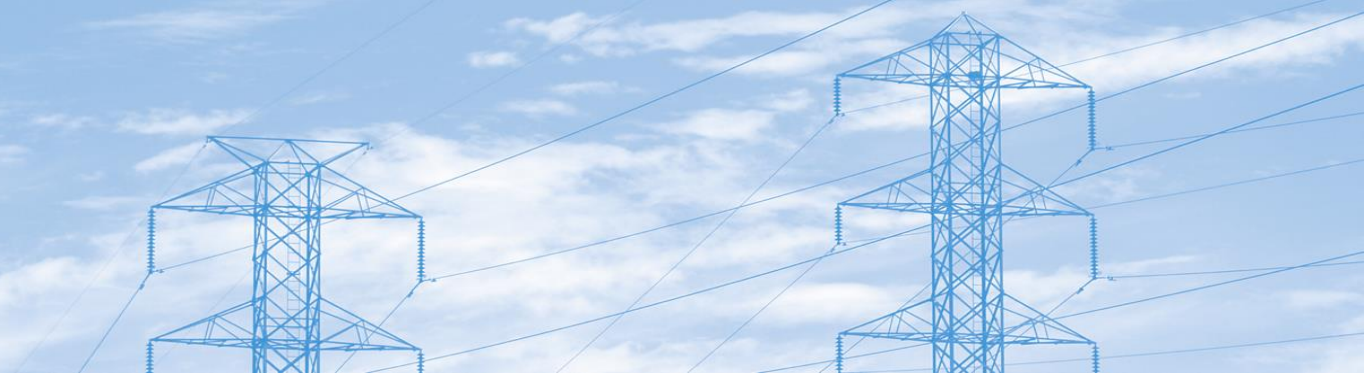
**Table 2. WMP Initiative Inspections**

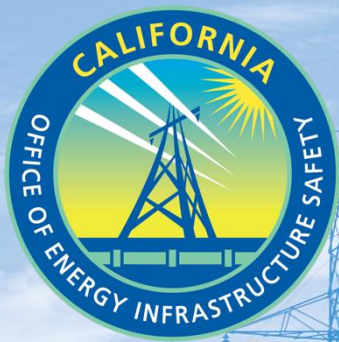
| Item | Structure ID | HFTD | Defect Type | Severity | Defect Description |
|---|---|---|---|---|---|
| 1 | 1561562E | Tier 3 | Down guy wire loose | Minor | Loose guy wire |

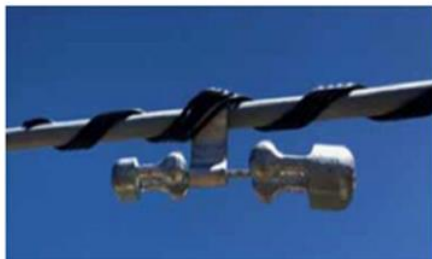
Figure 1: Stockbridge Damper
