OFFICE OF ENERGY INFRASTRUCTURE SAFETY

715 P Street, 20th Floor | Sacramento, CA 95814
916.902.6000 | www.energysafety.ca.gov

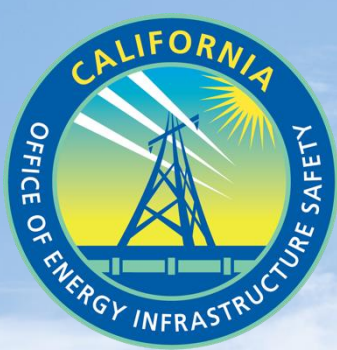
(b) The office’s primary objective is to ensure that regulated entities are reducing wildfire risk and complying with energy infrastructure safety measures as required by law.

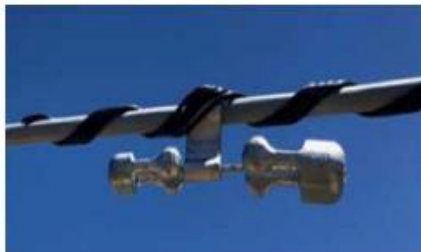
Figure 1: Stockbridge Damper
