Lise Jordan Sr. Director 245 Market Street, Rm. 1360 San Francisco, CA 94105

Mailing Address: Mail Code N13V P.O. Box 770000 San Francisco, CA 94177

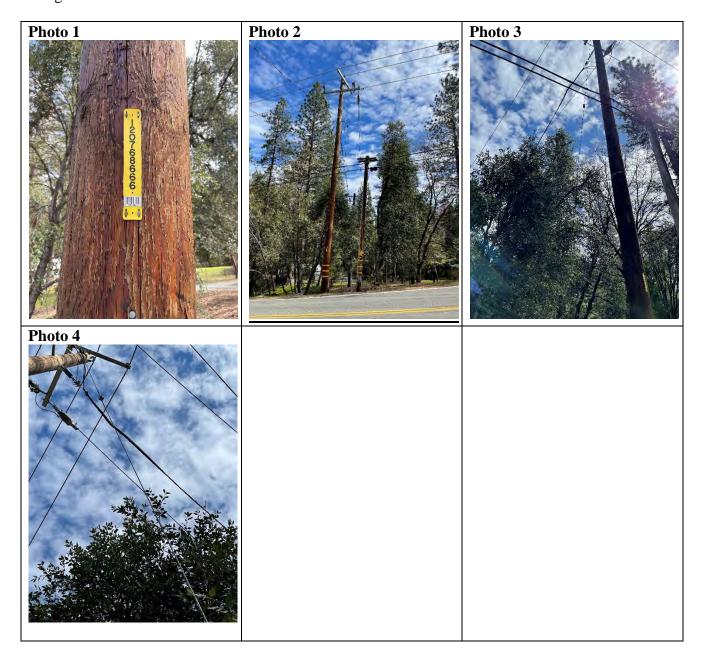
<u>Defect 1: Structure 120798920</u> Disposition: Defect not Found - No vegetation found contacting the guy wire above the insulator during field verification.

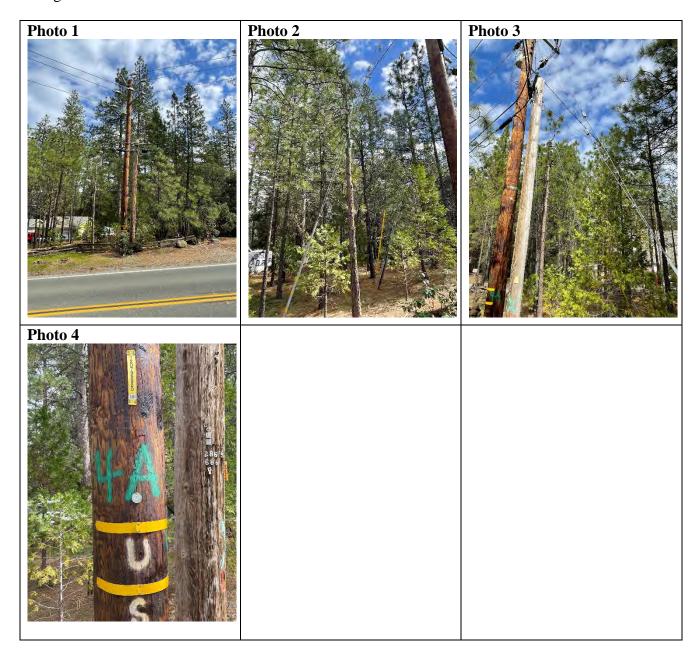
<u>Defect 1: Structure 120851082</u> Disposition: Defect not Found - No vegetation found contacting the guy wire above the insulator during field verification.

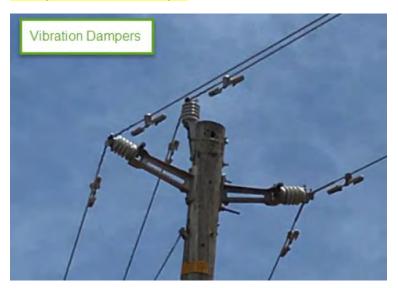
Example: Broken strands under vibration damper

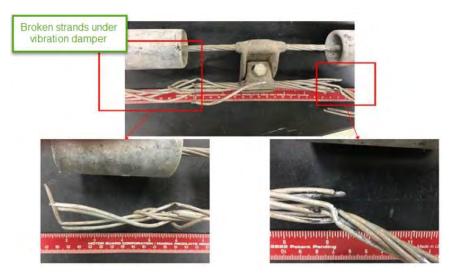
Example: Splice tied in to insulator

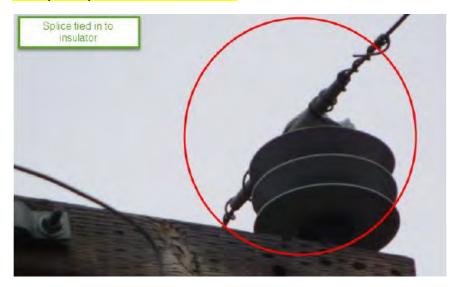
Example: Loose primary neutral ground:

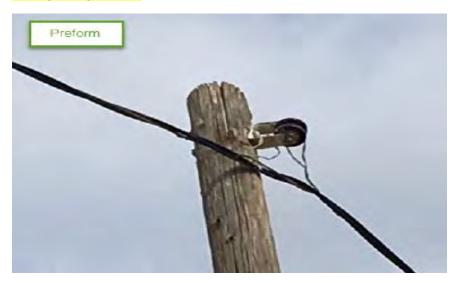
Example: Burnt conductor:

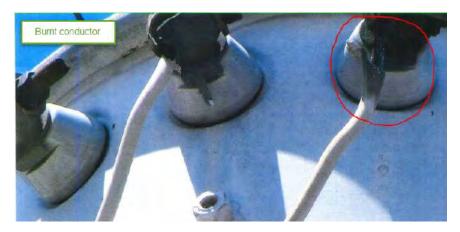
Example: Bird protection installed on conductor:

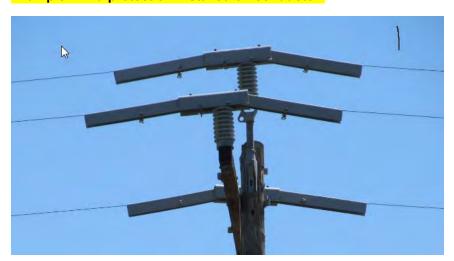
BROKEN SERVICE NEUTRAL

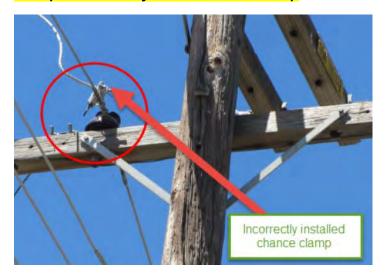
Example: Secondary connector installed in primary

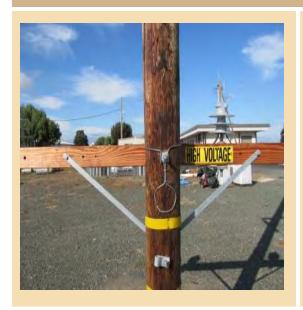
At this Location: Pole, burnt, pole failed

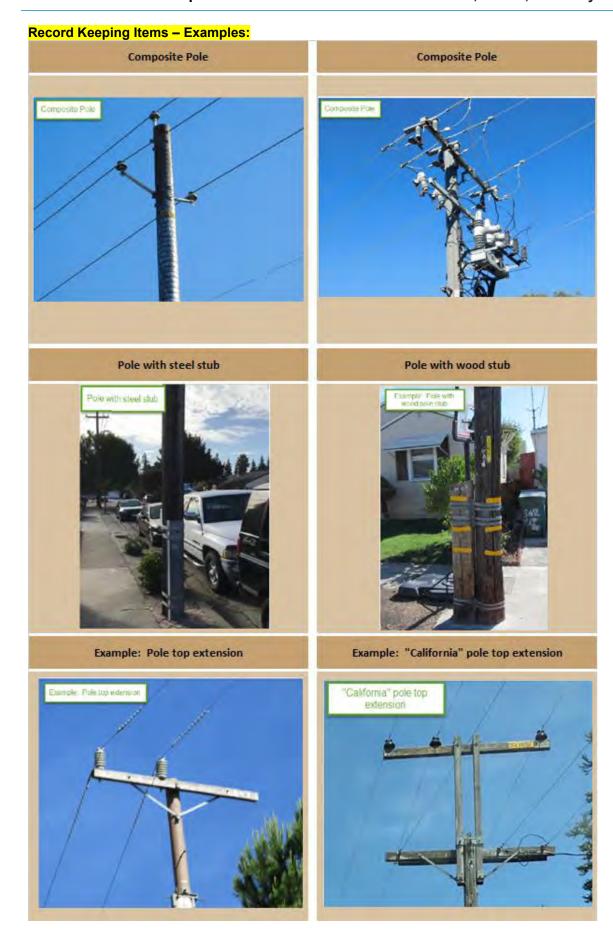
POLE BROKEN AT THE COMMUNICATION LEVEL

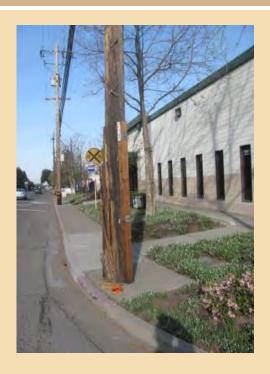
At this Location: Pole damaged by vehicle. Splint installed as temporary repair. Inspection shows adequate circumference/strength. Sharp ragged splinters. Curb is adequate protection – visibility strips not required.

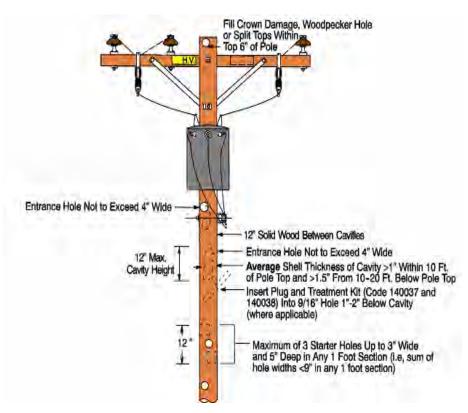
Assessing woodpecker damage
