TRANSMITTED VIA ELECTRONIC MAIL

June 15, 2022

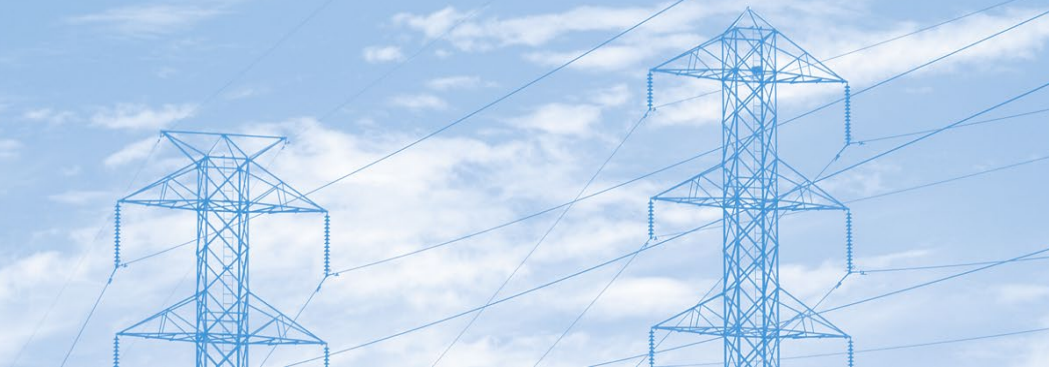
correction timelines. The correction timelines identified below apply to the results of both WMP initiative inspections as well as general wildfire safety inspections.

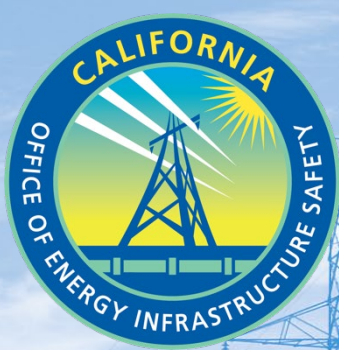
Structure ID	HFTD	Defect Type	Severity	Defect Description
1	4495329E	Tier 3	Vegetation near supply conductor w/radial clearance requirements	Moderate	Lateral tree branch within 4 feet of conductors.
2	1603964E	Tier 3	Vegetation contacting guy wire above insulator	Minor	Vegetation (vine) contacting guy wire above insulator.
3	1603964E	Tier 3	Vegetation near supply conductor w/radial clearance requirements	Moderate	Vegetation (vine) at crossarm and signs of wrapping around pole.
