## TRANSMITTED VIA ELECTRONIC MAIL

July 22, 2022

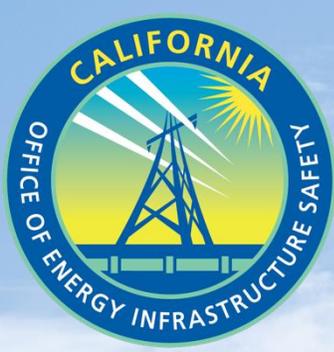
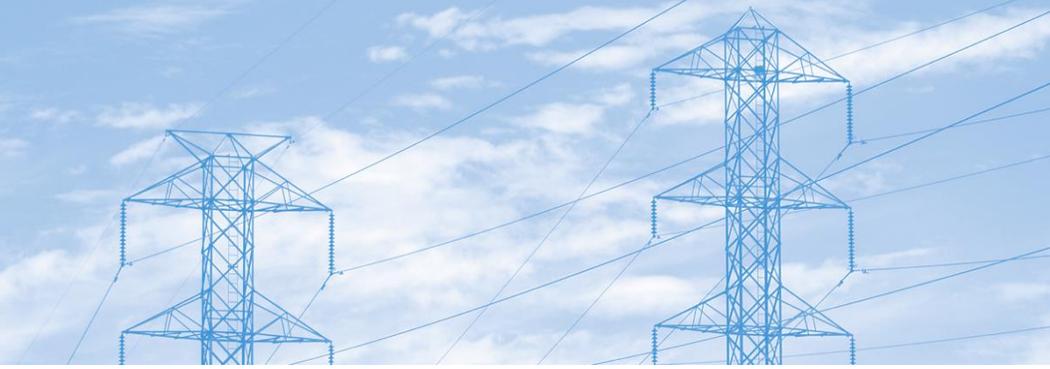
3 below. Issues discovered during these inspections are categorized as defects and are accompanied by a notice of defect (NOD).

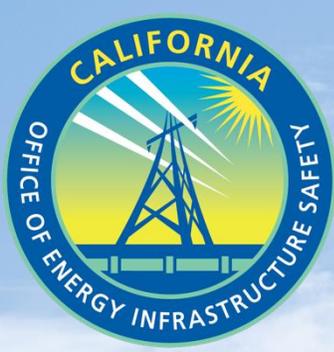
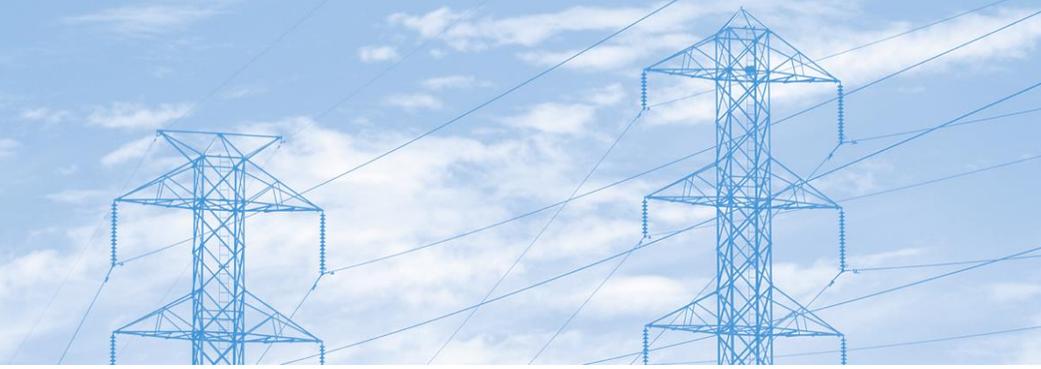
**Table 1. Risk Category and Correction Timelines**

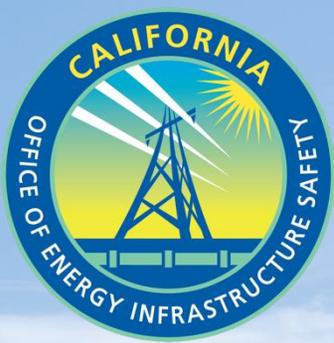
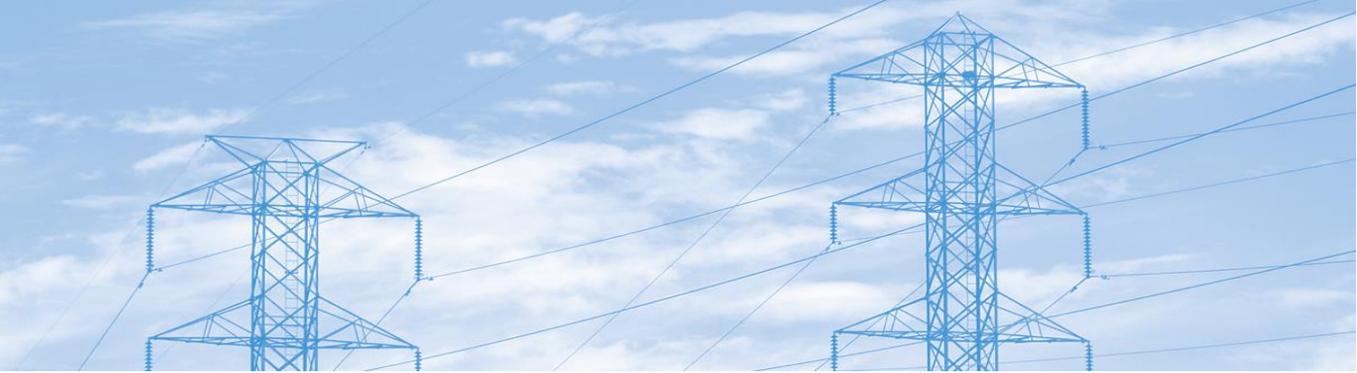
**Table 2. WMP Initiative Inspections**

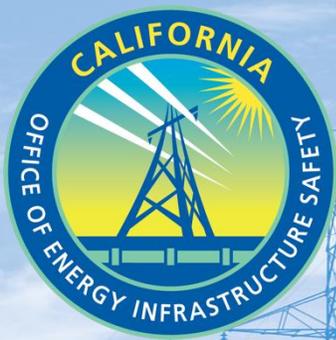
Item	Structure ID	HFTD	Defect Type	Severity	Defect Description
1	4719578E	Tier 2	Cold End Hardware	Minor	Triangular wildlife Guard loose/detaching from crossarm

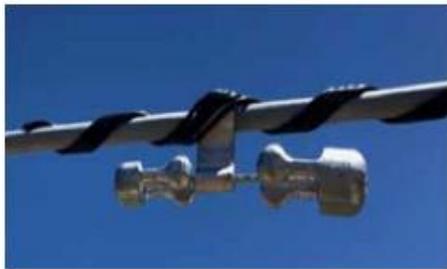
Figure 1: Stockbridge Damper
