TRANSMITTED VIA ELECTRONIC MAIL

July 22, 2022

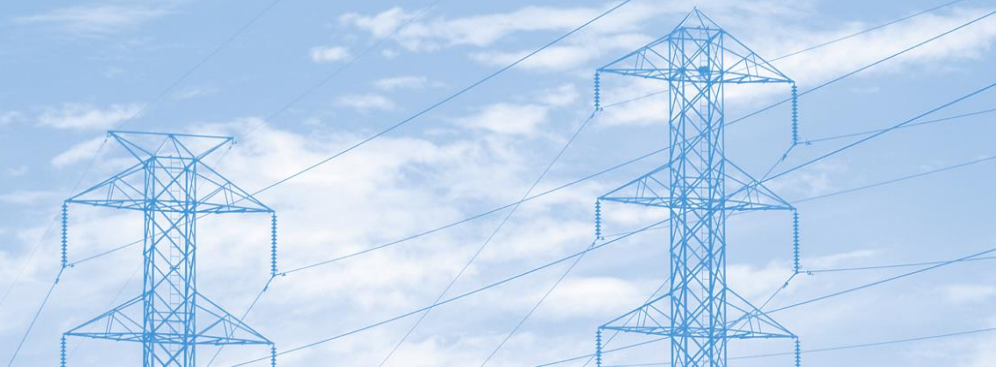
“General Wildfire Safety Inspections” and findings are detailed in Table 2 below. Issues discovered during these inspections are categorized as defects and are accompanied by a notice of defect (NOD).

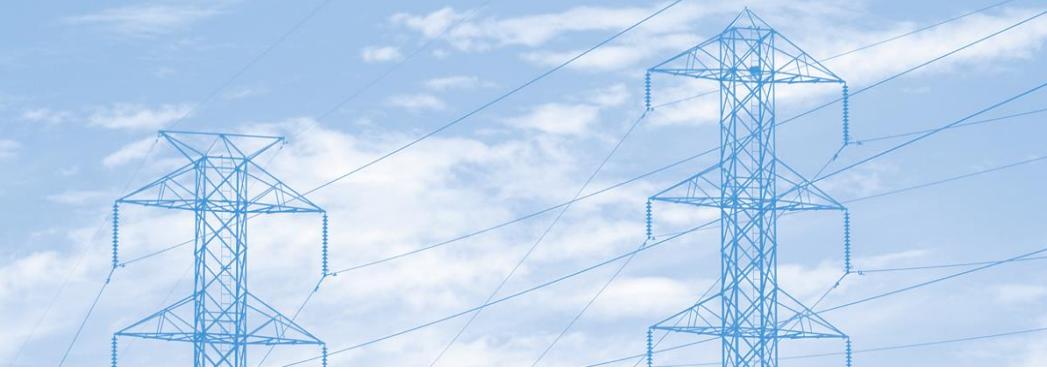
Table 1. Risk Category and Correction Timelines

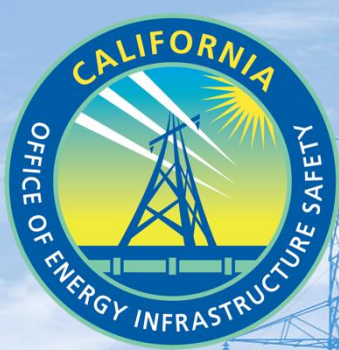
Item	Structure ID	HFTD	Defect Type	Severity	Defect Description
1	2344930E	Non-HFTD	Down guy wire loose	Minor	Span guy wire loose
2	4003373E	Non-HFTD	Down guy wire loose	Minor	Two loose down guys, one loose guy span
3	4003373E	Non-HFTD	Down guy wire loose	Minor	Two buried guy anchors
4	1564552E	Tier 2	Down guy wire loose	Minor	Buried guy anchor

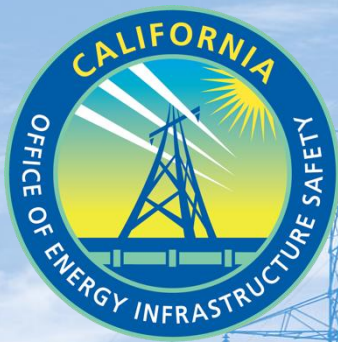
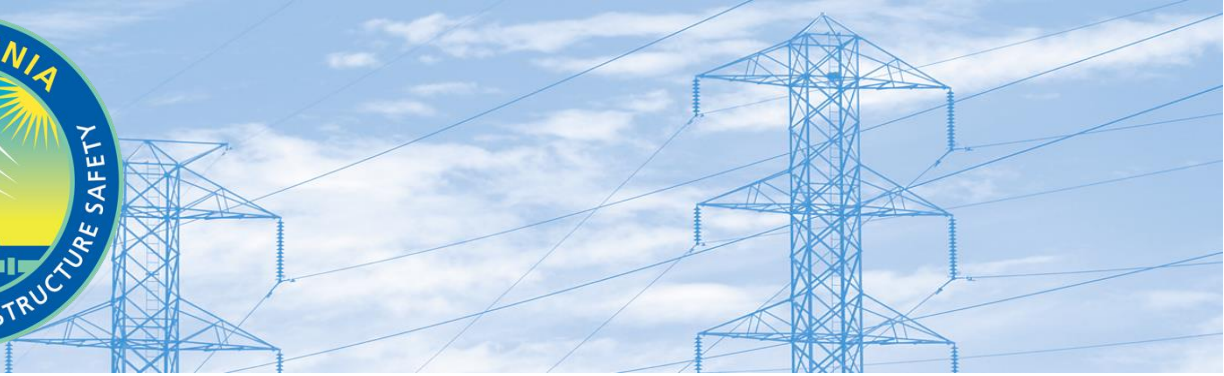
Pursuant to its objectives and statutory obligations, Energy Safety has completed the above referenced inspection and discovered violations and/or defects by Southern California Edison. Southern California Edison’s required response to these non-compliances and options for hearing are detailed in the associated notice of violation and/or defect, respectively.

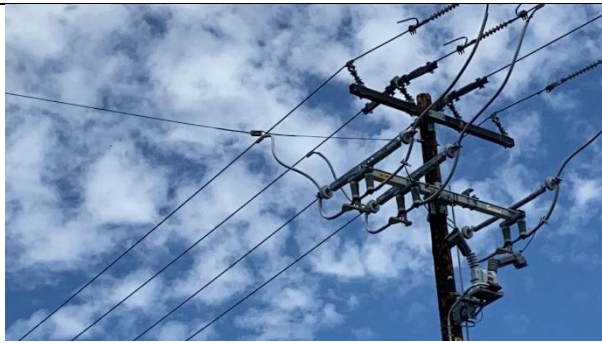
Item6GW1Img1: Close up Loose span guy

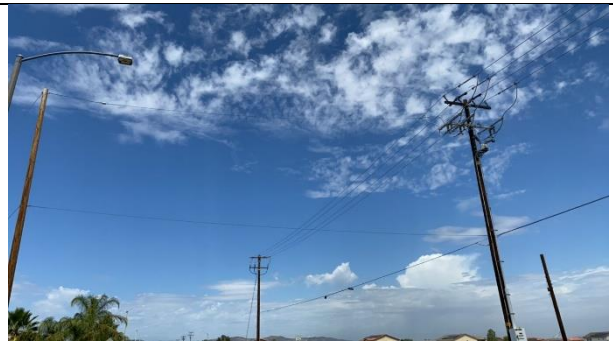
Item6GW1Img2: Overall view of guy span connecting to support pole

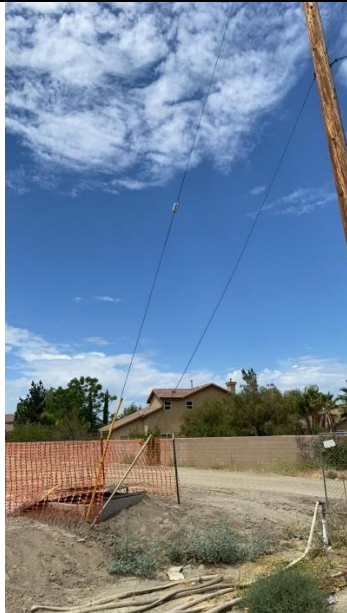
Item7GImg3: Two loose down guys

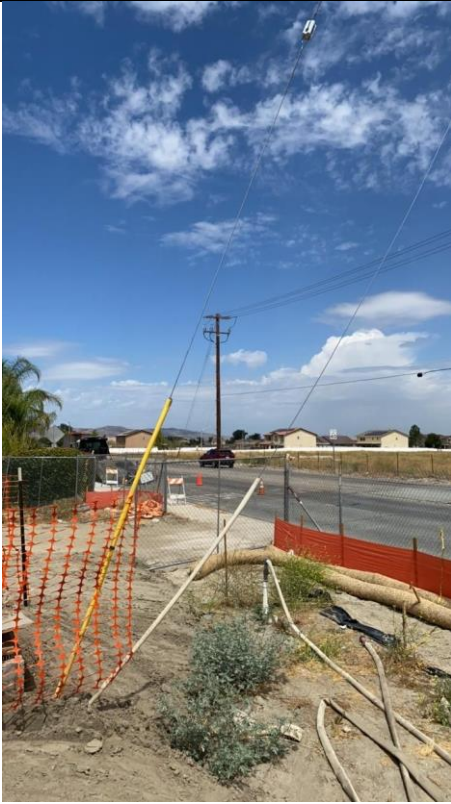
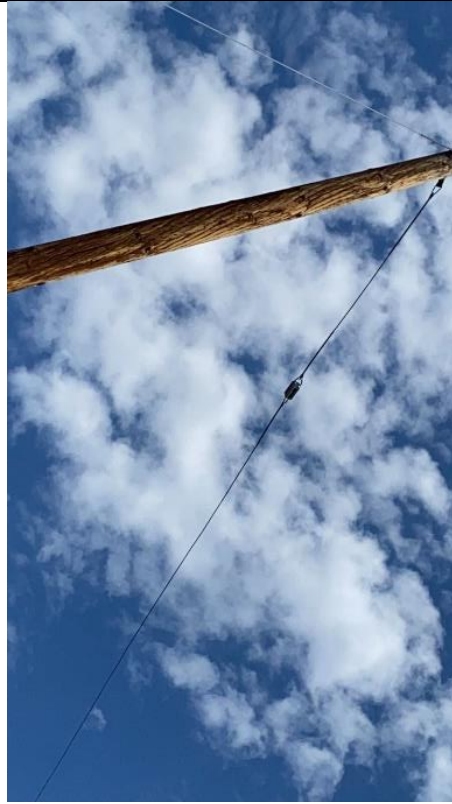
Item7GW1Img1: Two loose down guys

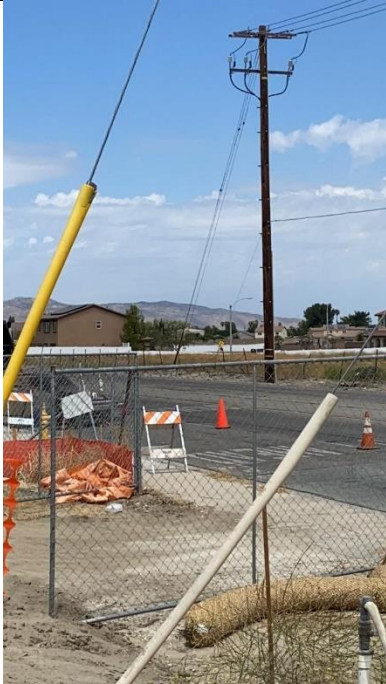
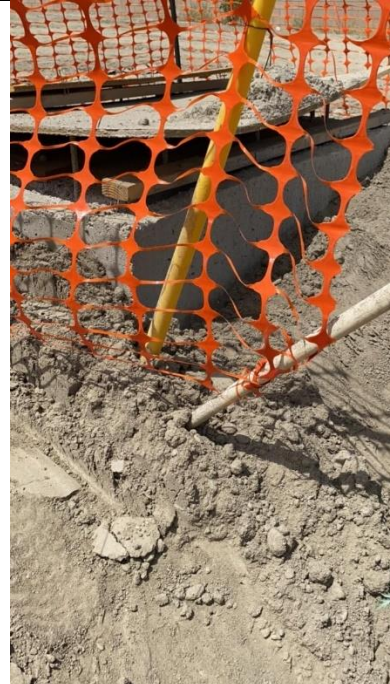
Item7GW1Img3: Loose down guys in motion
