Job Aid: Overhead Inspection

This job aid is designed to assist Electric Distribution Compliance Inspectors in assessing and prioritizing **compelling abnormal conditions** on overhead facilities during scheduled GO 165 Inspections.

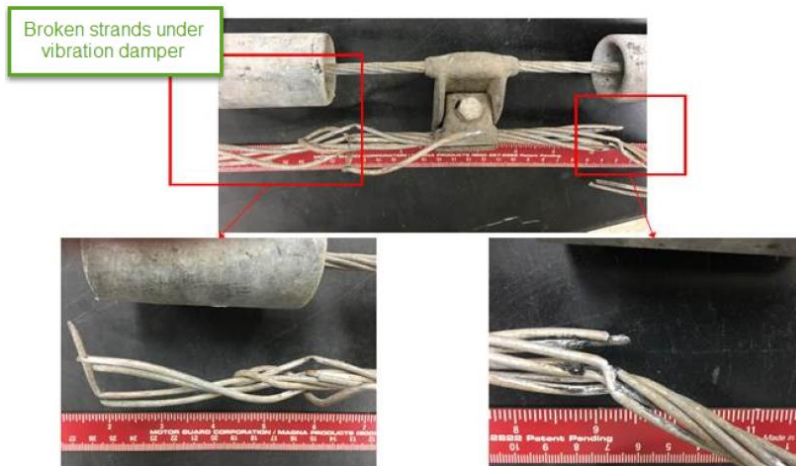
Example: Broken strands under vibration damper

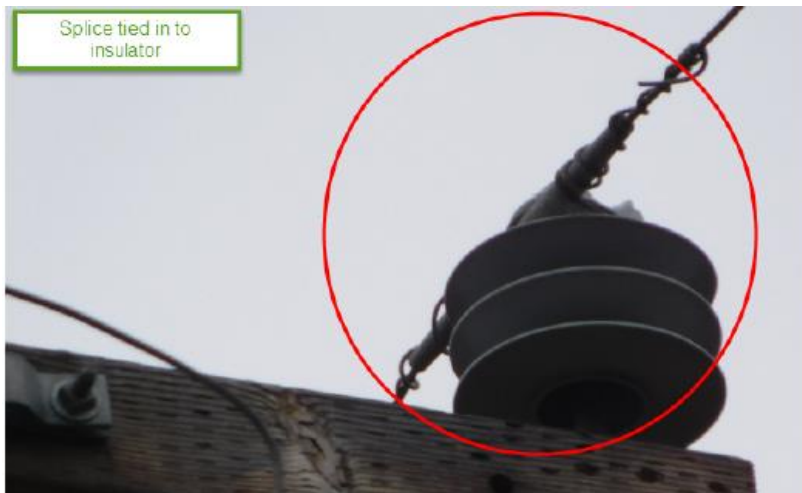
Example: Splice tied into insulator

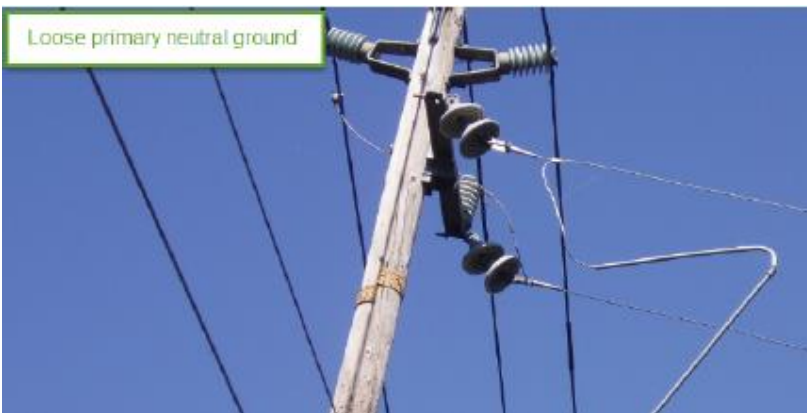
Example: Loose primary neutral ground:

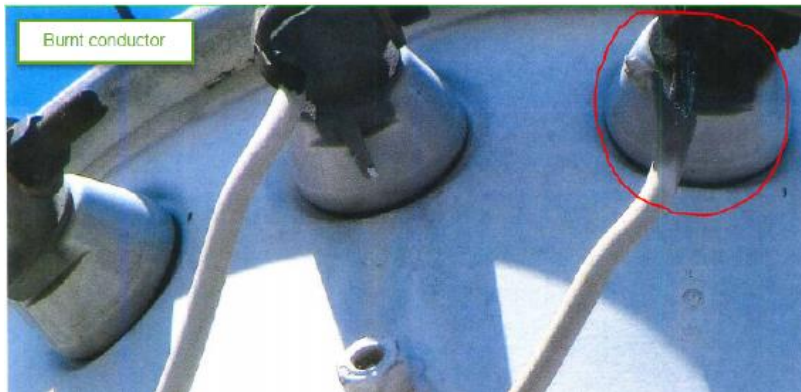
Example: Burnt conductor

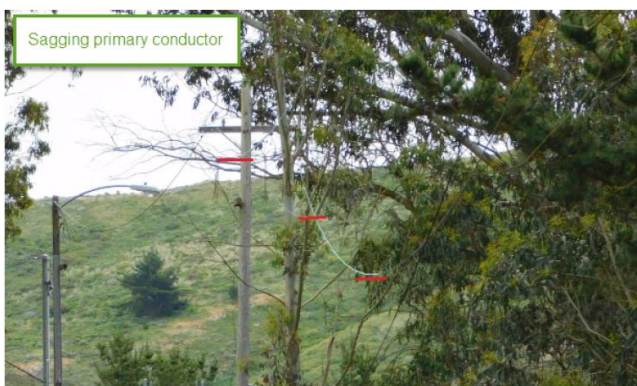
Example: Sagging conductor

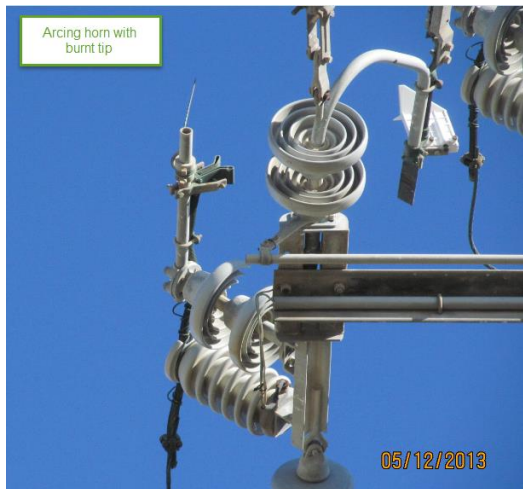
Example: Arcing horn with burnt tip

Minor Work: No

EC Form: Yes

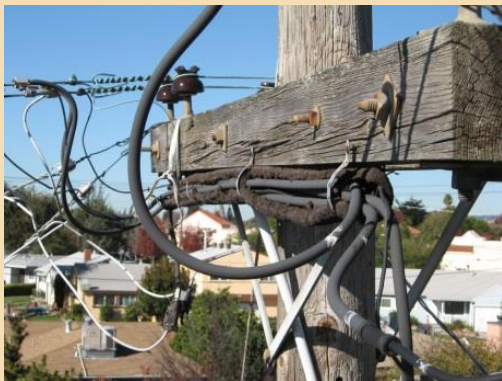
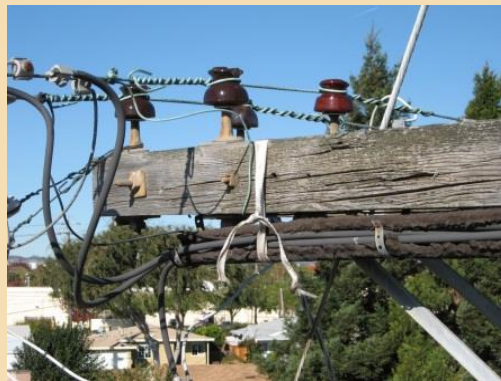
UNDER-ARM BUS LOOSE AND DETERIORATED

At this Location: UAB deteriorated, partial repair with rope, secured with one strap.

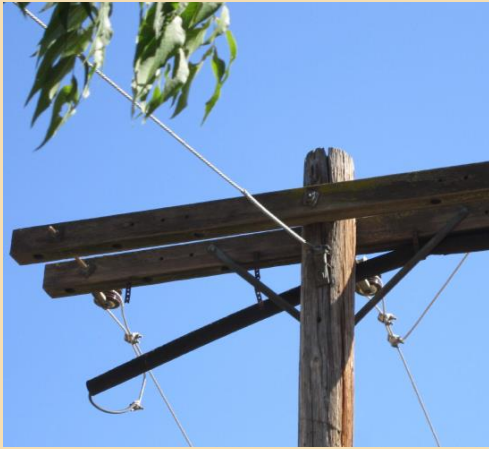
UNDER-ARM BUS LOOSE

At this Location: UAB Loose

Perform Minor Work: Yes

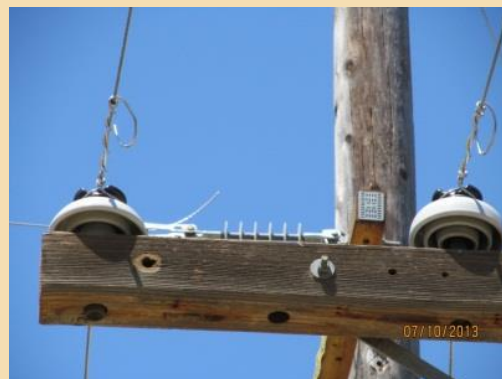
PRIMARY WOOD PIN SQUATTER

At this Location: Primary wood pin squatter. Replace Crossarm. No armor rod with hand-tie.

Perform Minor Work: No

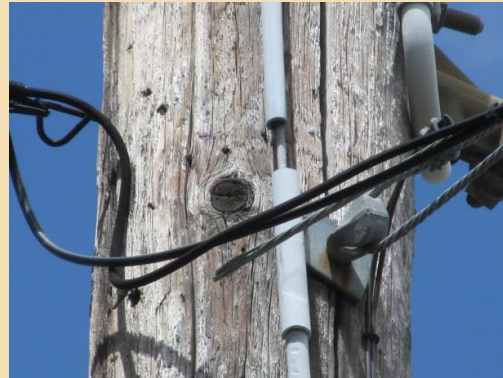
**PVC MOLDING NOT SECURE EXPOSING
GROUND**

At this Location: PVC molding not secure, due to failure of previous repairs, allowing human contact.

Perform Minor Work: Yes

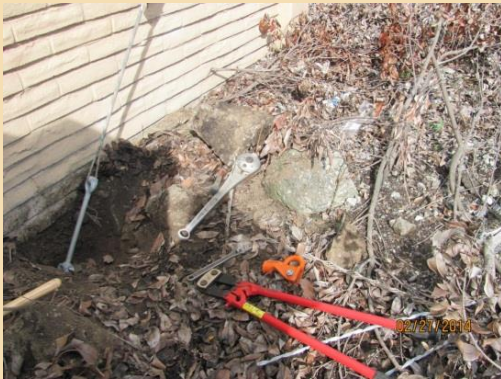
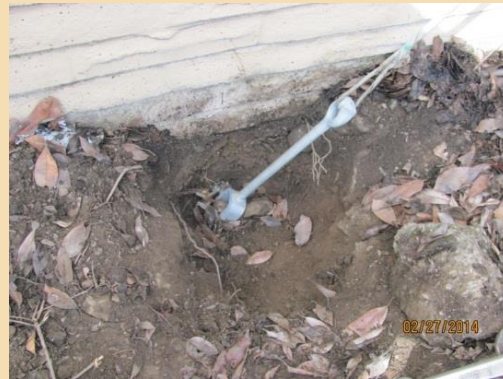
ANCHOR EXTENSION

At this Location: Inspector performed minor work, exposed anchor, evaluated anchor to be in good condition so that extension could be installed, then installed extension. (Back fill not shown)

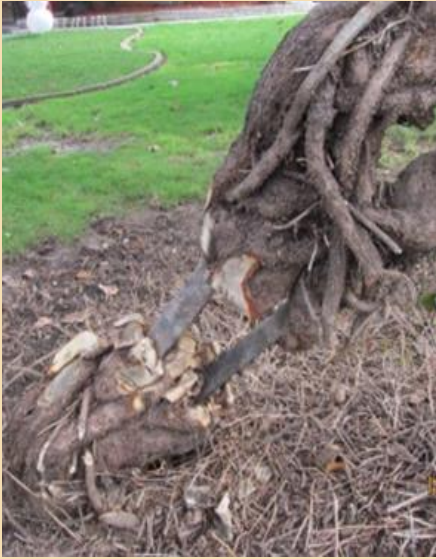
ANCHOR BURIED BY VEGETATION

**Anchor buried by roots**

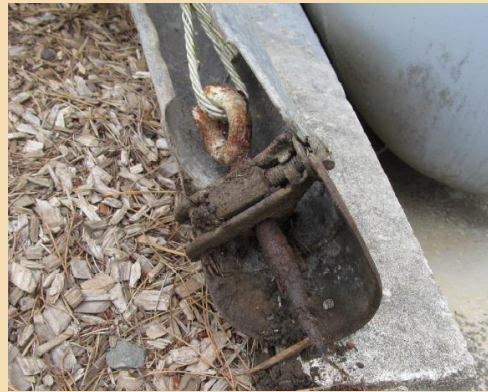
At this Location: Corroded Anchor

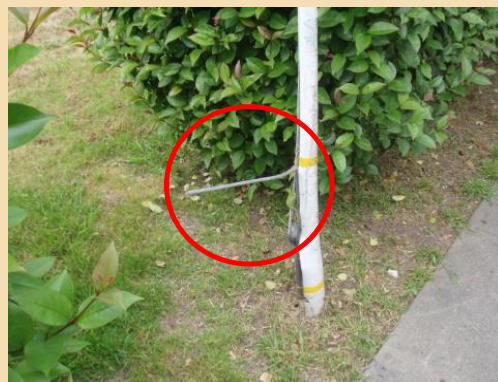
GUY DAMAGED REPAIR

At this Location: Guy tail extends beyond the preform near sidewalk, safety hazard.

Perform Minor Work: Yes

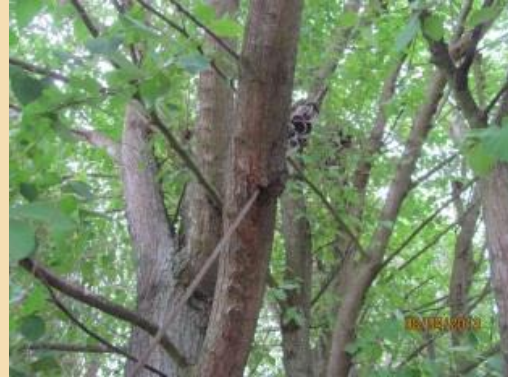
TREE GROWING AROUND GUY

- FDA=Guy / Broken/Damaged / Replace
- Priority "E", 3-12 months depending upon exposure

At this Location: Tree growing around guy

Perform Minor Work: No

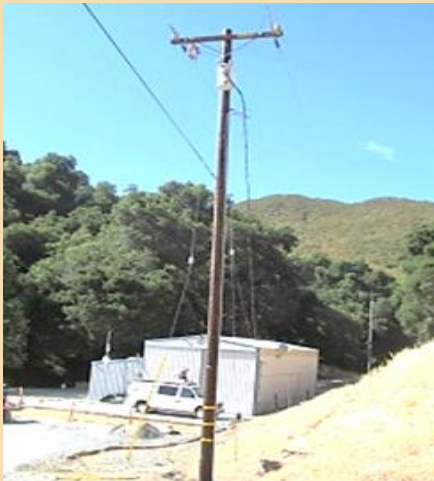
SLACK GUY

At this Location: Loose guy on left side

Perform Minor Work: Yes

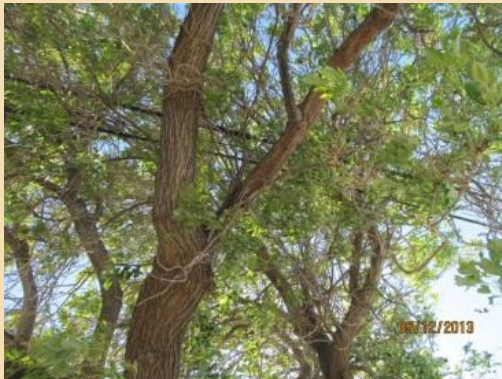
TREE LIMB GROWING AROUND GUY

Guy through tree

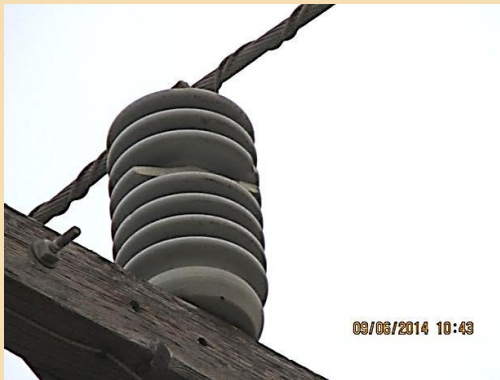
DAMAGED INSULATOR

At this Location: Damaged insulator with an insulator that I no longer approved. Replace all insulators and the arm

Perform Minor Work: No

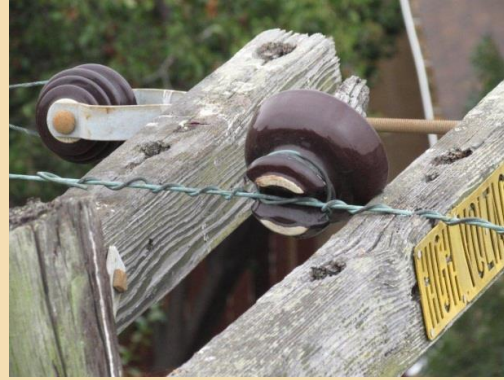
INSULATOR LAYING ON ITS SIDE / PRIMARY ON THE ARM

At this Location: Insulator lying on its side. Primary on the arm.

Perform Minor Work: No

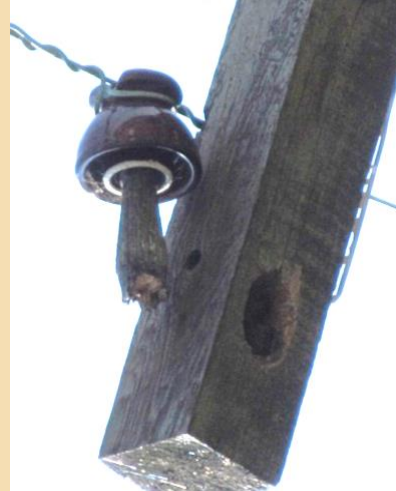
BROKEN WOOD PIN ON PRIMARY

At this Location: Broken wood pin. Primary (High Voltage Sign). Conductor on arm. Replace all insulators and the crossarm with a composite arm.

Perform Minor Work: No

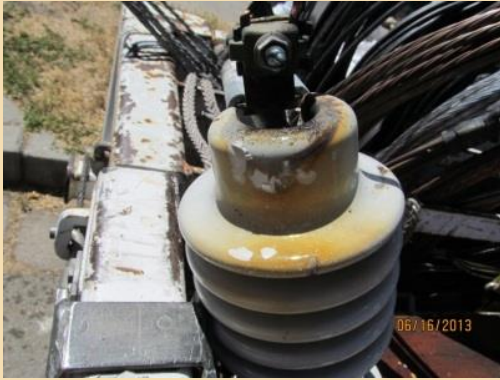
FLASHED INSULATOR POTHEAD

At this Location: Flashed pothead

Perform Minor Work: No

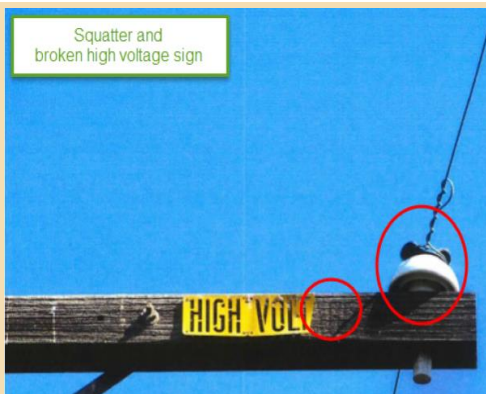
PRIMARY SQUATTER AND BROKEN HIGH VOLTAGE SIGN

At this Location: Primary squatter and broken high voltage sign

Perform Minor Work: No

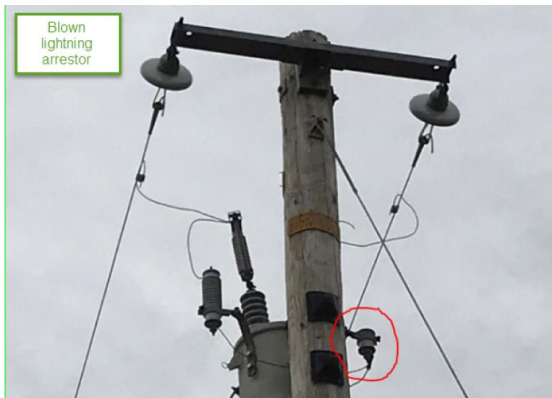
Example: Blown lightning arrestor

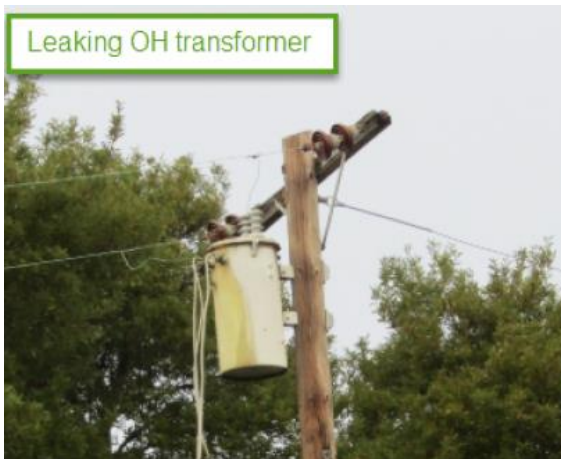
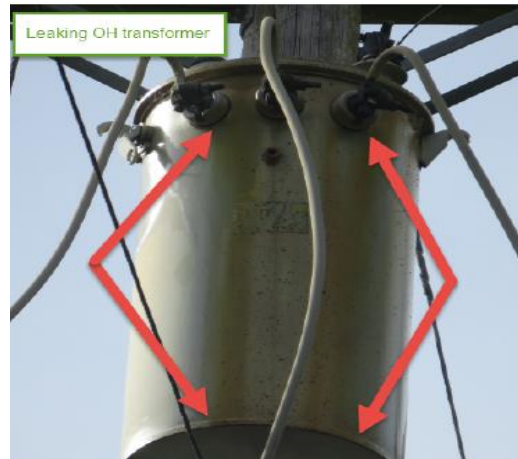
Minor Work: No**Related Documents:** TD-2320P-01 Attachment 4**Examples:** Leaking OH Transformer

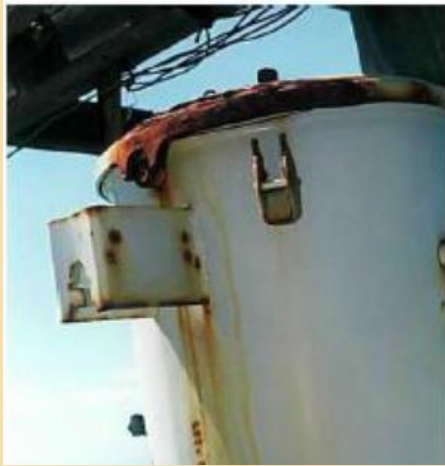
OH CORROSION EXAMPLES

At this Location: Corrosion Weakening Integrity of Tank

Metal is separating into layers

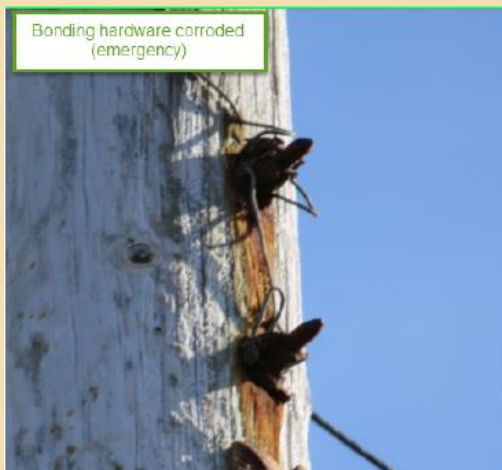
At this Location: Bonding hardware corroded

Perform Minor Work: No

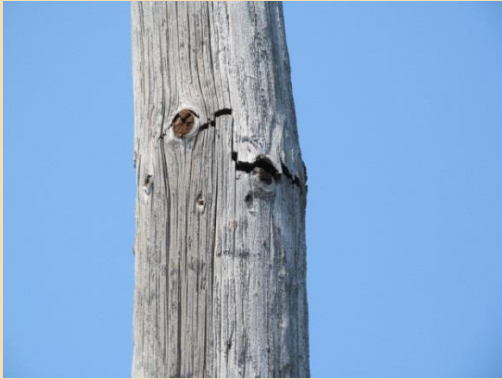
BROKEN POLE

At this Location: Broken pole. Complete the Pole Inspection Test Report. Pole supported in four directions.

Perform Minor Work: No

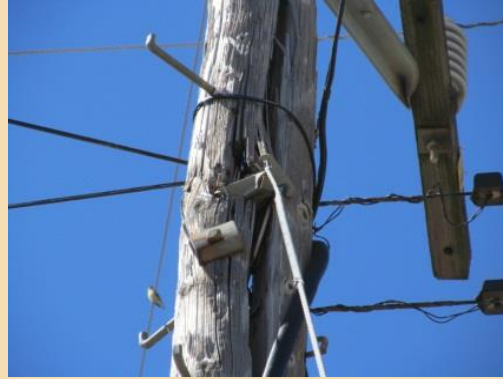
POLE SPLIT AT COMMUNICATION LEVEL

At this Location: Pole split at communication level. Complete the Pole Inspection Test Report.

Perform Minor Work: No

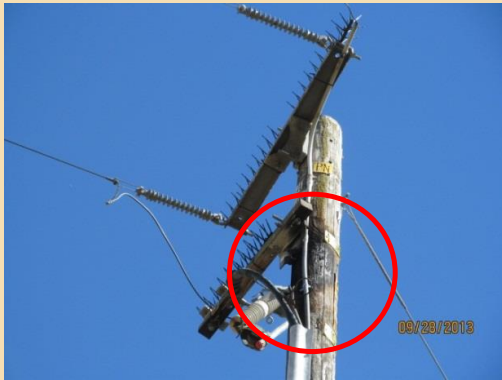
DAMAGE TO POLE FROM SPECIFIC EVENT

**At this Location:** Pole burnt

If pole has reduced circumference. Write EC notification for estimating to confirm pole loading.

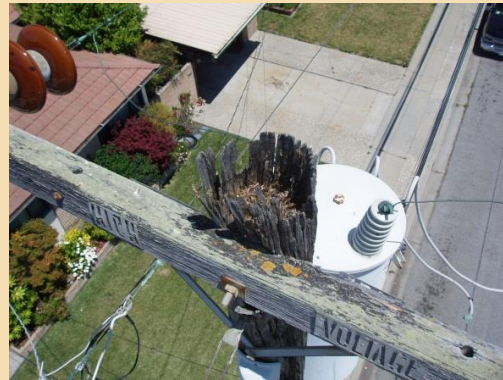
DECAY OF POLE OVER TIME

At this Location: Pole top decayed. Entire pole failed pole test. Complete the Pole Inspection Test Report.

Perform Minor Work: No**Write Third-Party Notification:** No**Write EC Form:** Yes

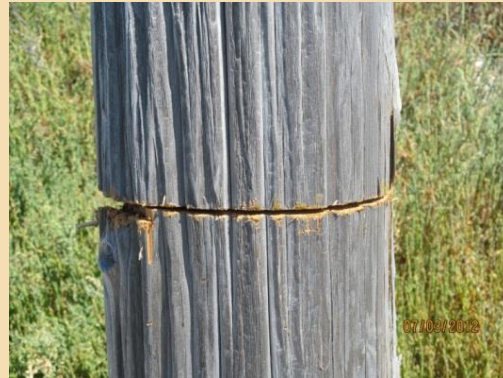
- FDA=Pole / Broken/Damaged/ Replace
- Priority "A" or "B", 0-3 months depending upon exposure

At this Location: Vandalized pole. Chain saw cut into lower portion of pole. More than half of pole circumference cut into.

Notify supervisor of possible vandalism. Supervisor will have to communicate to damage claims. Complete Poles Inspection Test Report.

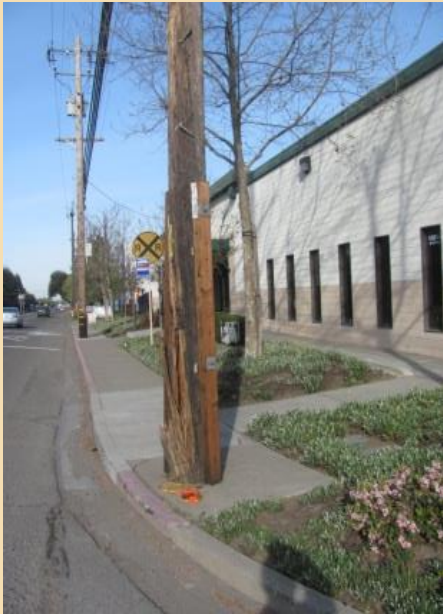
POLE DAMAGED ON THE BOTTOM BUT OK

At this Location: Pole damaged by vehicle. Splint installed as temporary repair. Inspection shows adequate circumference/strength. Sharp ragged splinters. Curb is adequate protection – visibility strips not required.

If pole has reduced circumference write EC notification for estimating to confirm pole loading. If damage requires replacement, create an EC notification to replace the pole.

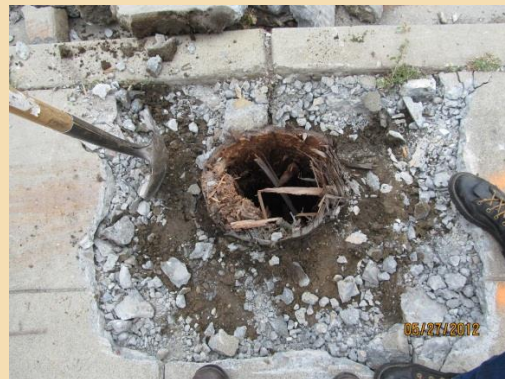
**After extraction showing
below ground deterioration**

At this Location: Deteriorated condition found during normal inspection. Complete Pole Inspection Test Report. If pole has reduced circumference. Write EC notification for estimating to confirm pole loading.

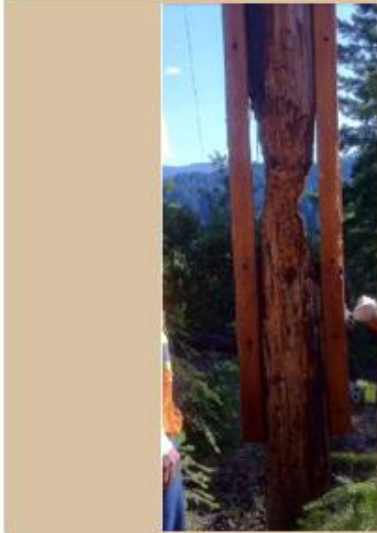
Significant reduced circumference (bear damage)

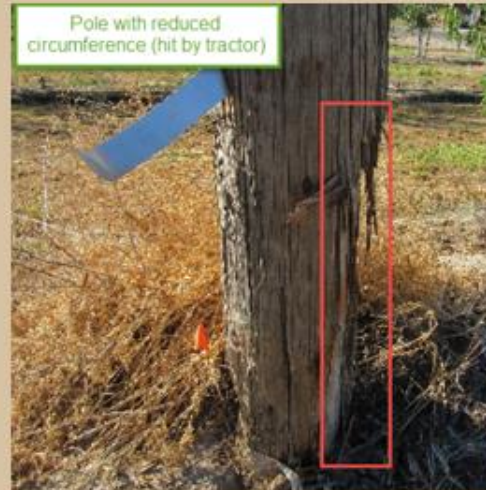
Significant reduced circumference (tractor damage)

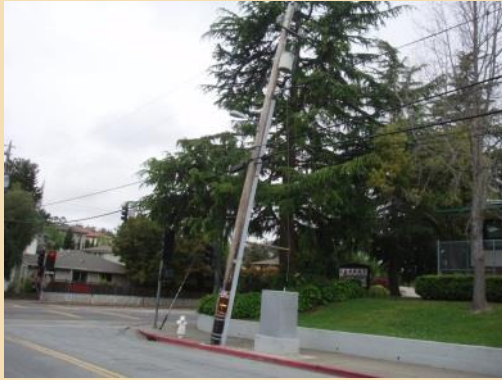
STUBBED POLE LEANING TOWARDS SCHOOL

At this Location: Stubbed pole leaning towards school, supported by down guy. Pole Bands are loose due to additional deterioration of the pole. Pole test data sheet indicates that pole no longer meets stubbing criteria causing reduced clearance issues

Perform Minor Work: No

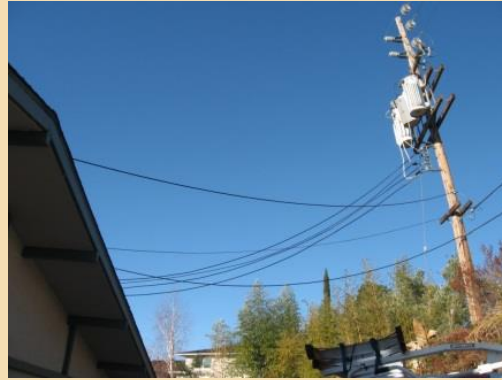
POLE LEANING 3 POT TRANSFORMER IN BUCK POSITION

At this Location: Pole is leaning less than 10% out of plumb, leaning in direction of offset equipment. Pole inspection found pole stable.

Perform Minor Work: No

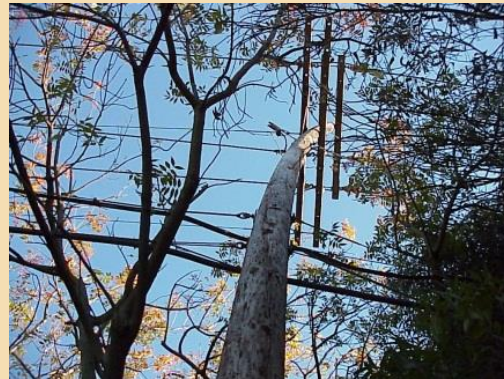
UNBALANCED LOAD AT TOP

At this Location: Deformed pole with bowed top in line with conductor.

Perform Minor Work: No

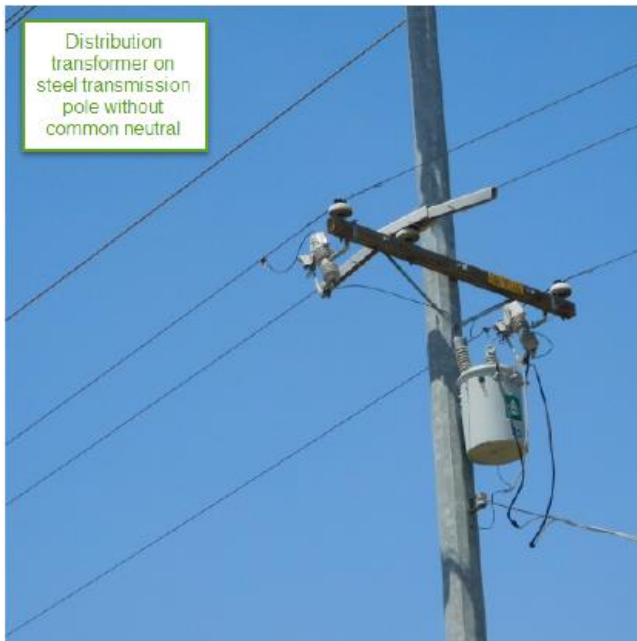
Example: Distribution transformer on steel transmission pole without common neutral.

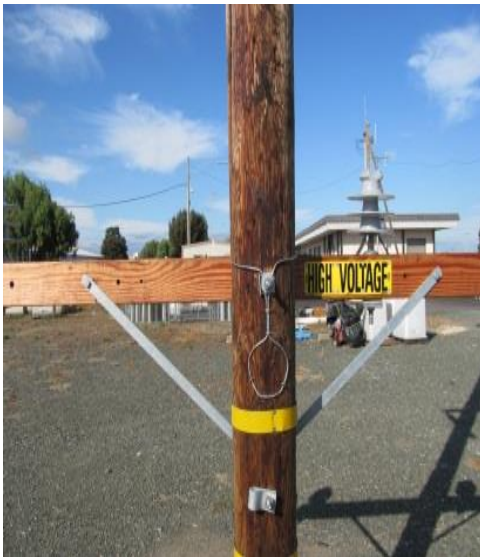
Related Documents: TD-2305M-B009**Example:** Wood Crossarm on Transmission with Distribution Underbuild that requires bridging

Example 3:**Checklist item:** Missing or broken distribution bridging or bonding**Guidance:** If observed, yes, create EC notification to repair or install missing bridging.**EC Form:** Yes

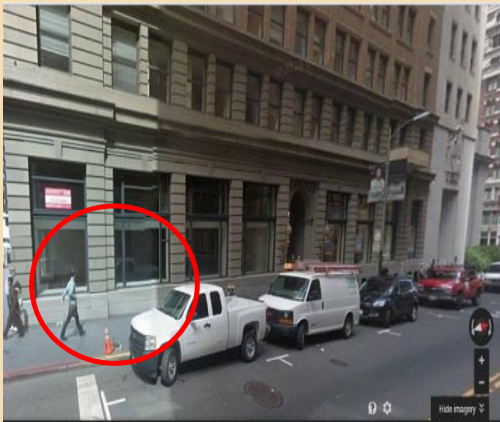
MISSING STREET LIGHT

At this Location: Cone indicates location of missing decorative street light and pole. Exposed wire is de-energized. Include picture of similar street light for replacement.

Perform Minor Work: Yes, make safe.

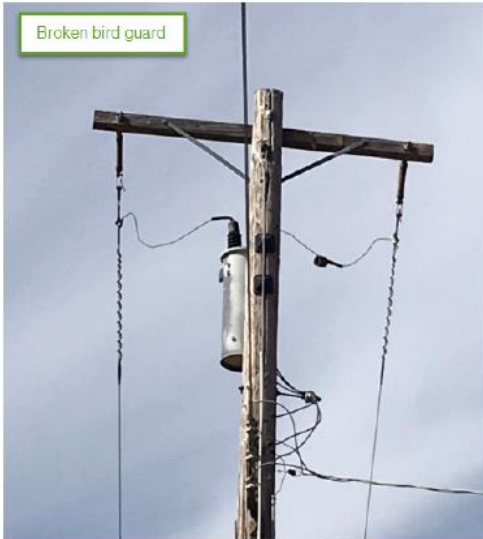
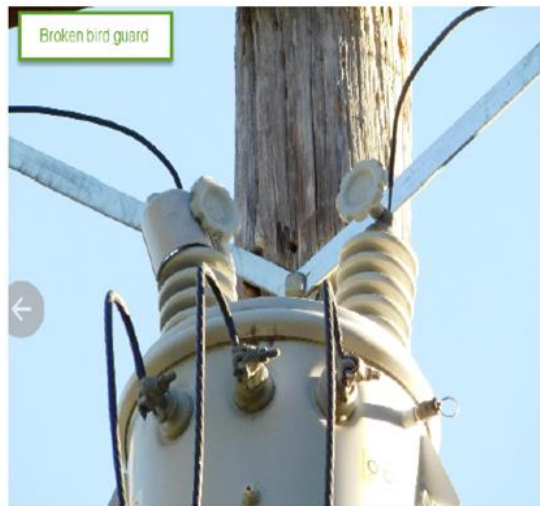
Examples: Broken bird guard

Minor Work: No

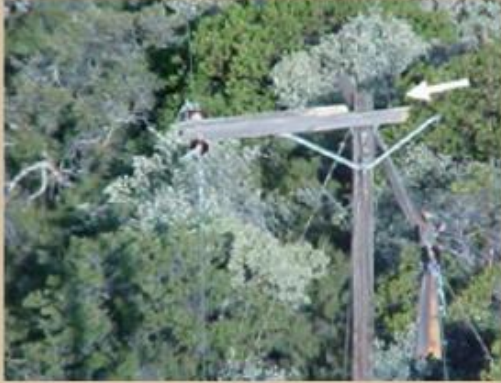
Crossarm is completely broken/fractured

Emergency - make safe immediately

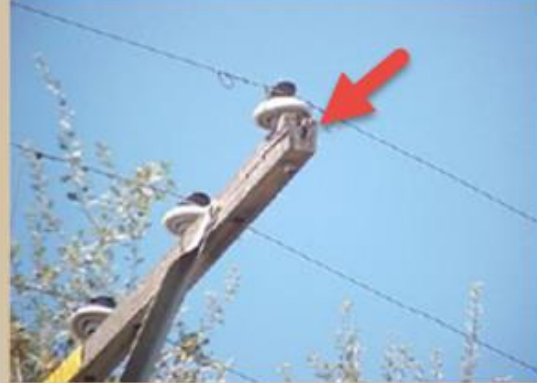
SPLIT CROSSARM

Primary Squatter (wood pin). Crossarm split within 2" of pinhole.

Replace in the next 3 months.
