# Job Aid: Overhead Assessment

This job aid is designed to assist Electric Distribution Compliance Inspectors, PG&E Employees, and Contractors in assessing and prioritizing compelling **abnormal conditions** on overhead facilities, including but not limited to GO 165 Inspections. Compelling Abnormal Condition is defined as any electric distribution pole, equipment, component, conductors, vegetation, or third-party condition that causes a safety or fire ignition risk that, in the judgment of the field employee, may adversely impact public safety and/or service reliability **within 5 years**.

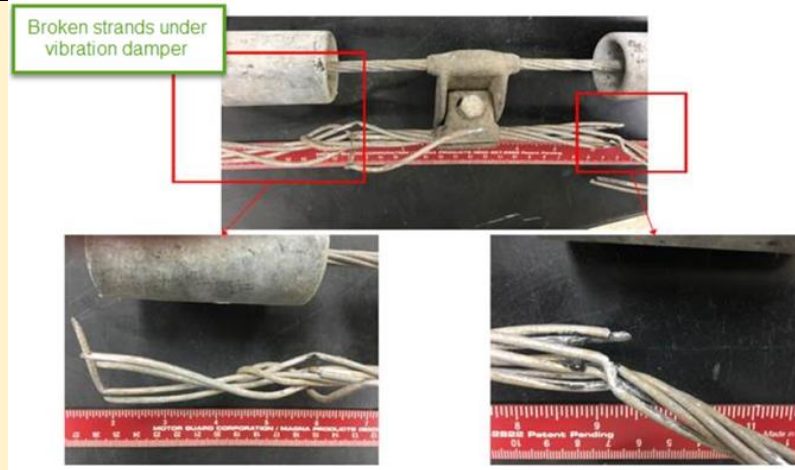
**At this Location:** Broken strands (more than 40%) under vibration Damper

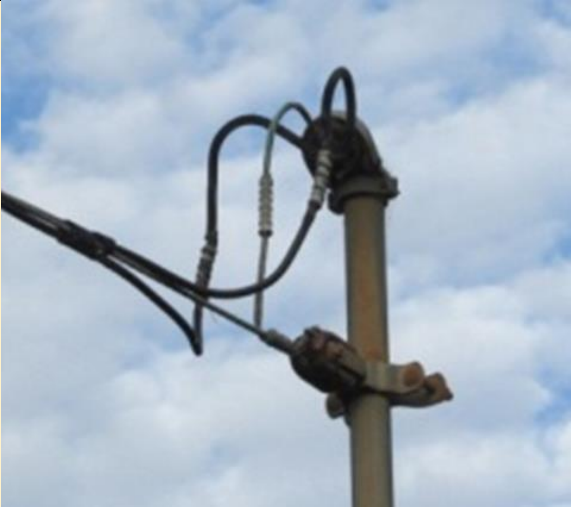
Exposed Service Connector

<b>At this Location:</b> Exposed Conductors, with an acceptable air gap between conductors
	<b>Perform Minor Work:</b> Yes, if safe to do so
	<b>Write 3<sup>rd</sup> Party Notification:</b> No
	<b>Write EC Notification:</b> Yes, if minor work cannot be performed
	<b>FDA=</b> Conductor / Broken / Damaged / Repair
	<b>Priority =</b> E Tag, 3-12 months depending on exposure

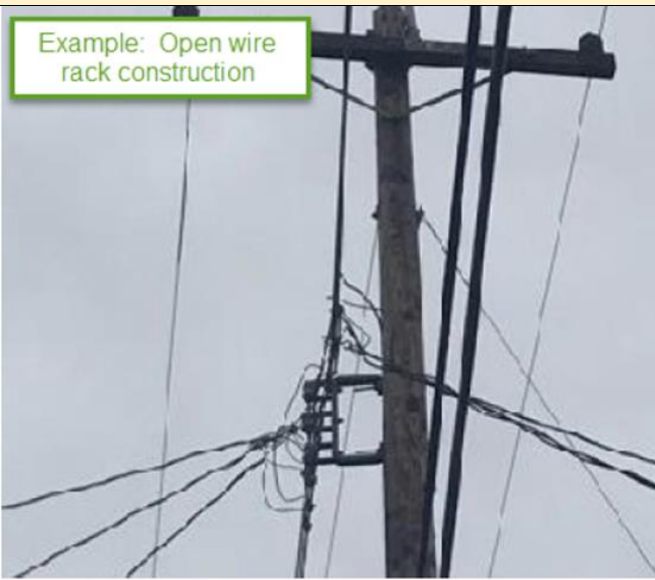
Example: Open wire rack construction

**At this Location:** Span length >135' missing spreader bracket for open wire extended rack construction.

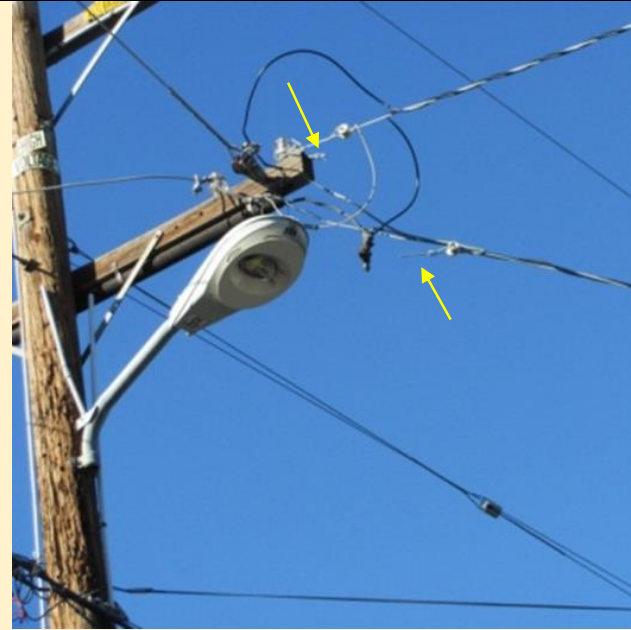
### Hardware Broken

**At this Location:** The #6 solid copper is broken causing strain on the conductor. Unsecured service.

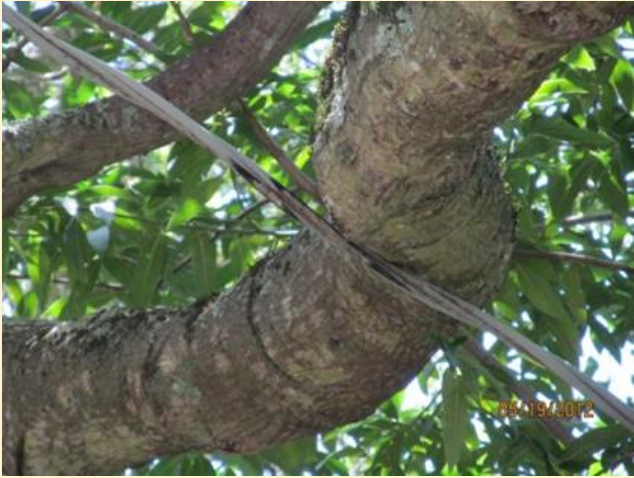
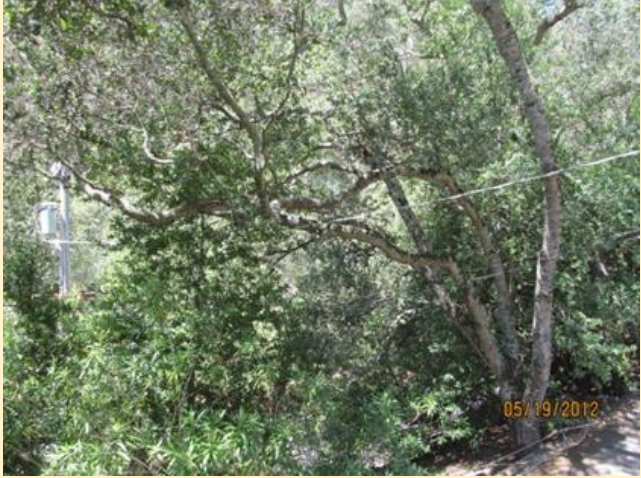
OVERHEAD SERVICE STRAIN ABRASION	OVERHEAD SERVICE STRAIN ABRASION

<b>At this Location:</b> Service strain abrasion, with possible burning at some sections. Damaged insulation.	<b>At this Location:</b> Service strain abrasion, no slack remaining
<b>Perform Minor Work:</b> Yes, if safe to do so. If you replace the service conductor, this is capital Minor Work.  Fill out EC Form to account for this minor work; charge time to your division standing order.	<b>Perform Minor Work:</b> Yes, if safe to do so. If you replace the service conductor this is capital Minor Work.  Fill out EC Form to account for this minor work; charge time to your division standing order.
<b>Write 3<sup>rd</sup> Party Notification:</b> No	<b>Write 3<sup>rd</sup> Party Notification:</b> No
<b>Write EC Notification:</b> Yes, if minor work not possible, or to document completed capital minor work  <b>FDA =</b> Conductor / Broken / Damaged Repair or Replace  <b>Priority =</b> E Tag, 3-12 months depending on exposure, in comments add note about strain abrasion burnt conductor  If abrasion has caused an exposed hot leg, assign Priority "A", emergency, and stand-by.	<b>Write EC Notification:</b> Yes, if minor work not possible, or to document completed capital minor work  <b>FDA =</b> Conductor / Broken / Damaged Repair or Replace  <b>Priority =</b> E Tag, 3-12 months depending on exposure, in comments add note about strain abrasion burnt conductor  If abrasion has caused an exposed hot leg, assign Priority "A", emergency, and stand-by.

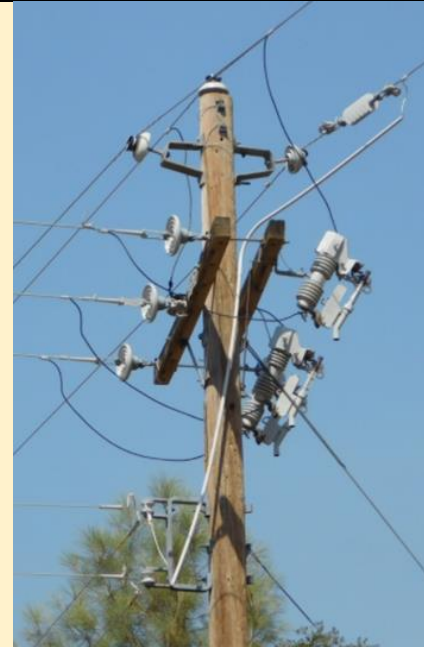
### Loose Primary Neutral Ground

**At this Location:** Loose primary neutral ground, unsupported conductor, hanging

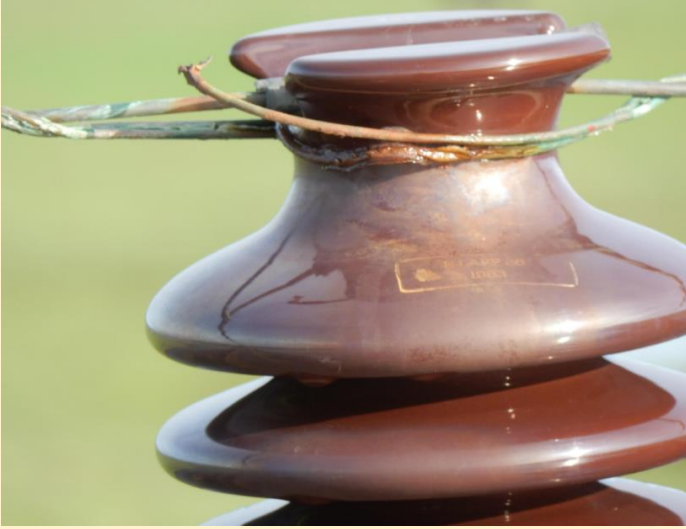
Tie Wire Corroded

<b>At this Location:</b> Tie wire is corroded, strand is broken
	<b>Perform Minor Work:</b> No
	<b>Write 3<sup>rd</sup> Party Notification:</b> No
	<b>Write EC Notification:</b> Yes <b>FDA=</b> Tie Wire / Corroded / Replace <b>Priority =</b> E Tag, 3-12 months depending on exposure

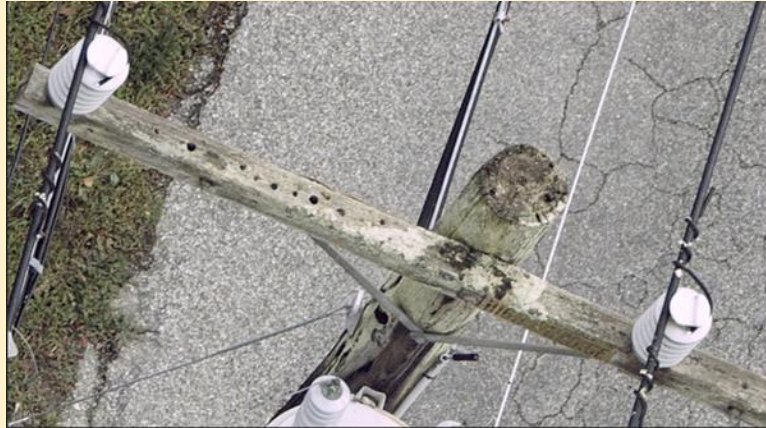
### Broken / Corroded Tie Wire

**At this Location:** Broken tie wire

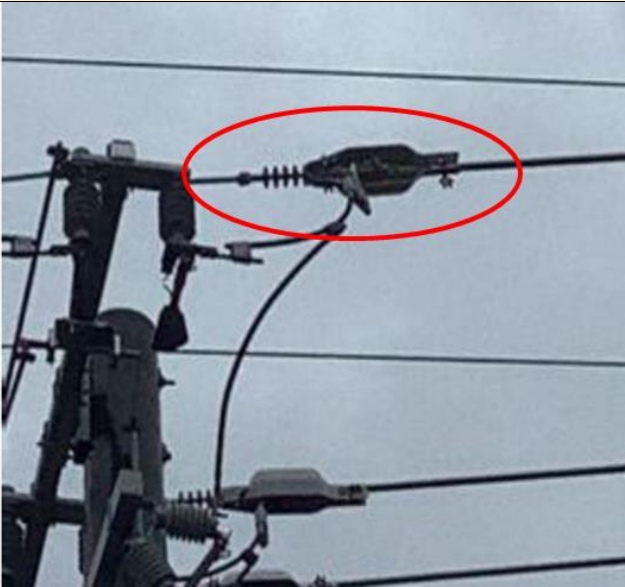
Mis-Aligned Dead-End Covers

<b>At this Location:</b> Dead-End Cover mis-aligned on tree wire construction.
	<b>Perform Minor Work:</b> Yes, if safe to do so. Install anti-rotation Clamp
	<b>Write 3<sup>rd</sup> Party Notification:</b> No
	<b>Write EC Notification:</b> Yes
	<b>FDA=</b> Dead End Cover / Broken / Damaged / Replace <b>OR</b> <b>FDA=</b> Dead End Cover / Broken / Damaged / Repair <b>Priority =</b> F Tag, 5 year, depending on exposure

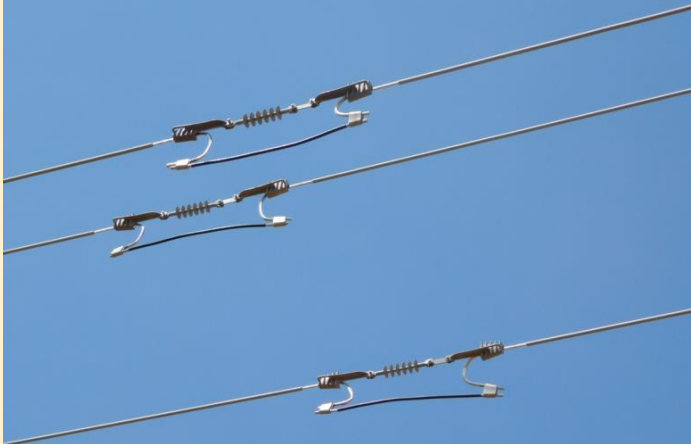
Exposed Primary Covered Conductor – Flying Bells, Wedge Connectors not removed after Work

<b>At this Location:</b> Flying Bells installed in on primary tree wire, now have exposed connectors and conductor.
	<b>Perform Minor Work:</b> No
	<b>Write 3<sup>rd</sup> Party Notification:</b> No
	<b>Write EC Notification:</b> Yes <b>FDA:</b> Tree Wire / Exposed / Repair <b>Priority:</b> F Tag, depending on exposure

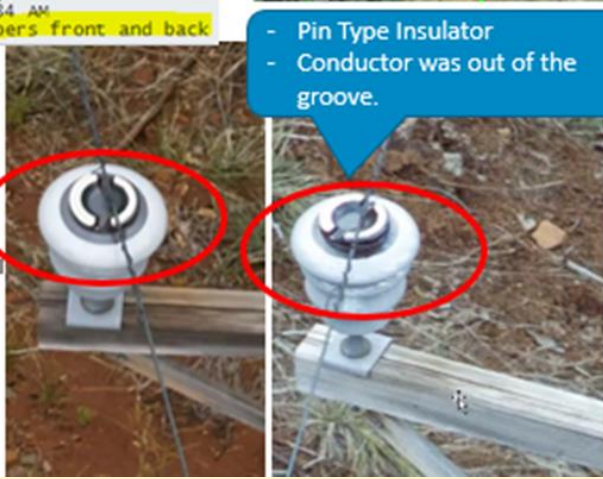
Conductor Tied to Side of Skirt, not in Groove	Tie Wire Broken / Loose / Not in Groove

<b>At this Location:</b> Insulator spun, and conductor tied on the skirt, non-angle pole.	<b>At this Location:</b> Tie Wire Broken / Loose / Not in Groove
<b>Perform Minor Work:</b> No	<b>Perform Minor Work:</b> No
<b>Write 3<sup>rd</sup> Party Notification:</b> No	<b>Write 3<sup>rd</sup> Party Notification:</b> No
<b>Write EC Notification:</b> Yes  <b>FDA =</b> Tie Wire / Broken / Damaged / Replace  <b>Priority =</b> B Tag, 0-3 months depending on exposure	<b>Write EC Notification:</b> Yes  <b>FDA =</b> Tie Wire / Improperly Installed / Repair  <b>Priority =</b> B Tag, 0-3 months depending on exposure

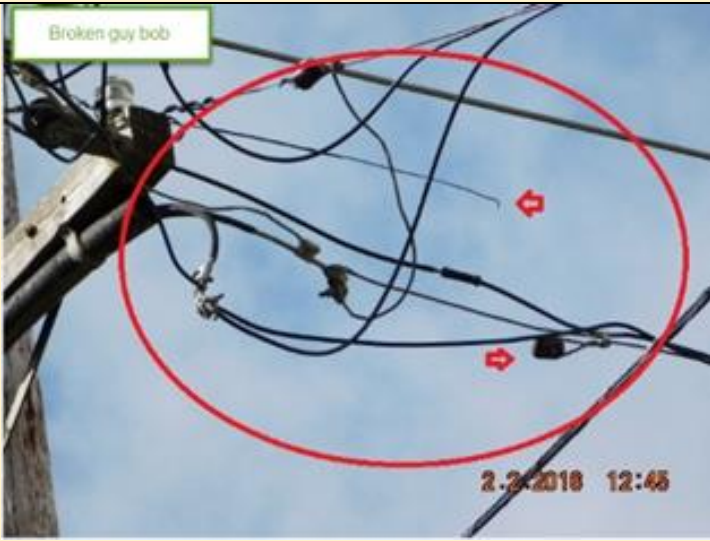
Broken Service Bob

<b>At this Location:</b> Broken service Insulator which has become unattached between the copper wire and the insulator.
	<b>Perform Minor Work:</b> No
	<b>Write 3<sup>rd</sup> Party Notification:</b> No
	<b>Write EC Notification:</b> Yes
	<b>FDA=</b> Hardware/Framing / Broken / Damaged / Repair  <b>Priority=</b> "E", 3-12 months depending upon exposure

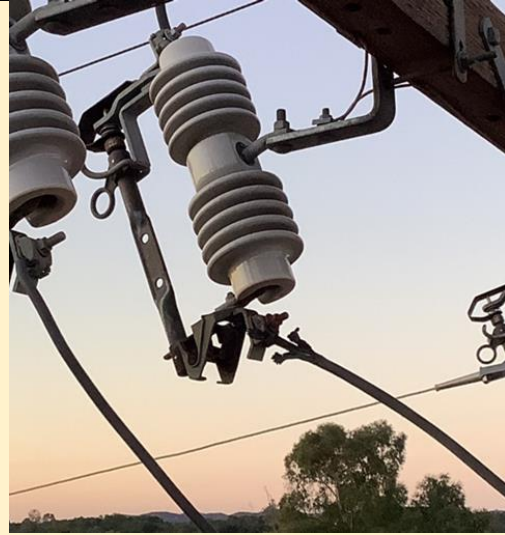
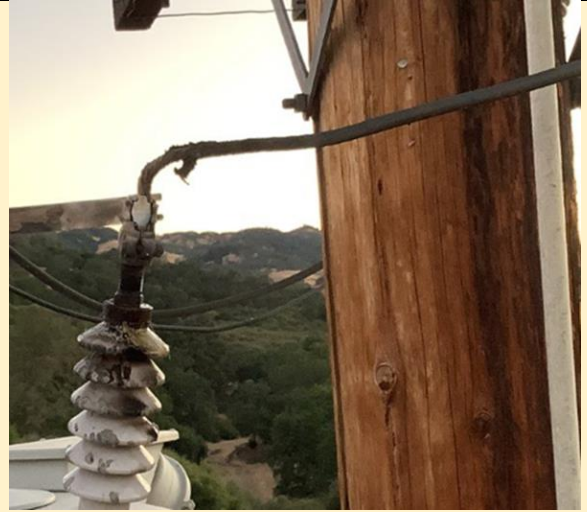
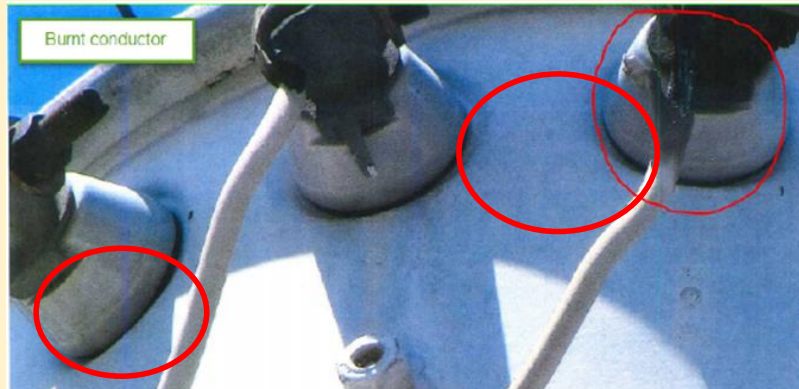
**At this Location:** Primary jumpers and / or transformer secondary connection jumpers frayed and burnt.

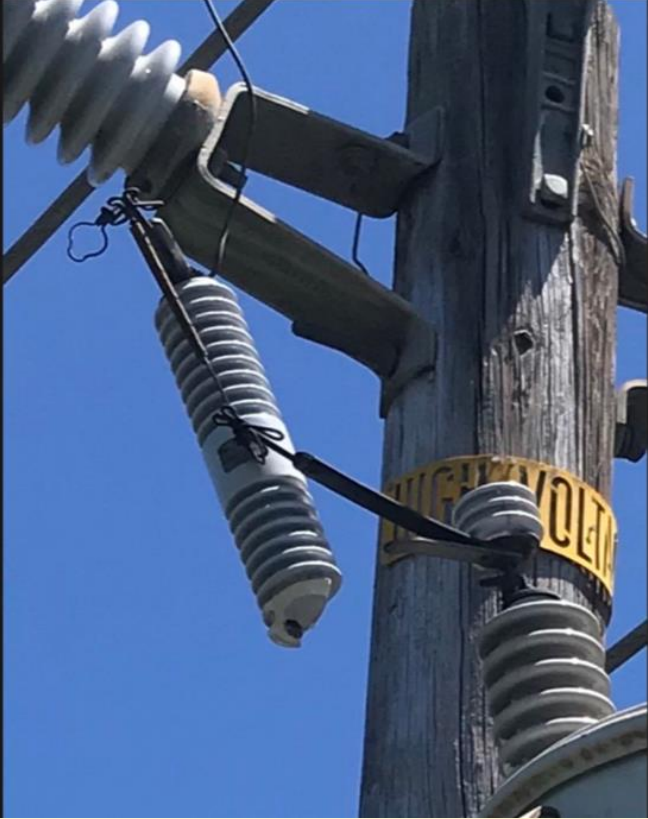
BROKEN DAMAGED CROSSARM MOUNTED CUTOUT	Broken Cutout

<b>At this Location:</b> Broken/Flashed cutout	<b>At this Location:</b> Broken Cutout
<b>Perform Minor Work:</b> No	<b>Perform Minor Work:</b> No
<b>Write 3<sup>rd</sup> Party Notification:</b> No	<b>Write 3<sup>rd</sup> Party Notification:</b> No
<b>Write EC Notification:</b> Yes <b>FDA =</b> Cutout / Broken/Damaged / Replace <b>Priority =</b> E Tag, 3-12 months depending upon exposure, no COE	<b>Write EC Notification:</b> Yes <b>FDA =</b> Cutout / Broken/Damaged / Replace <b>Priority =</b> A Tag, Follow the emergency procedure

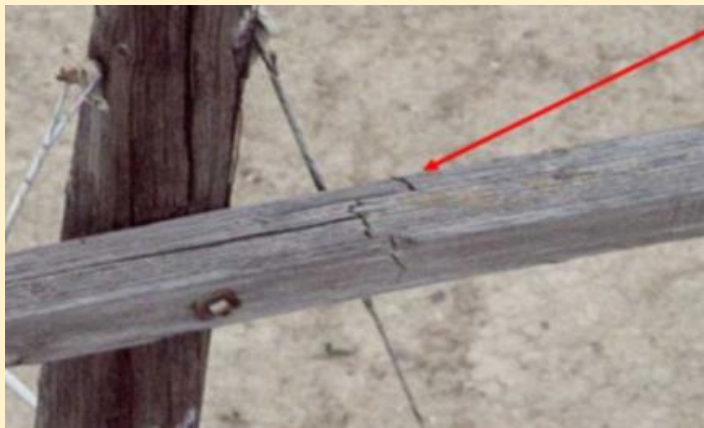
### Cracked Cross-Arm – Aerial View

**At this Location:** Top view of a cracked cross-arm on top and sides. May not be seen from the ground.

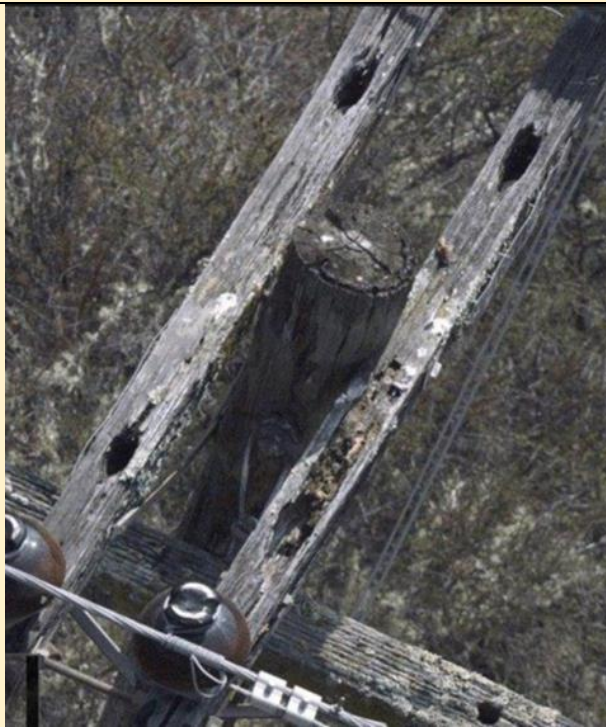
### Deteriorated Cross-Arm – Aerial View

**At this Location:** Deteriorated/Rotten Cross-Arm – Aerial View

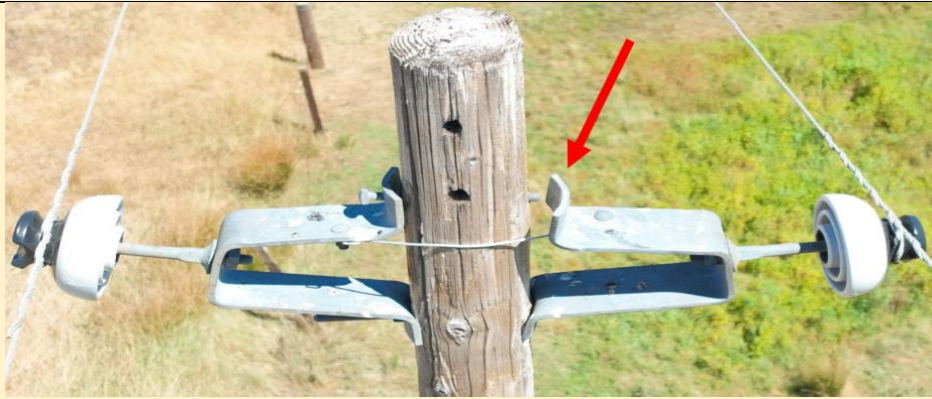
### Through Bolt Loose

**At this Location:** The nut has come off of the Through Bolt

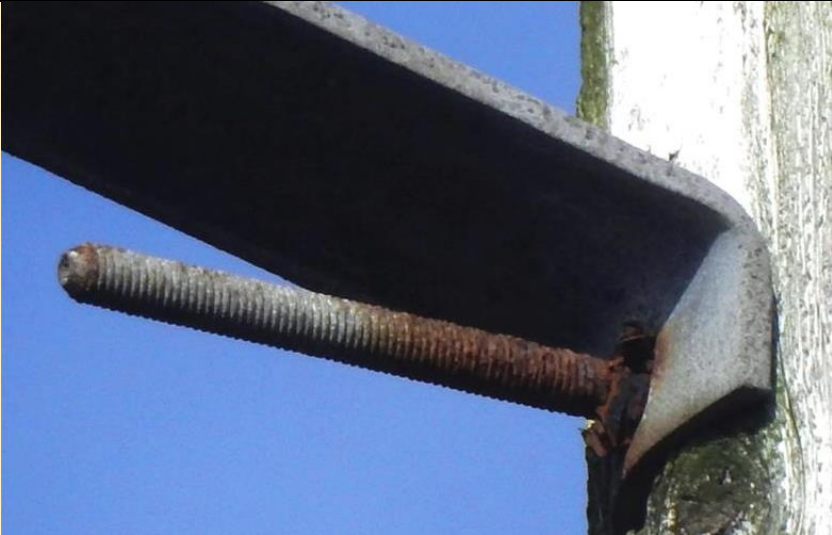
Corroded Hardware

<b>At this Location:</b> Bolt hardware extremely corroded
	<b>Perform Minor Work:</b> No
	<b>Write 3<sup>rd</sup> Party Notification:</b> No
	<b>Write EC Notification:</b> Yes <b>FDA=</b> Hardware / Broken / Damaged / Replace <b>Priority=</b> E tag, 3-12, depending on exposure / Severity

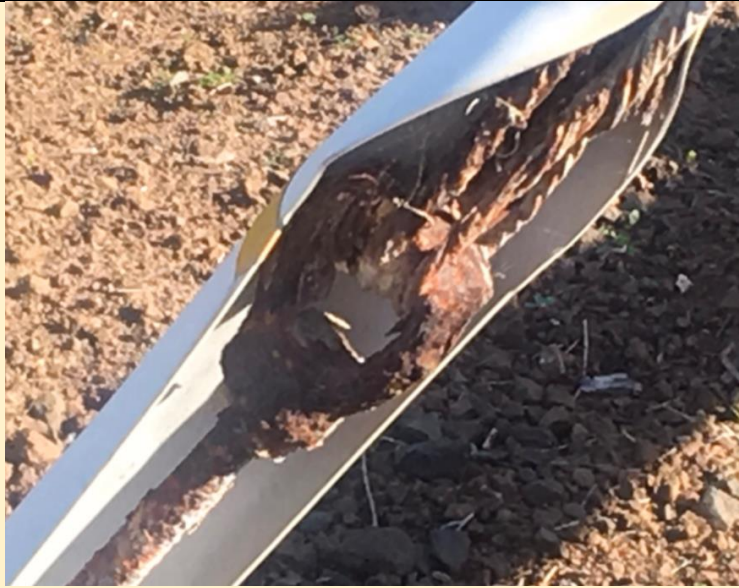
### Corroded Anchor

**At this Location:** Corroded Anchor

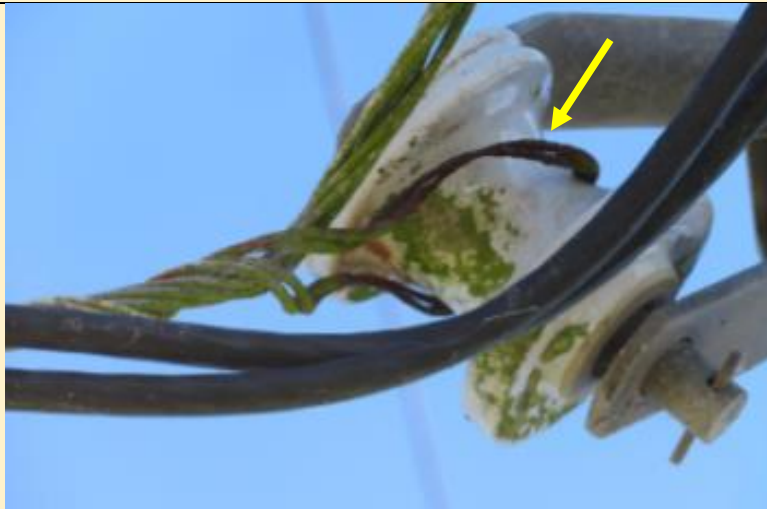
### Corroded Preform Tie

**At this Location:** Corroded Preform Tie

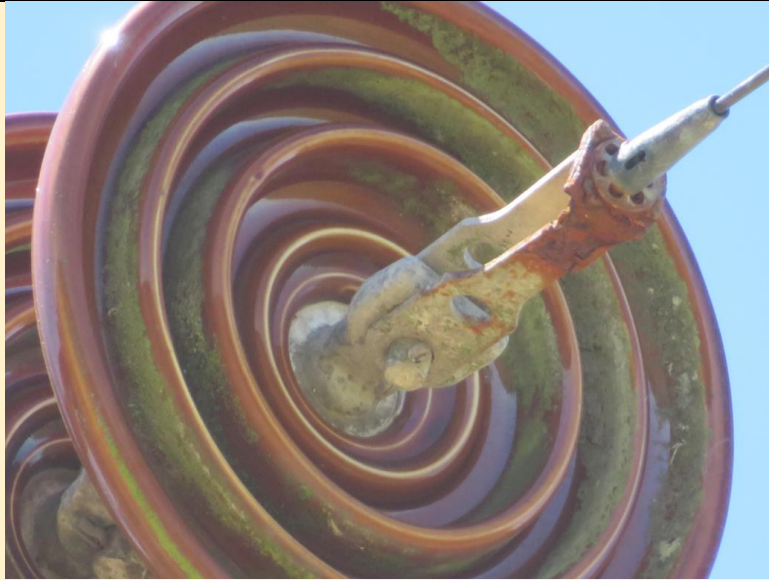
### Primary Dead-End Hardware Corroded

**At this Location:** Primary Dead-End Hardware Corroded

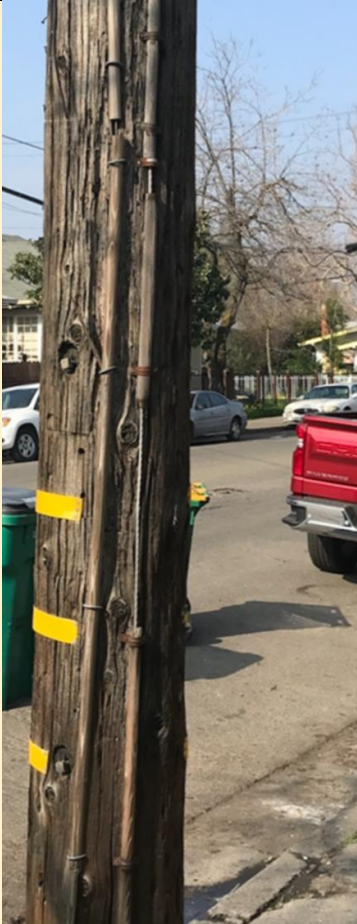
Exposed Ground

<b>At this Location:</b> Exposed grounds near sidewalk
	<b>Perform Minor Work:</b> Yes, at minimum make safe
	<b>Write 3<sup>rd</sup> Party Notification:</b> No
	<b>Write EC Notification:</b> Yes <b>FDA=</b> Ground / Exposed / Repair  <b>Priority=</b> A Tag, emergency – due to <b>High</b> public exposure at ground level.

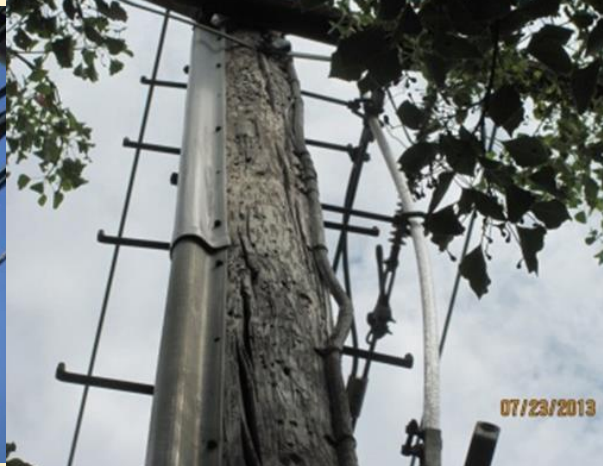
EXPOSED GROUND AT COMMUNICATION LEVEL	EXPOSED GROUND DUE TO TWISTED MOLDING

<b>At this Location:</b> Exposed ground at communications level. Wood molding broken in climbing space	<b>At this Location:</b> Exposed ground in wood molding.
<b>Perform Minor Work:</b> Yes, if safe to do so	<b>Perform Minor Work:</b> Yes, if safe to do so
<b>Write 3<sup>rd</sup> Party Notification:</b> No	<b>Write 3<sup>rd</sup> Party Notification:</b> No
<b>Write EC Notification:</b> Yes, only if unable to perform minor work.	<b>Write EC Notification:</b> Yes, only if unable to perform minor work.
<b>FDA=</b> Ground / Exposed / Repair	<b>FDA=</b> Ground / Exposed / Repair
<b>Priority=</b> F Tag At minimum – next inspection cycle; based on field condition and exposure, corrosion, etc.; prioritize as needed (A, B, E, or F)	<b>Priority=</b> F Tag At minimum – next inspection cycle; based on field condition and exposure, corrosion, etc.; prioritize as needed (A, B, E, or F)

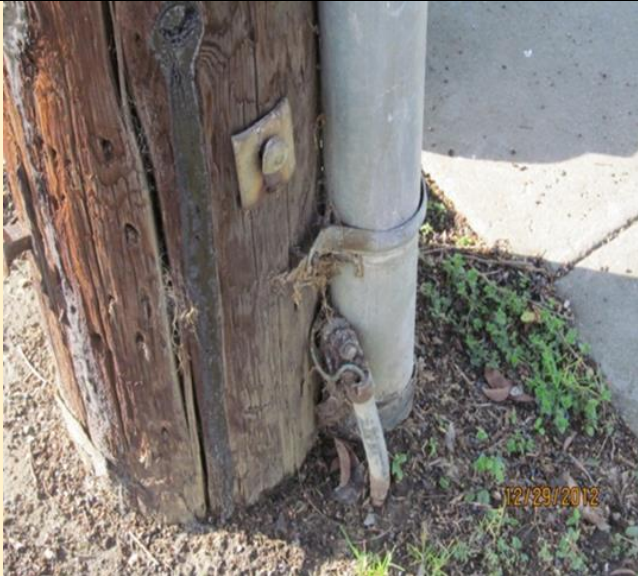
EXPOSED GROUND ROD

<b>At this Location:</b> Exposed ground rod, public exposure
	<b>Perform Minor Work:</b> Yes, at minimum make safe
	<b>Write 3<sup>rd</sup> Party Notification:</b> No
	<b>Write EC Notification:</b> Yes <b>FDA=</b> Ground / Exposed / Repair  <b>Priority=</b> A Tag, emergency – due to public exposure at ground level, if minor work not done.

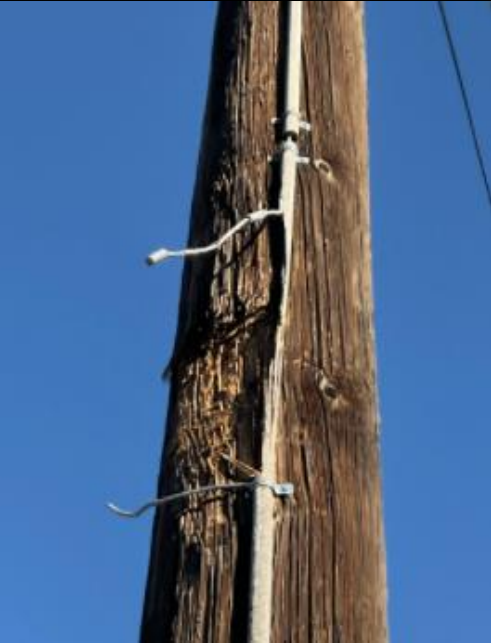
Broken Ground Run

<b>At this Location:</b> Pole ground has broken, above 8', on a Common Neutral 1000' ground.
	<b>Perform Minor Work:</b> Yes, if safe to do so, Refer to <a href="#">TD-2990P-01</a> for repair.
	<b>Write 3<sup>rd</sup> Party Notification:</b> No
	<b>Write EC Notification:</b> Yes, if not able to be performed under minor work
	<b>FDA=</b> Ground / Broken / Damaged / Replace or Repair  <b>Priority=</b> B Tag, 0-3 months, depending on exposure

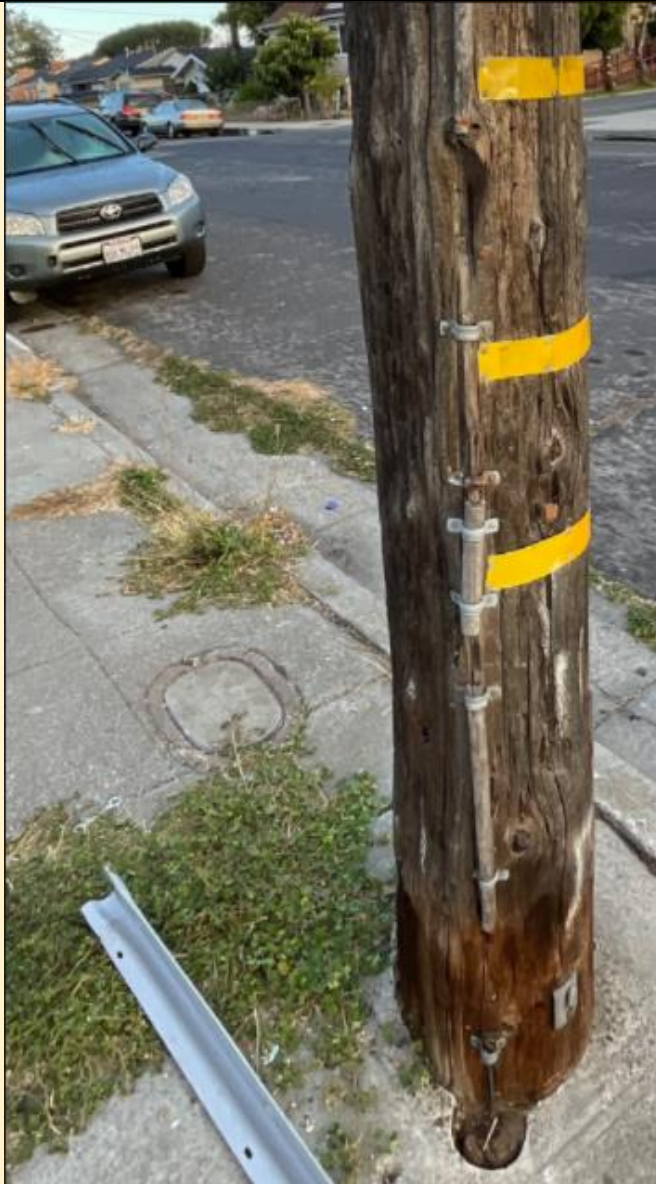
### Broken Ground Run

**At this Location:** Transformer ground has broken, below 8', in the sidewalk, exposed to the public

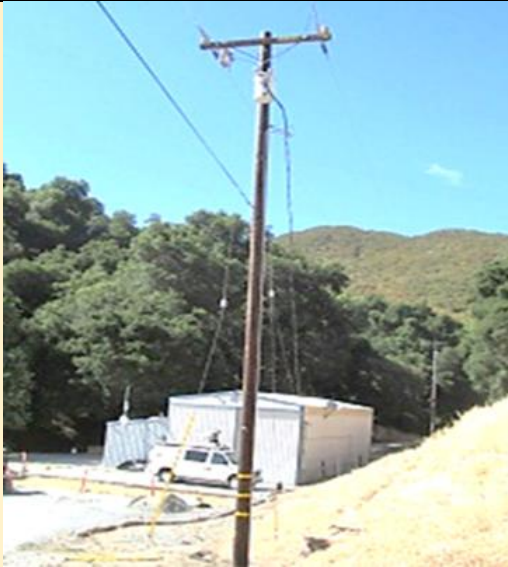
### SLACK GUY

**At this Location:** Loose guy on left side

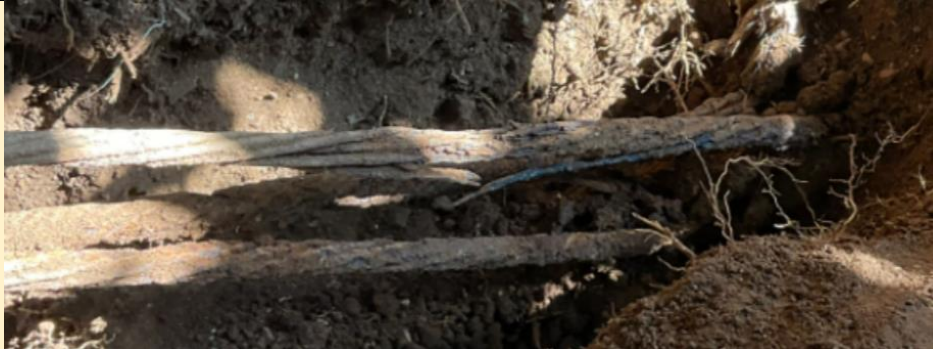
### GUY CORRODED AND MISSING STRANDS

**At this Location:** Guy corroded and missing strands

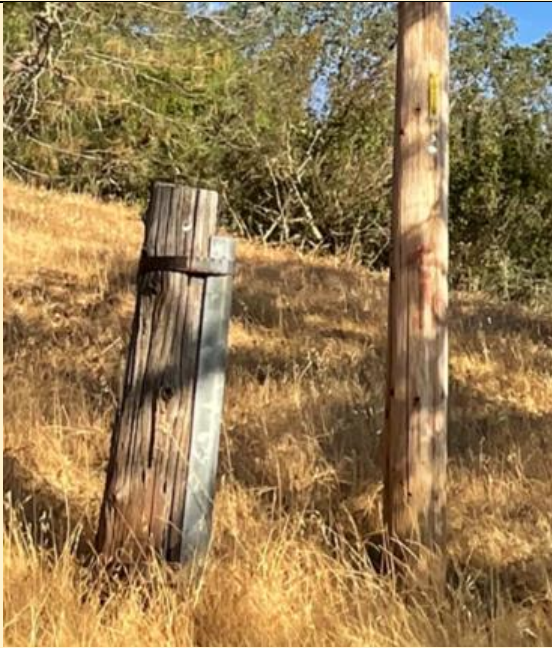
Abandoned Pole Butt

<b>At this Location:</b> Abandoned Pole Butt, low risk
	<b>Perform Minor Work:</b> No
	<b>Write 3<sup>rd</sup> Party Notification:</b> No
	<b>Write EC Notification:</b> No

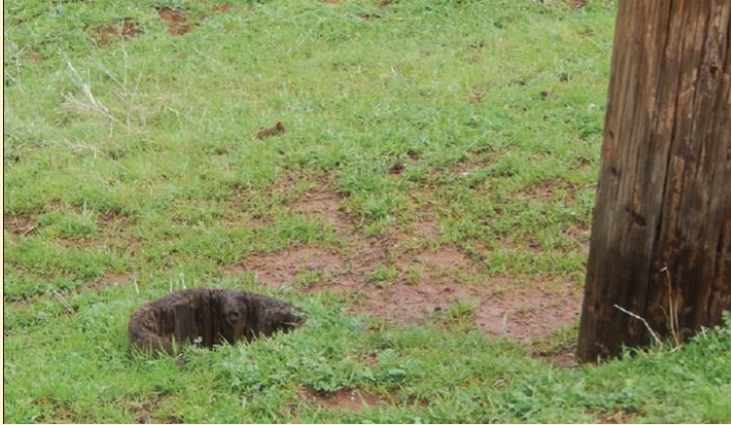
### Abandoned Pole Butt – Hollowed Out Below Ground Level

**At this Location:** Abandoned Pole Butt with a safety issue such as a tripping hazard, hollowed out below ground level.

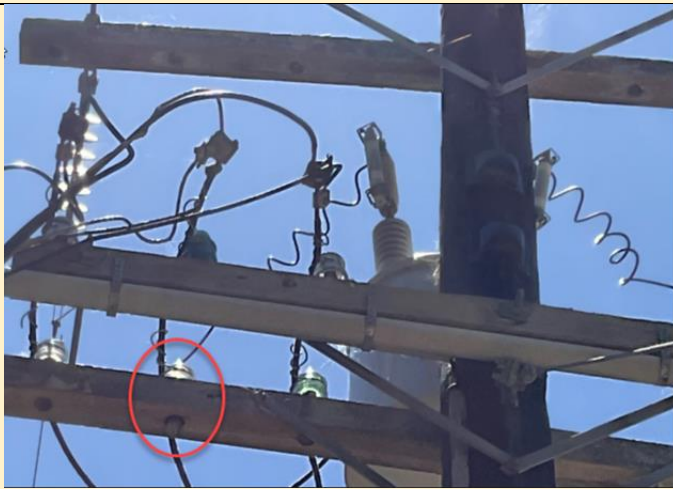
### Secondary Squatter, Crossarm in good shape

**At this Location:** Secondary Squatter, crossarm in good shape

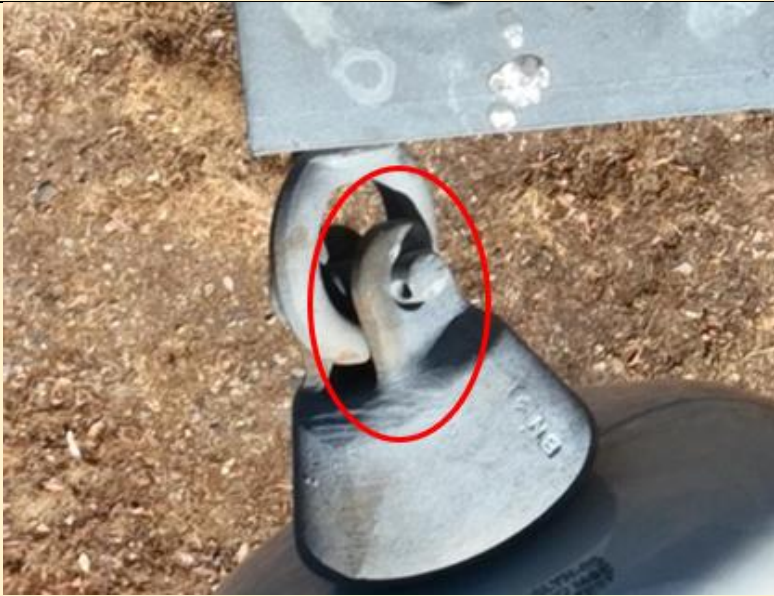
Missing Cotter Key / Retainer Pin Fully Seated

<b>At this Location:</b> Missing Cotter Key / Retainer Pin Fully Seated, may fall out
	<b>Perform Minor Work:</b> No
	<b>Write 3<sup>rd</sup> Party Notification:</b> No
	<b>Write EC Notification:</b> Yes <b>FDA=</b> Hardware / Missing / Install  <b>Priority=</b> B Tag, 0-3 months, depending on exposure

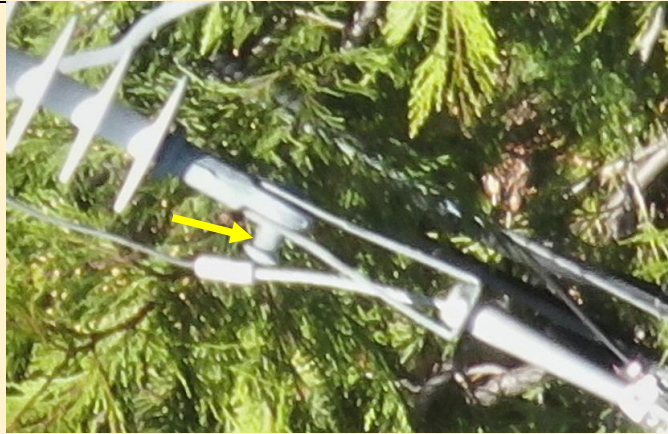
### Retainer Pin Coming loose, almost pulled out

**At this Location:** Retainer Pin coming loose, almost pulled out

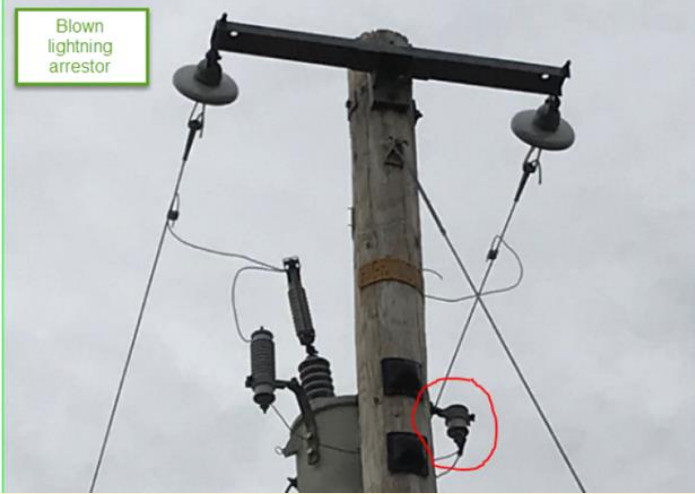
Non-Exempt Surge Arrestor Blown	Exempt ABB-type Arrestor Blown

<b>At this Location:</b> Non-Exempt Surge Arrestor Blown	<b>At this Location:</b> Exempt ABB arrestor operated / blown indicated by the orange marker sticking out the bottom
<b>Perform Minor Work:</b> No	<b>Perform Minor Work:</b> No
<b>Write 3<sup>rd</sup> Party Notification:</b> No	<b>Write 3<sup>rd</sup> Party Notification:</b> No
<b>Write EC Notification:</b> Yes <b>FDA=</b> Lightning Arrestor / Broken / Damaged / Replace  <b>Priority=</b> E Tag, 3-12 months, depending on exposure	<b>Write EC Notification:</b> Yes <b>FDA=</b> Lightning Arrestor / Broken / Damaged / Replace  <b>Priority=</b> E Tag, 3-12 months, depending on exposure

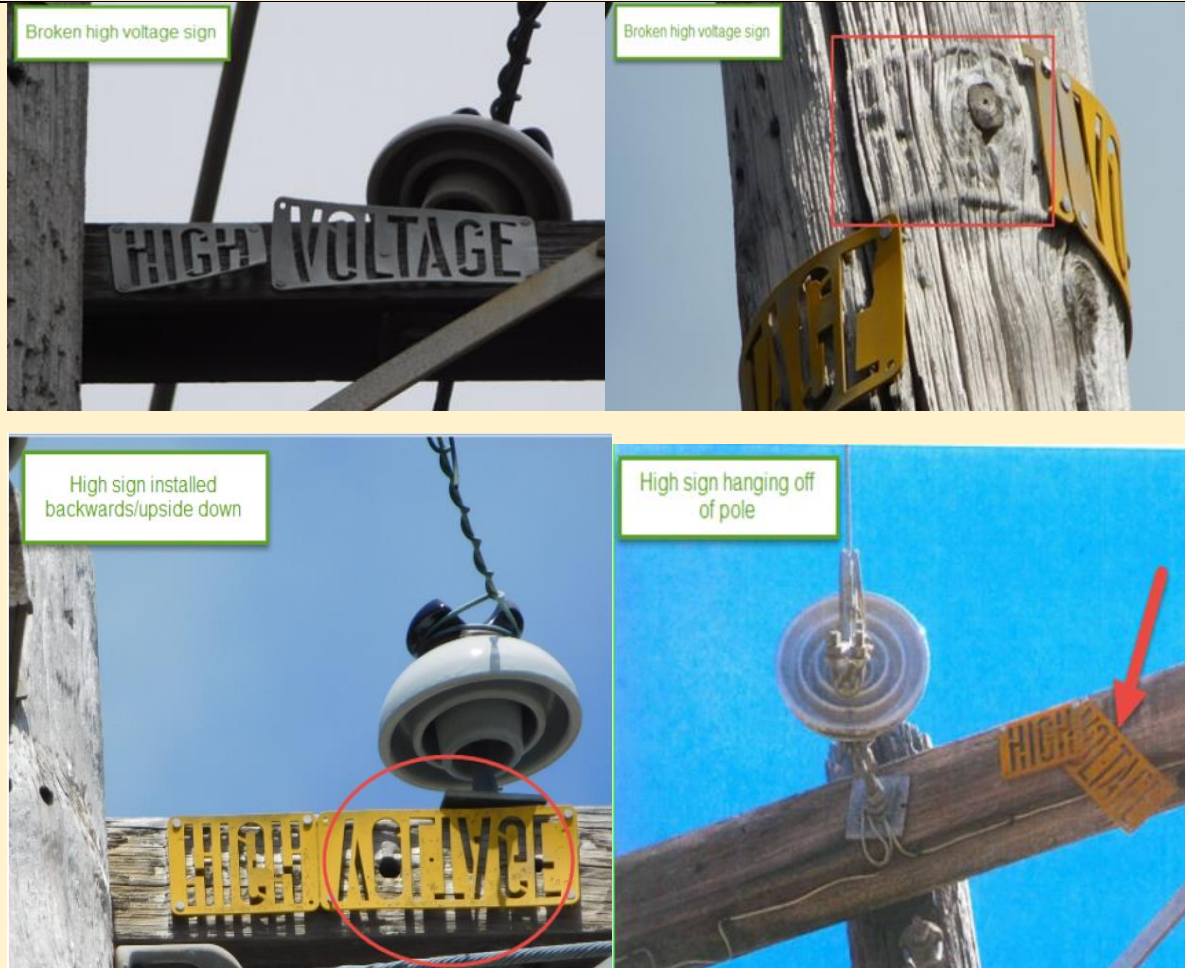
## BROKEN / MISSING HIGH SIGN

**At this Location:** Broken / Missing High Sign

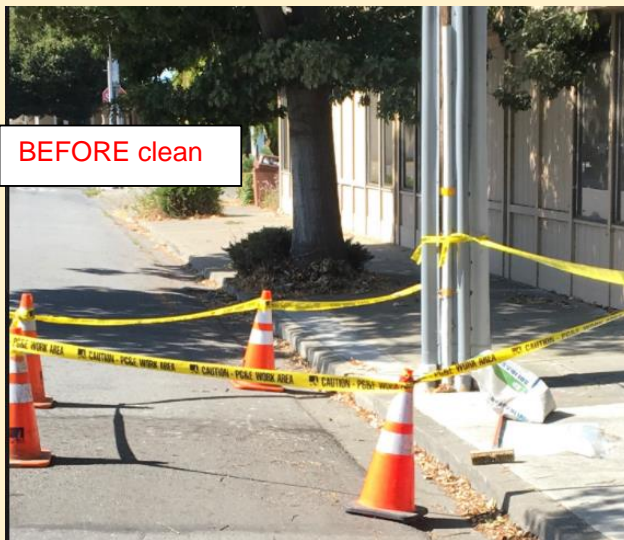
### LEAKING OH TRANSFORMER, OIL ON THE GROUND

**At this Location:** Leaking OH transformer, oil on the ground

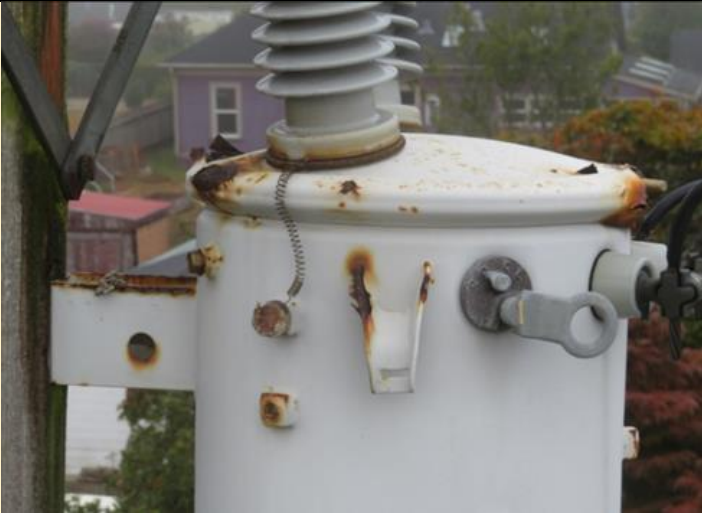
OH CORROSION

<b>At this Location:</b> Corrosion Weakening Integrity of Tank. Metal is separating into layers. Corrosion will breach tank
	<b>Perform Minor Work:</b> No
	<b>Write 3<sup>rd</sup> Party Notification:</b> No
	<b>Write EC Notification:</b> Yes <b>FDA=</b> Transformer / Corroded / Replace  <b>Priority=</b> E Tag, 3-12 months depending upon exposure

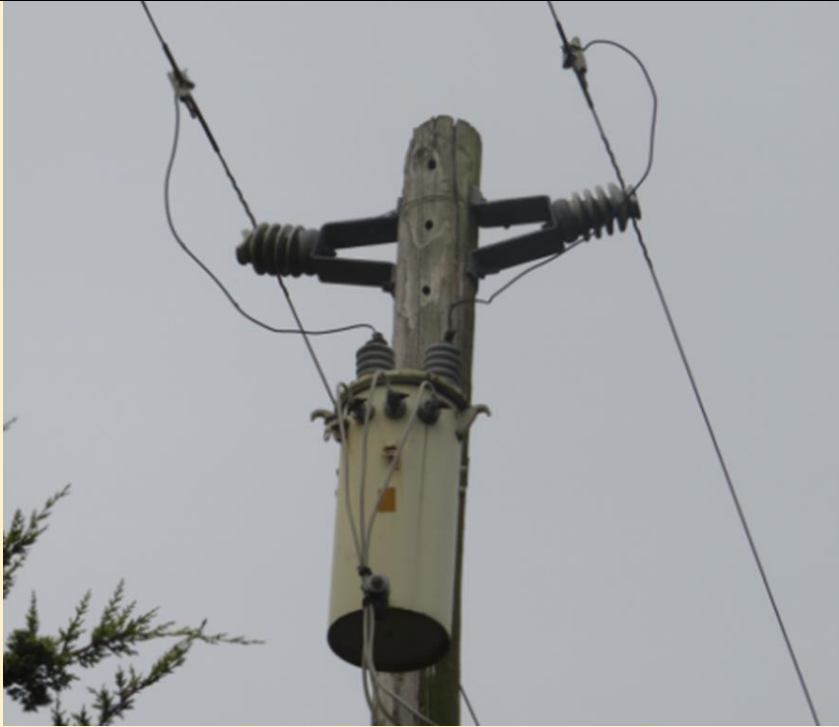
BLUE STICKER TRANSFORMER

<b>At this Location:</b> Blue Sticker not present on transformer, suspect for PCB. Answer questionnaire.	
<b>Perform Minor Work:</b> No	
<b>Write 3<sup>rd</sup> Party Notification:</b> No	
<b>Write EC Notification:</b> No

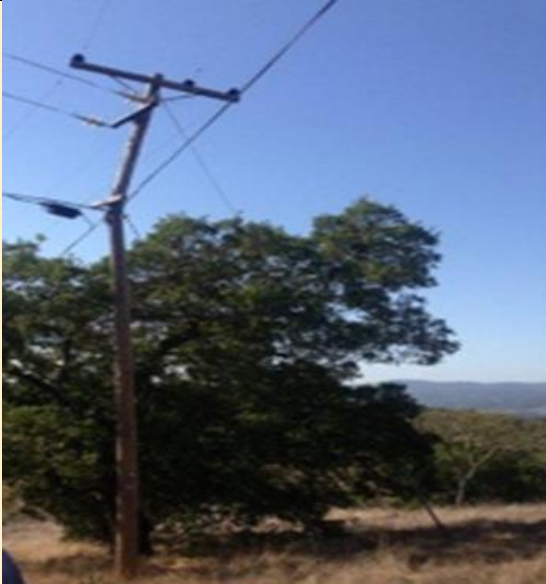
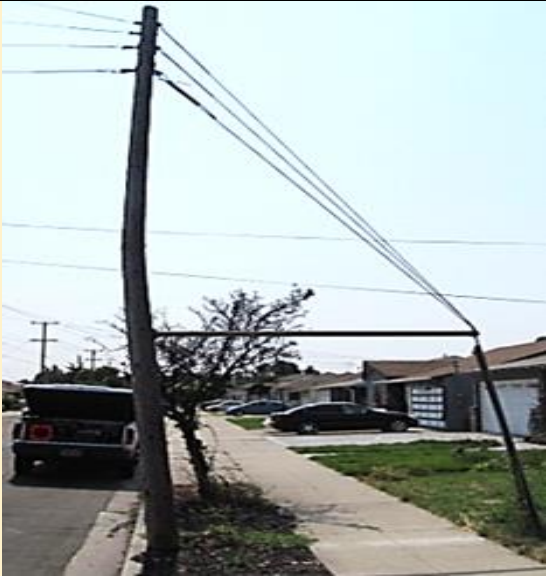
POLE BROKEN AT THE COMMUNICATION LEVEL	POLE BROKEN AT MIDDLE SECTION

<p><b>At this Location:</b> Pole broken at the communication level.</p> <p>Complete Pole Inspection Test Report</p>	<p><b>At this Location:</b> Broken pole, Supported by guy.</p> <p>Complete Pole Inspection Test Report</p>
<p><b>Perform Minor Work:</b> No</p>	<p><b>Perform Minor Work:</b> No</p>
<p><b>Write 3<sup>rd</sup> Party Notification:</b> No</p>	<p><b>Write 3<sup>rd</sup> Party Notification:</b> No</p>
<p><b>Write EC Notification:</b> Yes</p> <p><b>FDA=</b> Pole / Broken/Damaged / Replace</p> <p><b>Priority=</b> A Tag, Follow the emergency process</p>	<p><b>Write EC Notification:</b> Yes</p> <p><b>FDA=</b> Pole / Broken/Damaged / Replace</p> <p><b>Priority=</b> B Tag, 0-3 months, depending on exposure</p>

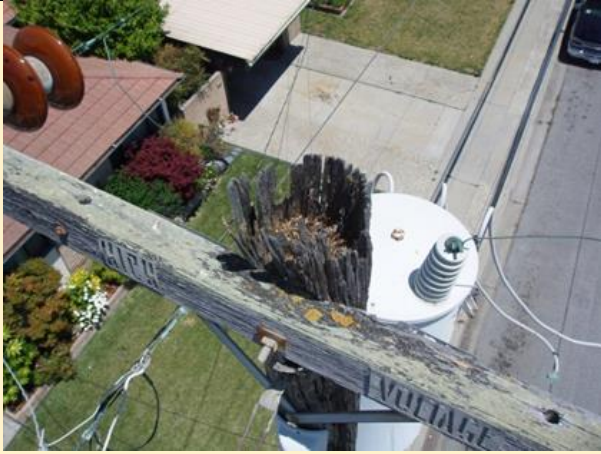
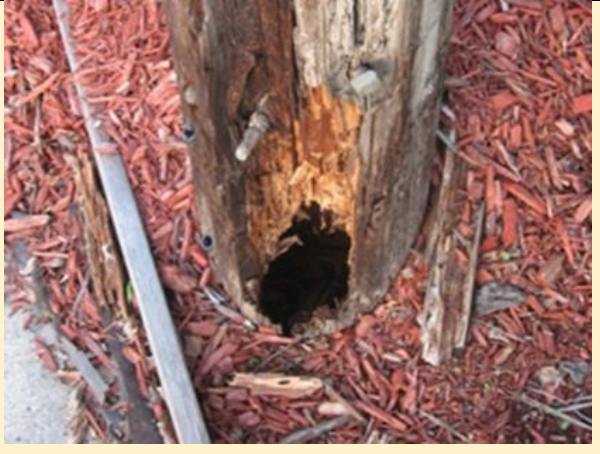
DECAY OF POLE OVER TIME	SEVERE DETERIORATION AT GROUND LEVEL

<b>At this Location:</b> Pole top decayed Complete the Pole Inspection Test Report	<b>At this Location:</b> Deteriorated condition found during inspection. Complete Pole Inspection Test Report.
<b>Perform Minor Work:</b> No	<b>Perform Minor Work:</b> No
<b>Write 3<sup>rd</sup> Party Notification:</b> No	<b>Write 3<sup>rd</sup> Party Notification:</b> No
<b>Write EC Notification:</b> Yes <b>FDA=</b> Pole Decayed/Rotten/Replace	<b>Write EC Notification:</b> Yes <b>FDA=</b> Pole Decayed/Rotten/Replace
<b>Priority=</b> B Tag, 0-3 months, depending on exposure	<b>Priority=</b> A Tag, Follow the emergency process.

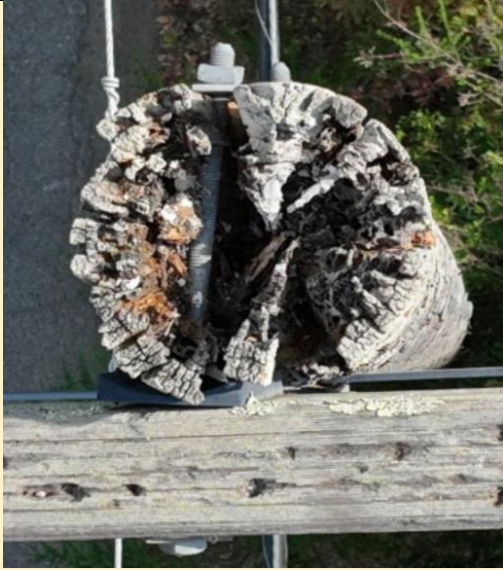
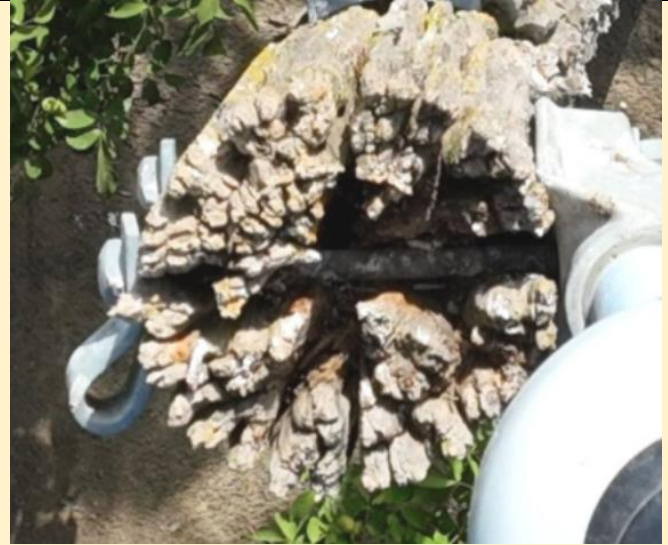
**At this Location:** Pole top decayed. Complete the Pole Inspection Test Report

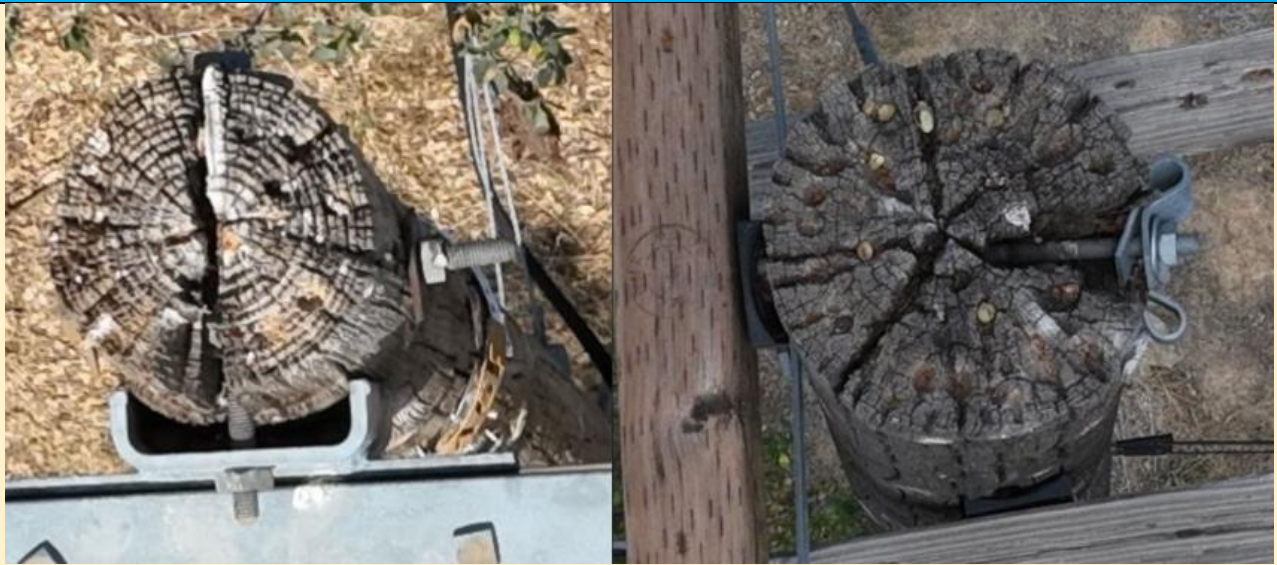
**At this Location:** Pole top decayed. Complete the Pole Inspection Test Report

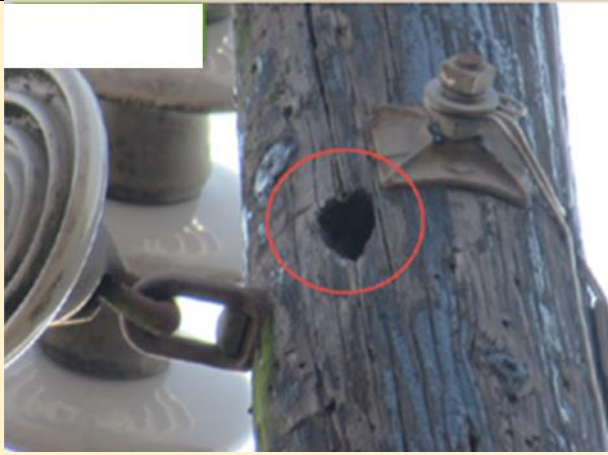
**At this Location:** Woodpecker holes near framing hardware, per Guidance "There is 1 vertical inch of solid wood directly below any through bolt to support existing or proposed attachments".

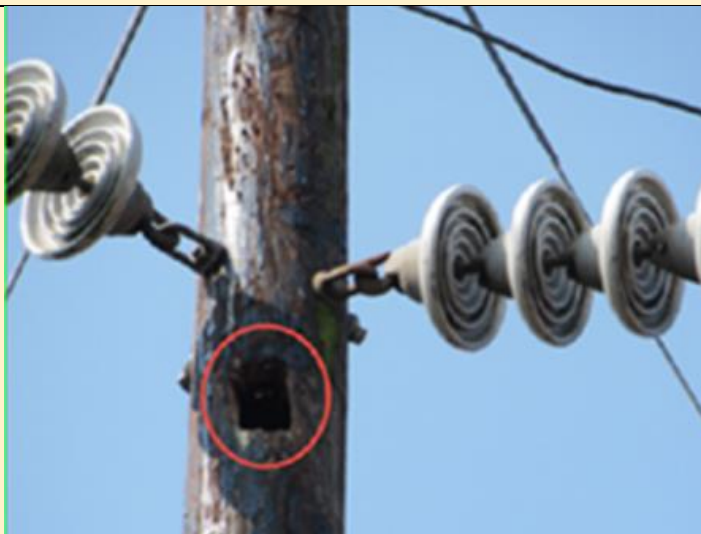
**At this Location: Comparing to the insulators** Woodpecker holes appear to be close to 7" per Guideline "Nesting cavities or other open pockets have an outside hole diameter that is less than 4 inches wide.". When in doubt, write notification
