# Job Aid: Overhead Assessment

This job aid is designed to assist Electric Distribution Compliance Inspectors, PG&E Employees, and Contractors in assessing and prioritizing compelling **abnormal conditions** on overhead facilities, including but not limited to GO 165 Inspections. Compelling Abnormal Condition is defined as any electric distribution pole, equipment, component, conductors, vegetation, or third-party condition that causes a safety or fire ignition risk that, in the judgment of the field employee, may adversely impact public safety and/or service reliability **within 5 years**.

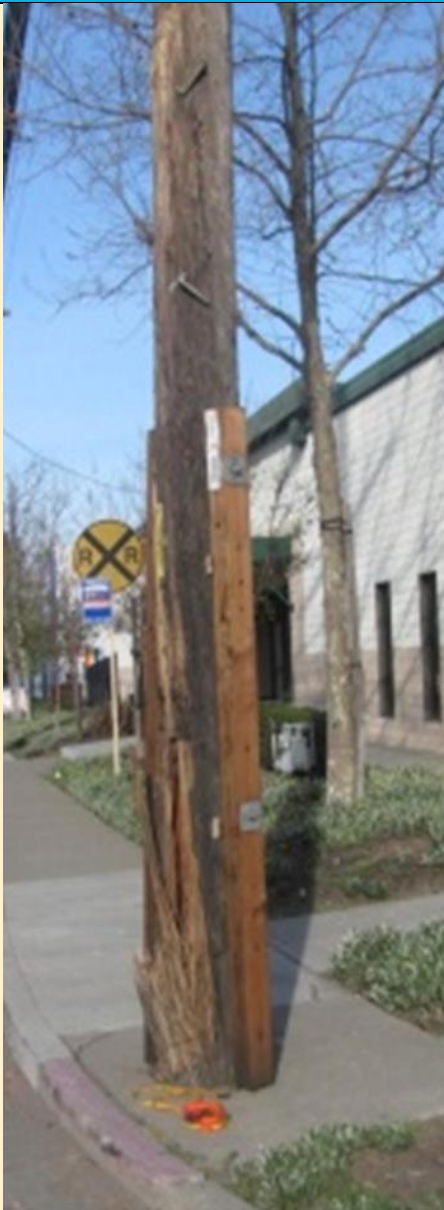
**At this Location:** Pole damaged by vehicle. Cross-arm acting as Splint installed as temporary repair

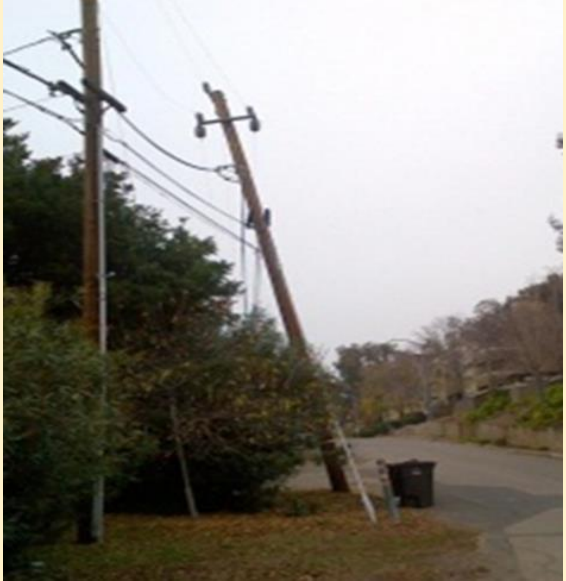
<b>At this Location:</b> Leaning pole greater than 10% out of plumb. Pole is stable. No equipment, in rural area. Causing reduced clearance.	<b>At this Location:</b> Leaning towards a tree more than 10% out of plumb. Inspector pulled plug and confirmed pole is solid below ground. Probability of equipment failure is moderate.
<b>Perform Minor Work:</b> No	<b>Perform Minor Work:</b> No
<b>Write 3<sup>rd</sup> Party Notification:</b> No	<b>Write 3<sup>rd</sup> Party Notification:</b> No
<b>Write EC Notification:</b> Yes <b>FDA=</b> Pole / Leaning / Replace	<b>Write EC Notification:</b> Yes <b>FDA=</b> Pole / Leaning / Replace
<b>Priority=</b> E Tag, 3-12 months, depending on exposure	<b>Priority=</b> B Tag, 0-3 months, depending on exposure

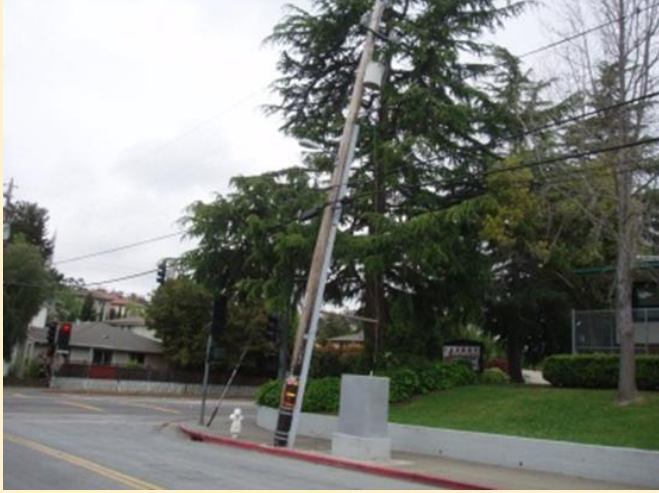
<b>At this Location:</b> Stubbed pole leaning towards school, supported by down guy. Pole Bands are loose due to additional deterioration of the pole.	<b>At this Location</b> Pole is leaning less than 10% out of plumb, leaning in direction of offset equipment.
<b>Perform Minor Work:</b> No	<b>Perform Minor Work:</b> No
<b>Write 3<sup>rd</sup> Party Notification:</b> No	<b>Write 3<sup>rd</sup> Party Notification:</b> No
<b>Write EC Notification:</b> Yes <b>FDA=</b> Pole / Decayed / Rotten / Replace  <b>Priority=</b> B Tag, 0-3 months, depending on exposure	<b>Write EC Notification:</b> No

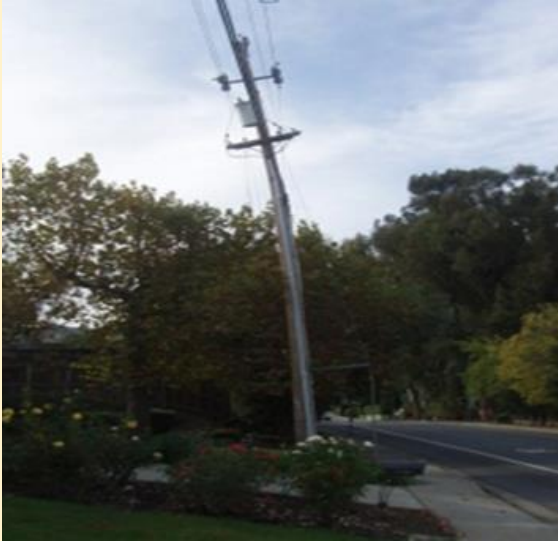
<b>At this Location:</b> Pole bent 4 feet out of line, less than 10% lean, deformed in the middle of the pole, towards vegetation
	<b>Perform Minor Work:</b> No
	<b>Write 3<sup>rd</sup> Party Notification:</b> No
	<b>Write EC Notification:</b> Yes <b>FDA=</b> Pole / Overload / Test  <b>Priority=</b> B Tag, 0-3 months depending on exposure

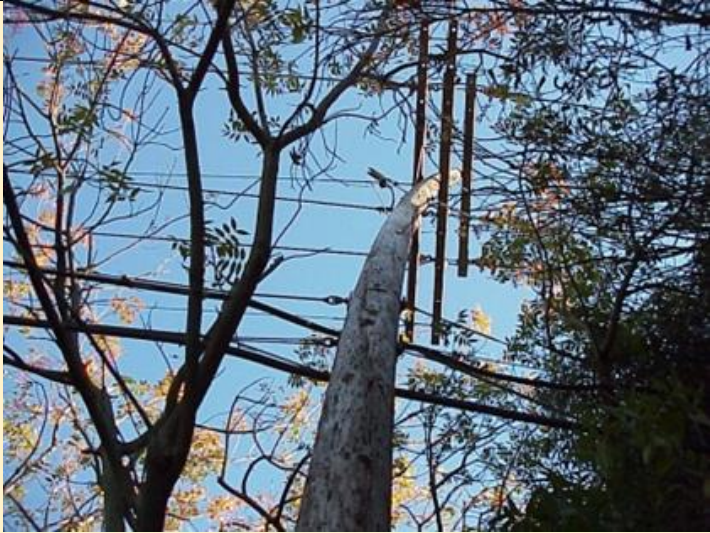
<b>At this Location:</b> Pole is twisted, cracked, due to communication. Field comments "overloaded by communications"	<b>At this Location:</b> Deformed pole with bowed top in line with conductor.
<b>Perform Minor Work:</b> No	<b>Perform Minor Work:</b> No
<b>Write 3<sup>rd</sup> Party Notification:</b> No	<b>Write 3<sup>rd</sup> Party Notification:</b> No
<b>Write EC Notification:</b> Yes <b>FDA=</b> Pole / Overloaded / Replace Pole Test Data Sheet is Required	<b>Write EC Notification:</b> Yes <b>FDA=</b> Pole / Overloaded / Replace Pole Test Data Sheet is Required
<b>Priority=</b> E Tag, 3-12 months, depending on exposure	<b>Priority=</b> E Tag, 3-12 months, depending on exposure

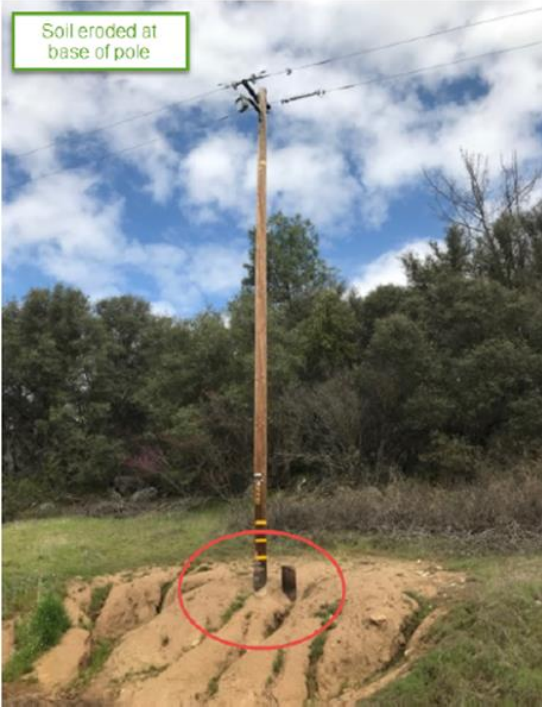
<b>At this Location:</b> a large amount of soil was washed or eroded away at the base of a pole, Not leaning.
	<b>Perform Minor Work:</b> No
	<b>Write 3<sup>rd</sup> Party Notification:</b> No
	<b>Write EC Notification:</b> Yes <b>FDA=</b> Pole / Soil Eroded / Graded / Replace  <b>Priority=</b> E Tag, 12 months depending on exposure

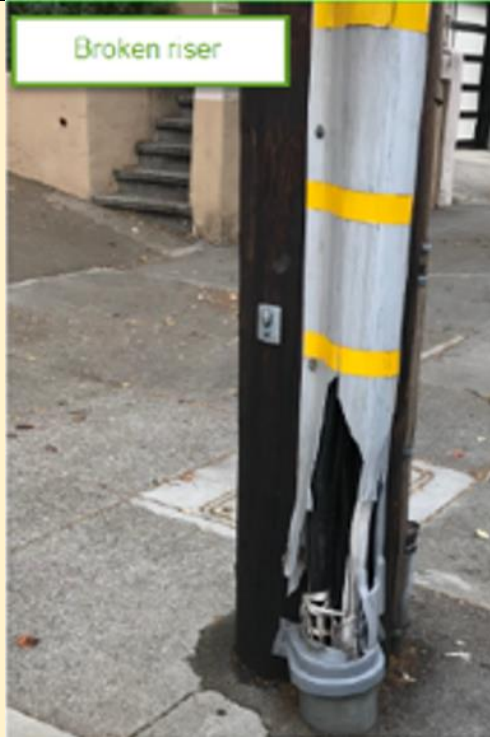
<p>A photograph of a broken riser on a utility pole. The riser is white with yellow reflective tape. The bottom of the riser is broken and hanging off the pole. A white tag with green text is placed above the broken riser. The tag reads: 'Broken riser'.</p>
<b>At this Location:</b> Cracked riser boot	<b>At this Location:</b> Broken riser
<b>Perform Minor Work:</b> Yes, if possible	<b>Perform Minor Work:</b> Yes, if possible
<b>Write 3<sup>rd</sup> Party Notification:</b> No	<b>Write 3<sup>rd</sup> Party Notification:</b> No
<b>Write EC Notification:</b> Yes, only if minor work cannot be performed <b>FDA=</b> Molding / Broken / Damaged	<b>Write EC Notification:</b> Yes, only if minor work cannot be performed <b>FDA=</b> Molding / Broken / Damaged / Replace

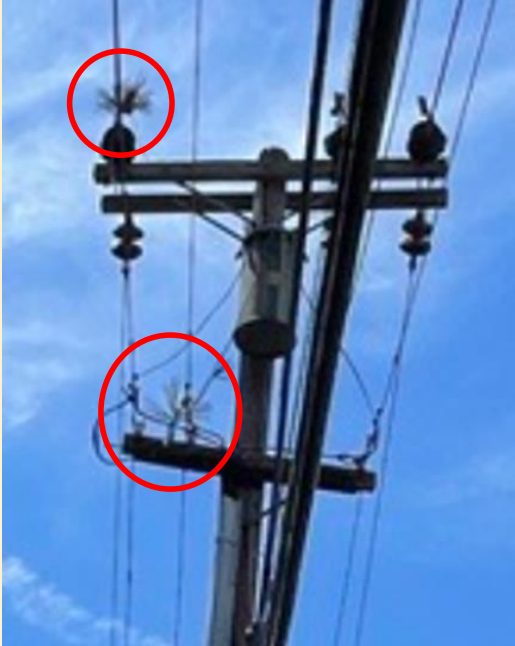
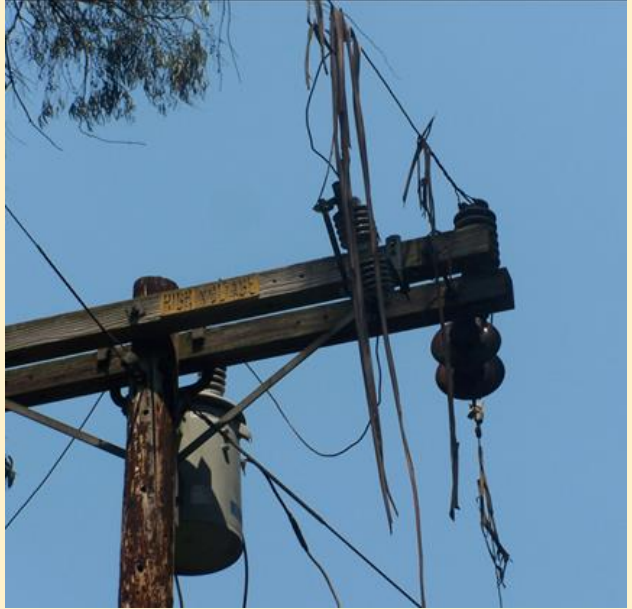
<b>At this Location:</b> Small branches on primary and secondary. Too small to cause a cross-phase or damage.	<b>At this Location:</b> Long tree bark strands, hanging from bare primary conductor, phase separation on single phase cross-arm far enough not to cause cross-phase
<b>Perform Minor Work:</b> Yes, if possible	<b>Perform Minor Work:</b> Yes, if possible
<b>Write 3<sup>rd</sup> Party Notification:</b> No	<b>Write 3<sup>rd</sup> Party Notification:</b> No
<b>Write EC Notification:</b> No	<b>Write EC Notification:</b> Yes, only when minor work not performed. <b>FDA=</b> Tree / Clearance / Remove  <b>Priority=</b> B Tag, 3 months, depending on exposure

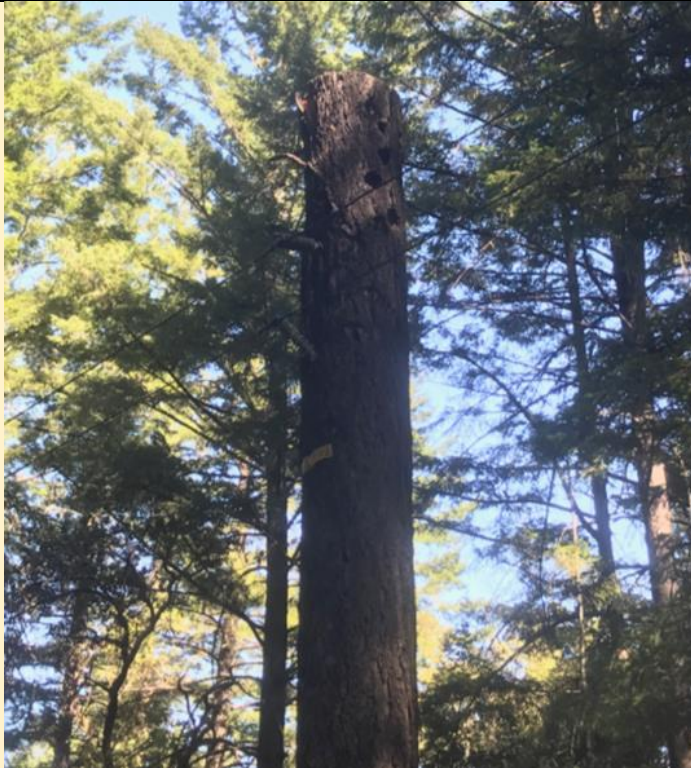
**At this Location:** Tier 2 area, tree connect on dead/dying tree with multiple woodpecker holes and damaged primary insulators

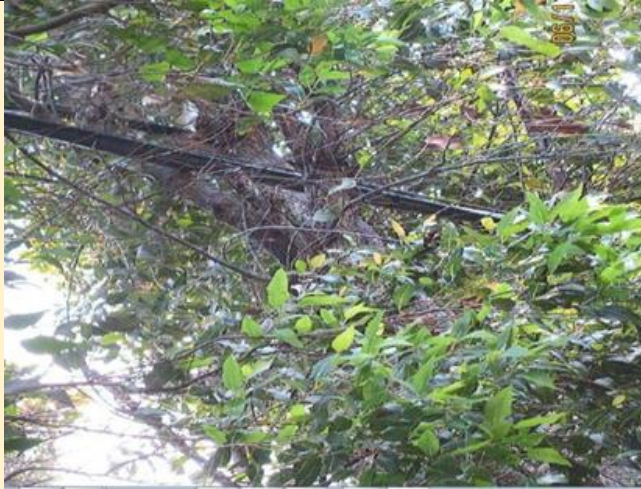
**At this Location:** Tree putting strain on the pole, due to communication line

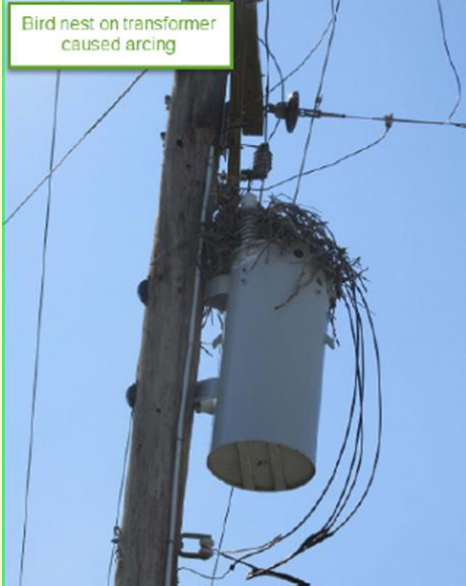
<b>At this Location:</b> Bird Nest on transformer, abandoned, touching high side jumper.
	<b>Perform Minor Work:</b> No
	<b>Write 3<sup>rd</sup> Party Notification:</b> No
	<b>Write EC Notification:</b> Yes  <b>FDA=</b> Overhead facility / Bird Nest / Remove <b>FDA=</b> Bird protection / Bird Protection Deteriorated / Install  <b>Priority=</b> A tag, Follow emergency procedure

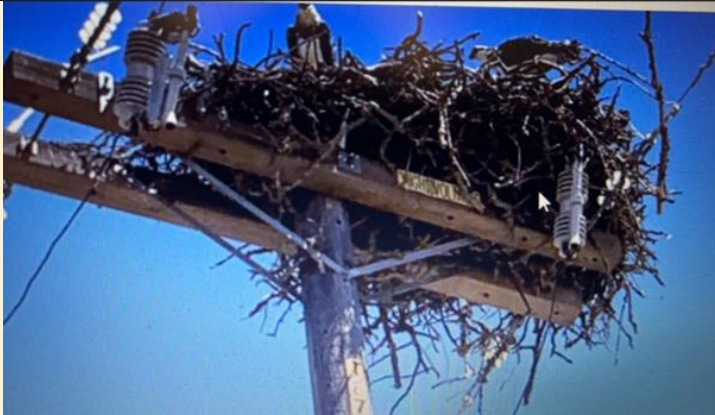
**At this Location:** Active Nest, missing cutout covers. **Notify lead or supervisor to contact bird program manager**
