Job Aid: Overhead Assessment

This job aid is designed to assist Electric Distribution Compliance Inspectors, PG&E Employees, and Contractors in assessing and prioritizing compelling **abnormal conditions** on overhead facilities, including but not limited to GO 165 Inspections. Compelling Abnormal Condition is defined as any electric distribution pole, equipment, component, conductors, vegetation, or third-party condition that causes a safety or fire ignition risk that, in the judgment of the field employee, may adversely impact public safety and/or service reliability **within 5 years**.

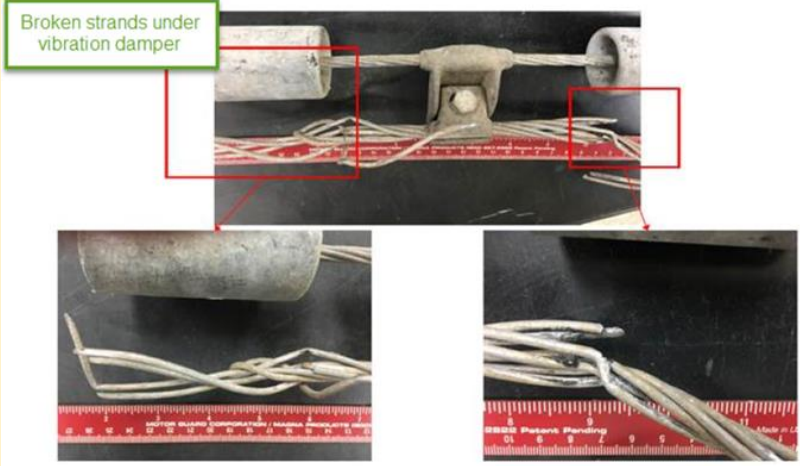
Broken Strands under Vibration damper

At this Location: Broken strands (more than 40%) under vibration Damper	
Perform Minor Work: No	
Write 3rd Party Notification: No	
Write EC Notification: Yes	
FDA = Conductor / Broken / Damaged / Replace	
Priority = A Tag, follow emergency process

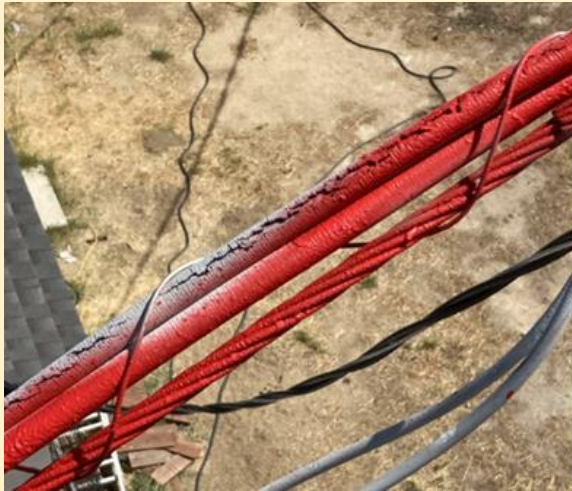
Damaged / Cracked Grey Service

At this Location: Cracked grey service / Aerial cable. Older grey services tend to crack and will appear to have rings around the insulation. Loose lashing, visually cracked, discoloration/corrosion, Degradation. Must be carefully evaluated. Call lead or supervisor.
	Perform Minor Work: Yes, if safe to do so. If you replace the service conductor, this is capital Minor Work. Fill out EC Notification to account for this minor work.
	Write 3rd Party Notification: No
	Write EC Notification: Yes FDA= Conductor / Broken / Replace OR FDA= Conductor / Damaged / Replace OR FDA= Conductor / Burnt / Replace
	Priority = E Tag, 0-12M depending on exposure. <u>Consider A-Tag</u> if signs of tracking between phases present.

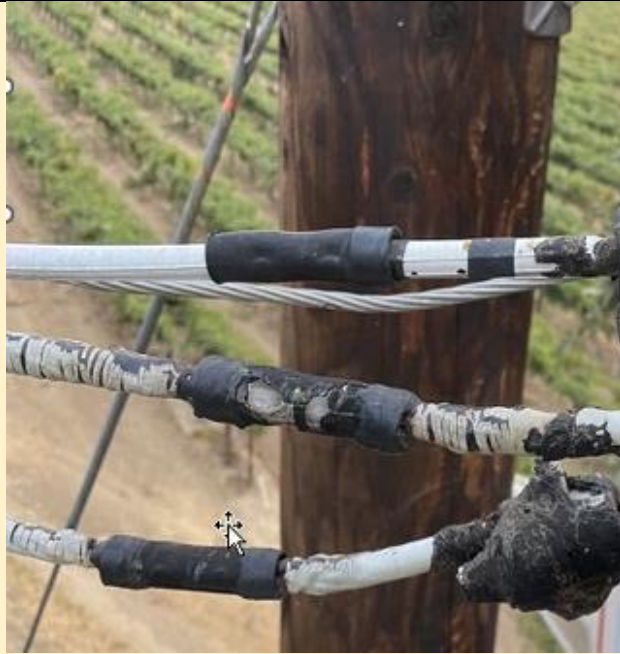
Cracked Grey Service and Deteriorated Insulation Tape

At this Location: Deteriorated cracked Grey service for potential cross-phasing

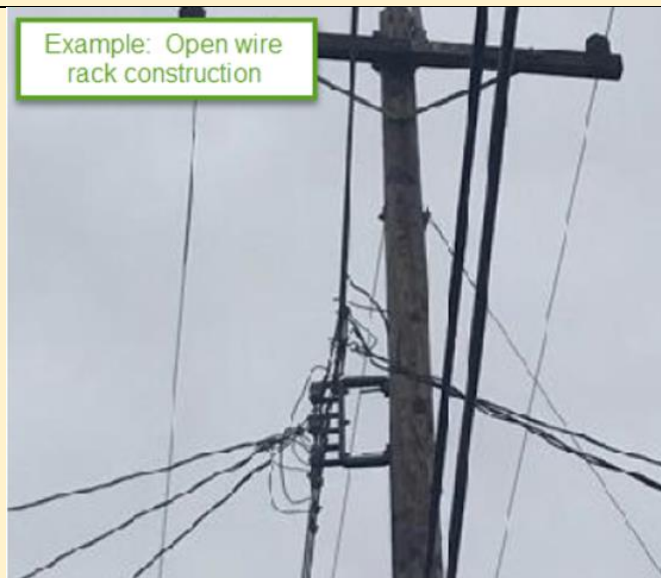
At this Location: Span length >135' missing spreader bracket for open wire extended rack construction.

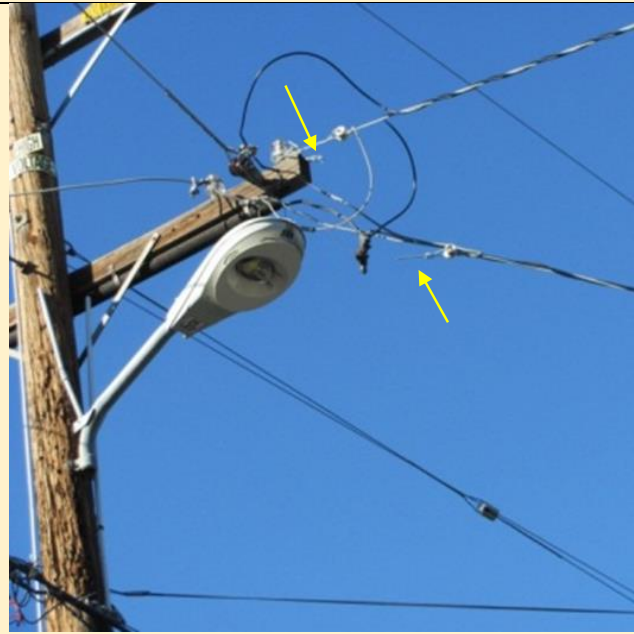
Hardware Broken

At this Location: The #6 solid copper is broken causing strain on the conductor. Unsecured service.
	Perform Minor Work: Yes, if safe to do so
	Write 3rd Party Notification: No
	Write EC Notification: Yes, if minor work cannot be performed FDA= Hardware / Framing / Broken / Damaged / Repair Priority = E Tag, 3-12 months depending on exposure

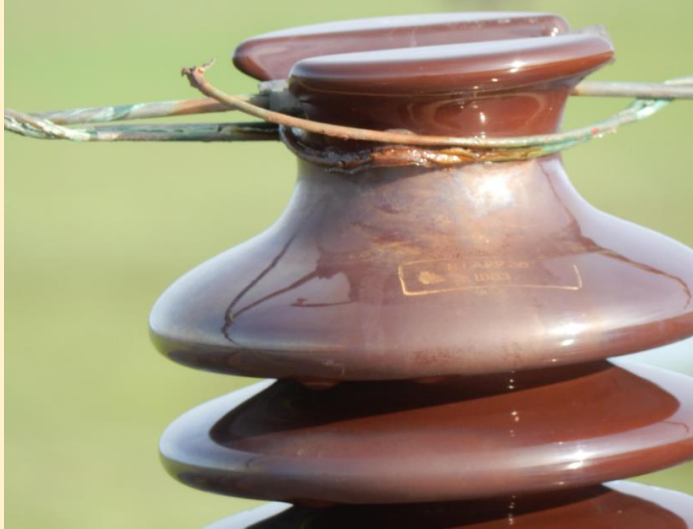
Tie Wire Corroded

At this Location: Tie wire is corroded, strand is broken
	Perform Minor Work: No
	Write 3rd Party Notification: No
	Write EC Notification: Yes FDA= Tie Wire / Corroded / Replace
	Priority = E Tag, 3-12 months depending on exposure

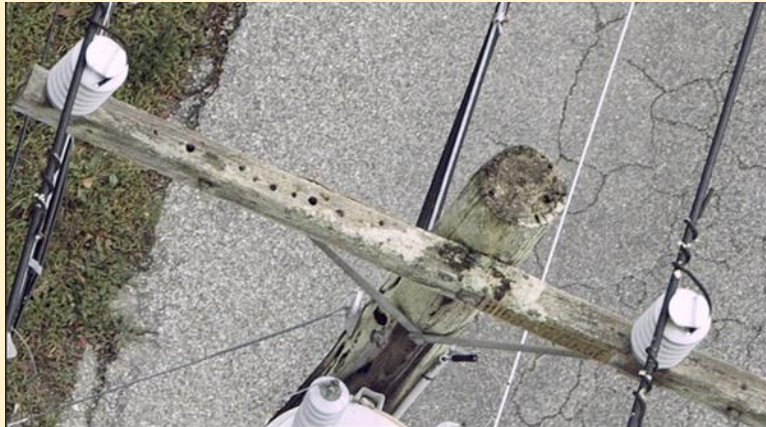
Broken / Corroded Tie Wire

At this Location: Broken tie wire

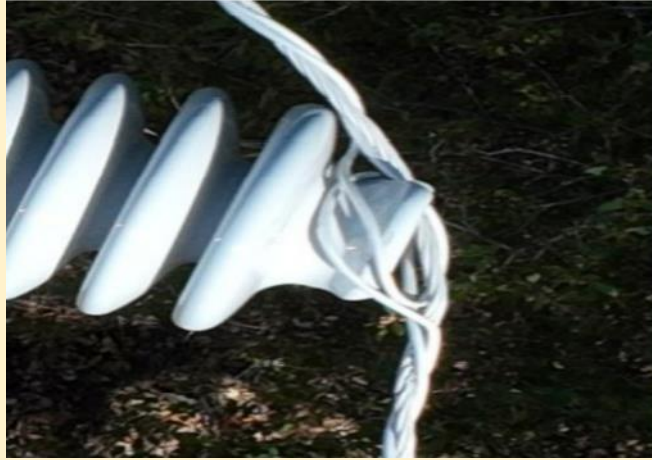
At this Location: Tie wire is slipping from an inside angle

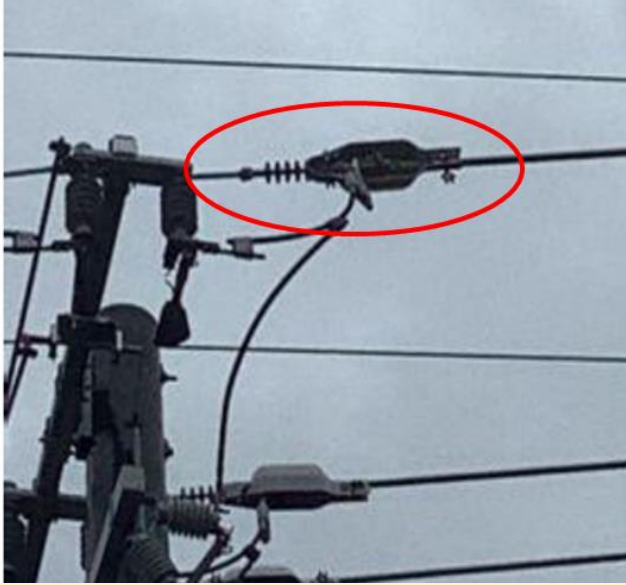
At this Location: Dead-End Cover mis-aligned on tree wire construction.
	Perform Minor Work: Yes, if safe to do so. Install anti-rotation Clamp
	Write 3rd Party Notification: No
	Write EC Notification: Yes FDA= Dead End Cover / Broken / Damaged / Replace OR FDA= Dead End Cover / Broken / Damaged / Repair Priority = F Tag, 5 years, depending on exposure

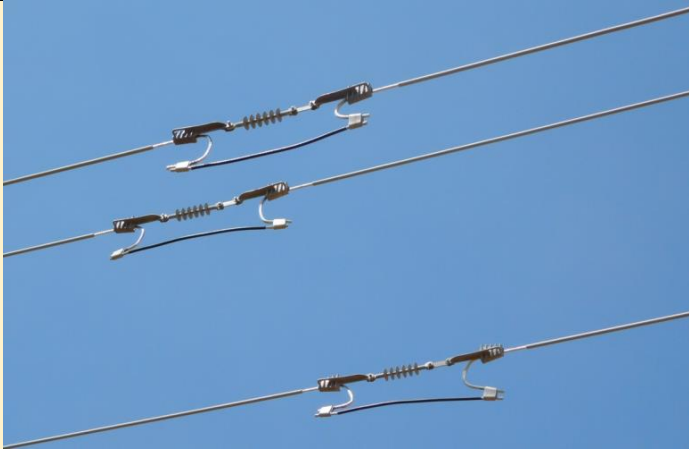
At this Location: Flying Bells installed in on primary tree wire, now have exposed connectors and conductor.
	Perform Minor Work: No
	Write 3rd Party Notification: No
	Write EC Notification: Yes FDA: Tree Wire / Exposed / Repair Priority: F Tag, depending on exposure

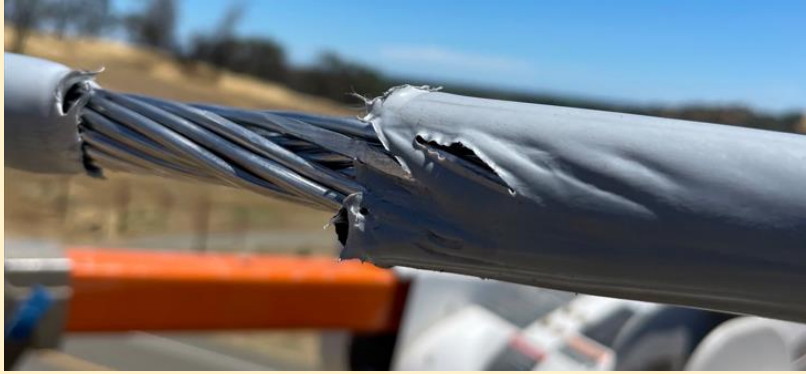
At this Location: Tree Wire jacket cut into, and bare conductor exposed
	Perform Minor Work: No
	Write 3rd Party Notification: No
	Write EC Notification: Yes FDA: Tree Wire / Exposed / Repair Priority: F Tag, depending on exposure

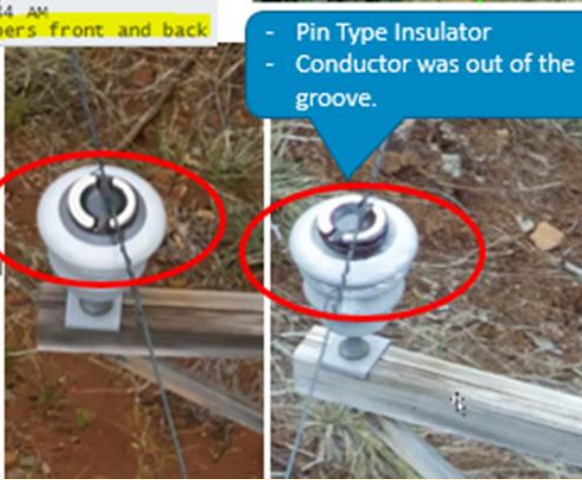
At this Location: Insulator spun, and conductor tied on the skirt, non-angle pole.	At this Location: Tie Wire Broken / Loose / Not in Groove
Perform Minor Work: No	Perform Minor Work: No
Write 3rd Party Notification: No	Write 3rd Party Notification: No
Write EC Notification: Yes FDA = Tie Wire / Broken / Damaged / Replace Priority = B Tag, 0-3 months depending on exposure	Write EC Notification: Yes FDA = Tie Wire / Improperly Installed / Repair Priority = B Tag, 0-3 months depending on exposure

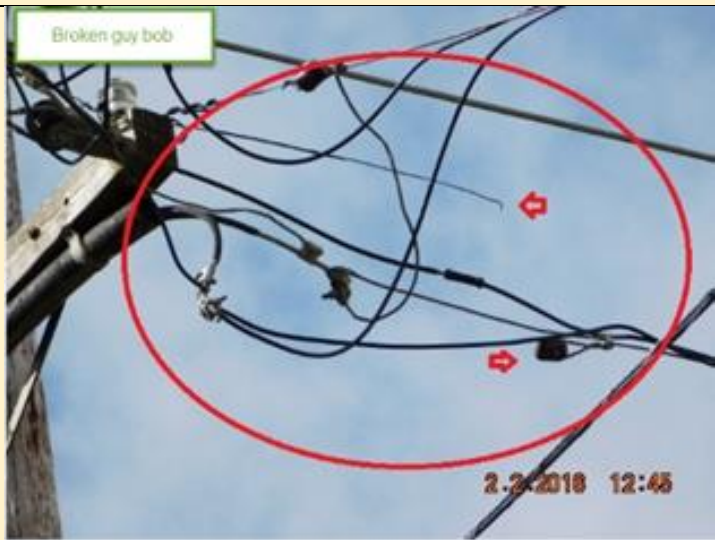
At this Location: Broken service Insulator which has become unattached between the copper wire and the insulator.
	Perform Minor Work: No
	Write 3rd Party Notification: No
	Write EC Notification: Yes
	FDA= Hardware/Framing / Broken / Damaged / Repair Priority= "E", 3-12 months depending upon exposure

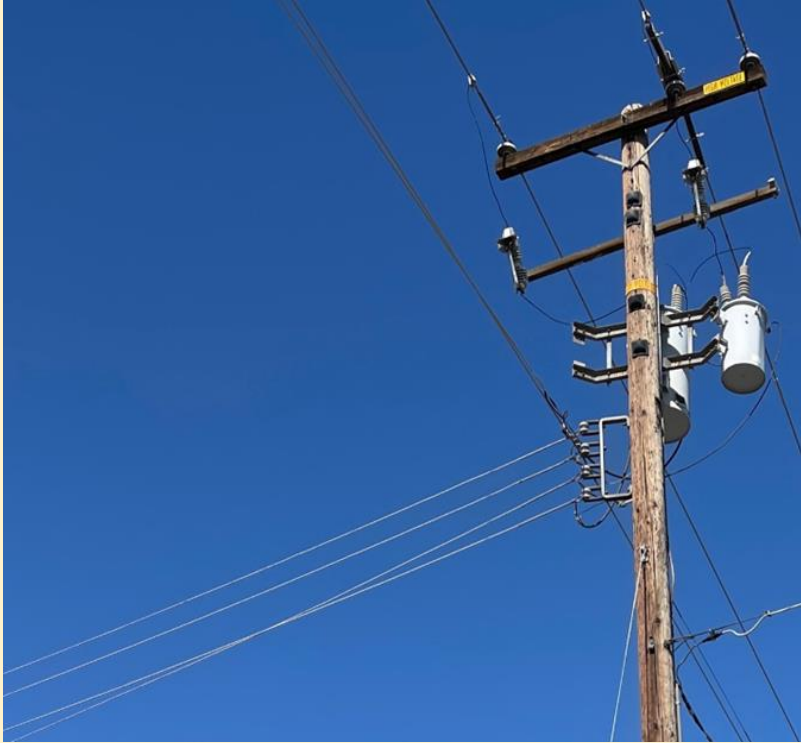
At this Location: Open wire secondary sag into neutral, energizing the neutral
	Perform Minor Work: No
	Write 3rd Party Notification: No
	Write EC Notification: Yes FDA= Conductor/ Sag / Clearance / Adjust or replace PRIORITY= A tag, follow emergency procedure

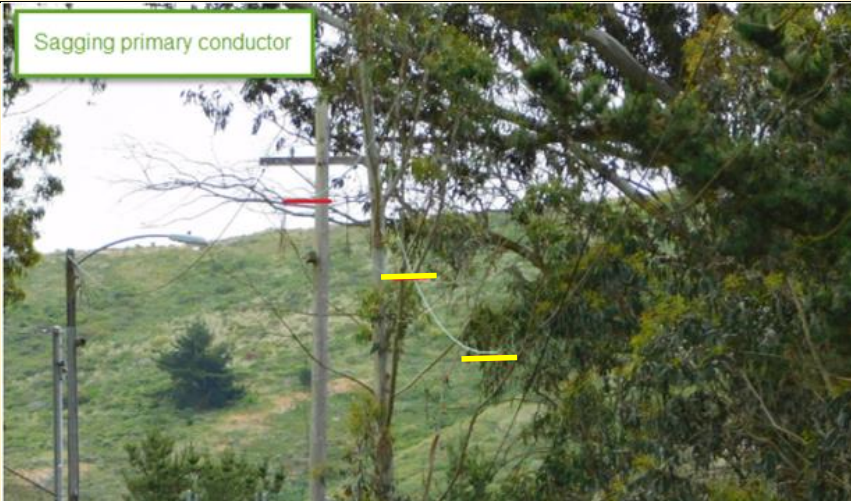
At this Location: Sagging Primary Conductor
	Perform Minor Work: No
	Write 3rd Party Notification: No
	Write EC Notification: Yes FDA= Conductor / Sag / Clearance / Adjust PRIORITY= E tag, 3-12 months depending upon exposure

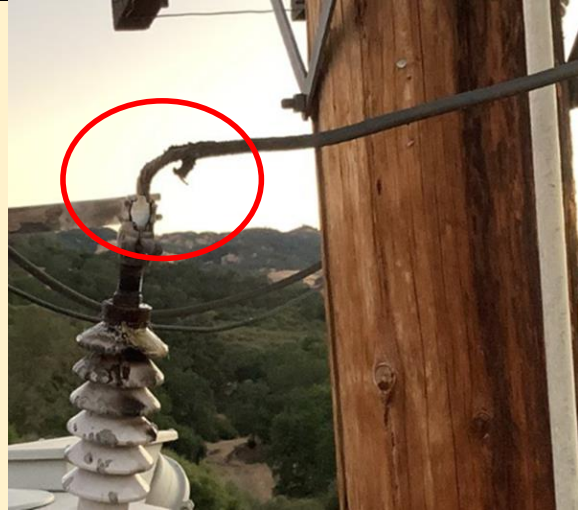
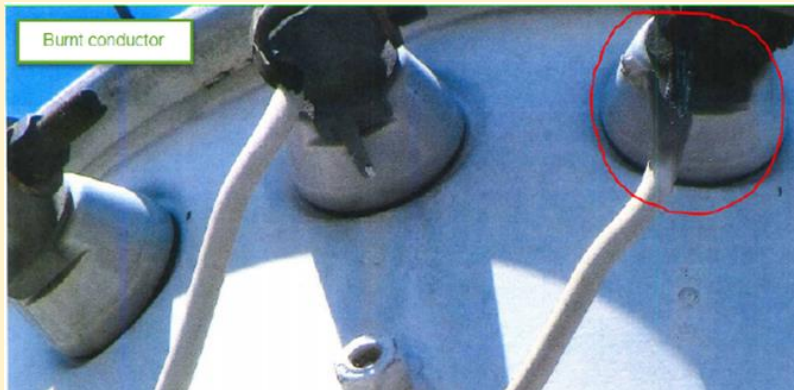
At this Location: Primary jumpers and / or transformer secondary connection jumpers frayed and burnt.

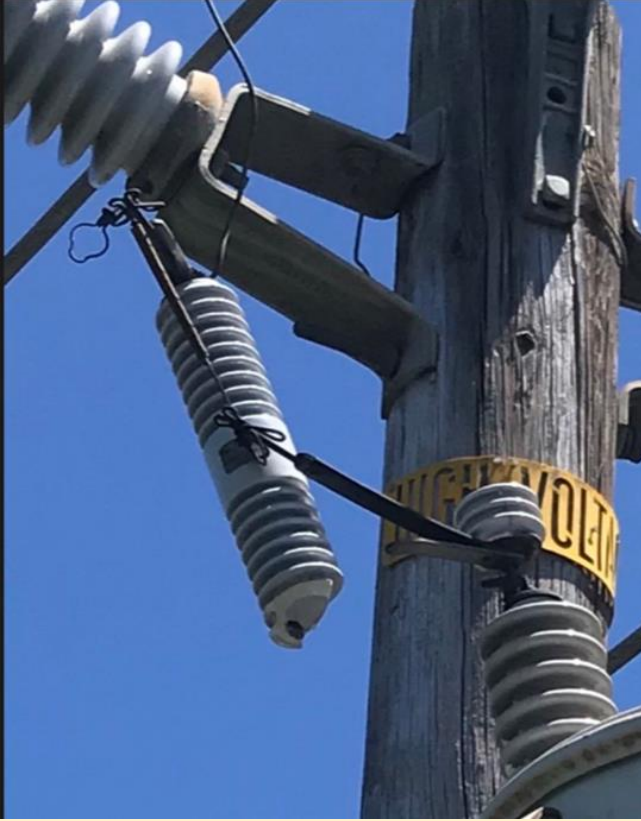
At this Location: Broken/Flashed cutout	At this Location: Broken Cutout
Perform Minor Work: No	Perform Minor Work: No
Write 3rd Party Notification: No	Write 3rd Party Notification: No
Write EC Notification: Yes FDA = Cutout / Broken/Damaged / Replace Priority = E Tag, 3-12 months depending upon exposure, no COE	Write EC Notification: Yes FDA = Cutout / Broken/Damaged / Replace Priority = A Tag, Follow the emergency procedure

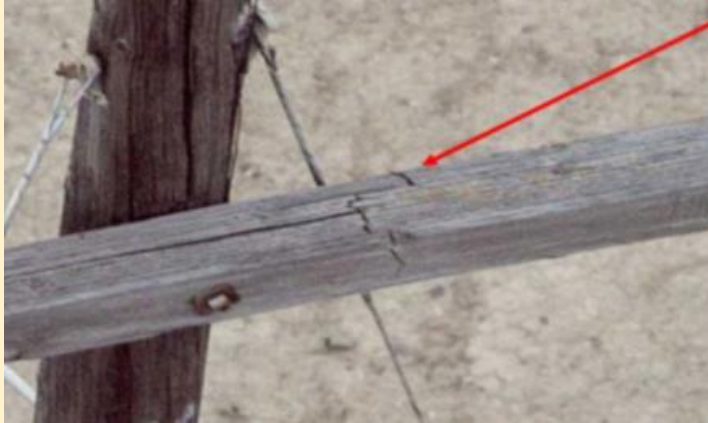
At this Location: Top view of a cracked cross-arm on top and sides. May not be seen from the ground.
	Perform Minor Work: No
	Write 3rd Party Notification: No
	Write EC Notification: Yes FDA = Cross-arm / Broken / Damaged / Replace Priority = A Tag, Follow emergency procedure

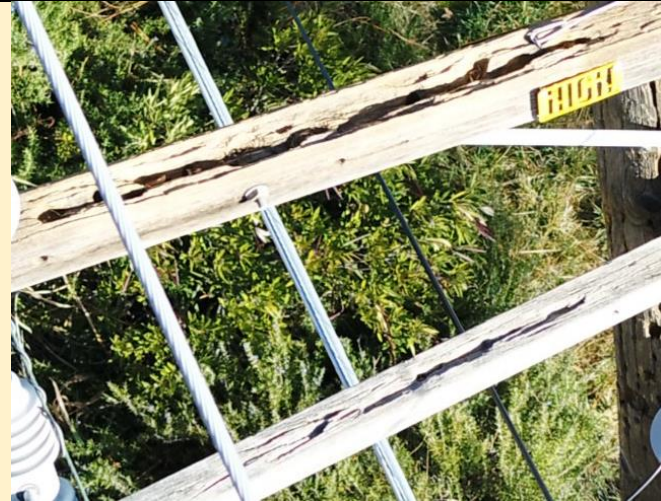
At this Location: Deteriorated Cross-Arm – Aerial View

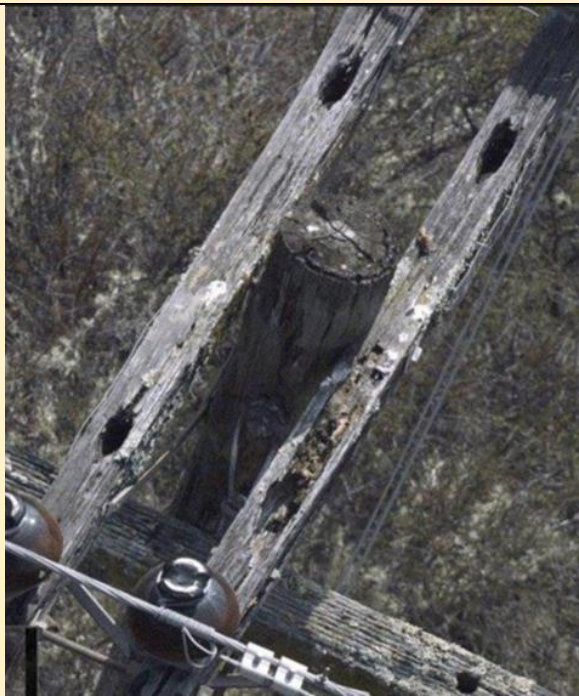
At this Location: Deteriorated/Rotten Cross-Arm – Aerial View

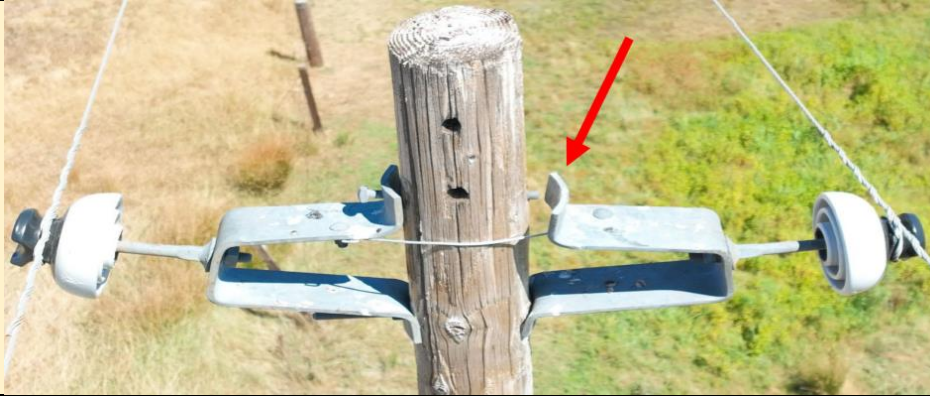
At this Location: The nut has come off of the Through Bolt

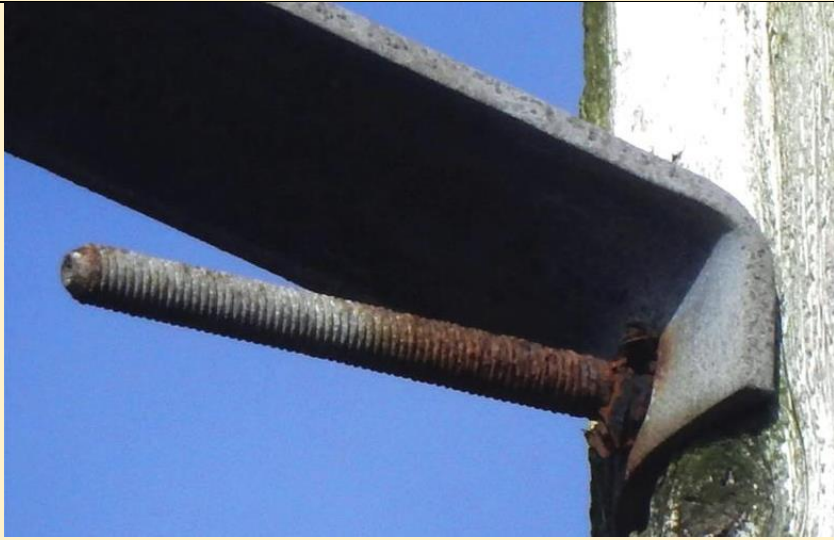
At this Location: Bolt hardware extremely corroded
	Perform Minor Work: No
	Write 3rd Party Notification: No
	Write EC Notification: Yes FDA= Hardware / Broken / Damaged / Replace Priority= E tag, 3-12, depending on exposure / Severity

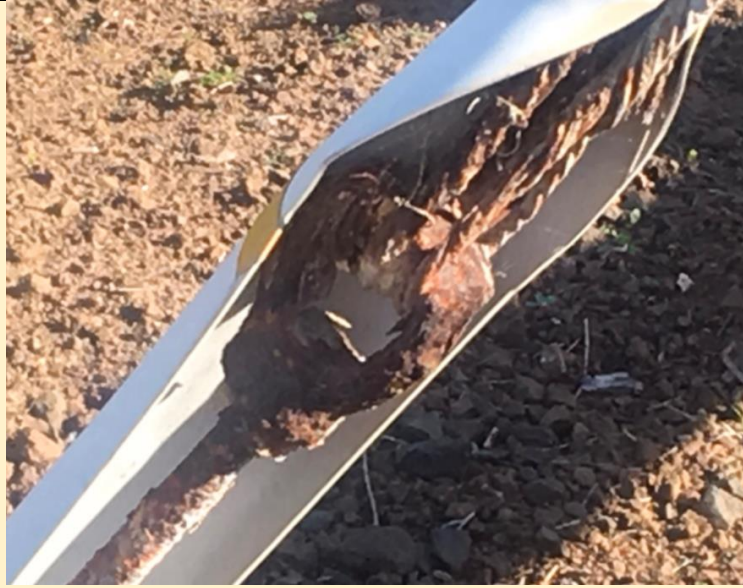
**At this Location:** Corroded Anchor**Perform Minor Work:** No**Write 3rd Party Notification:** No**Write EC Notification:** Yes**FDA=** Anchor / Corroded / Replace**Priority=** E tag, 3-12, depending on exposure / Severity

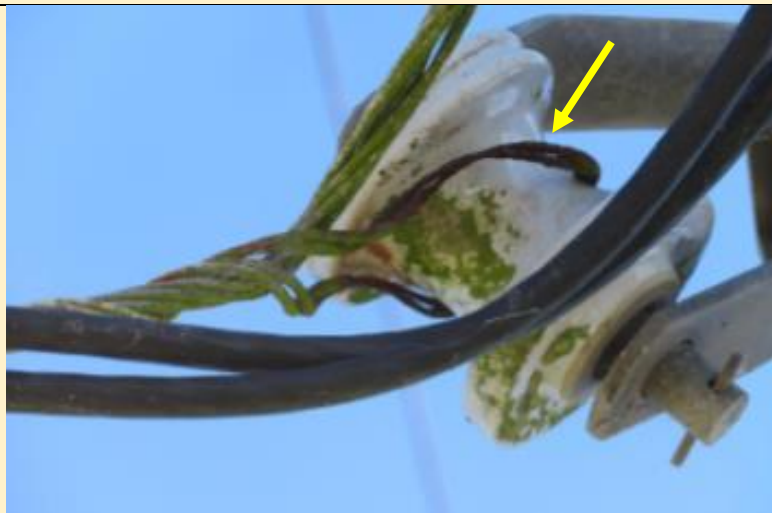
**At this Location:** Corroded Preform Tie**Perform Minor Work:** No**Write 3rd Party Notification:** No**Write EC Notification:** Yes**FDA=** Tie Wire / Corroded / Replace**Priority=** E tag, 3-12, depending on exposure / Severity

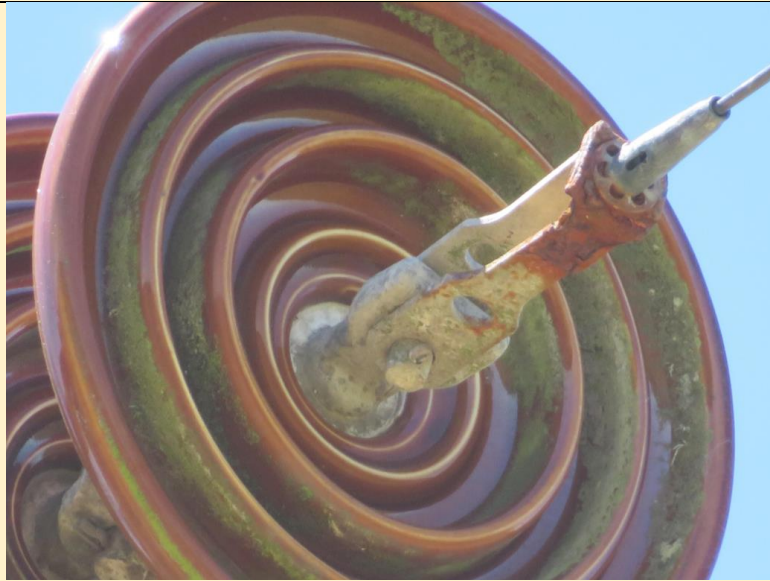
At this Location: Primary Dead-End Hardware Corroded

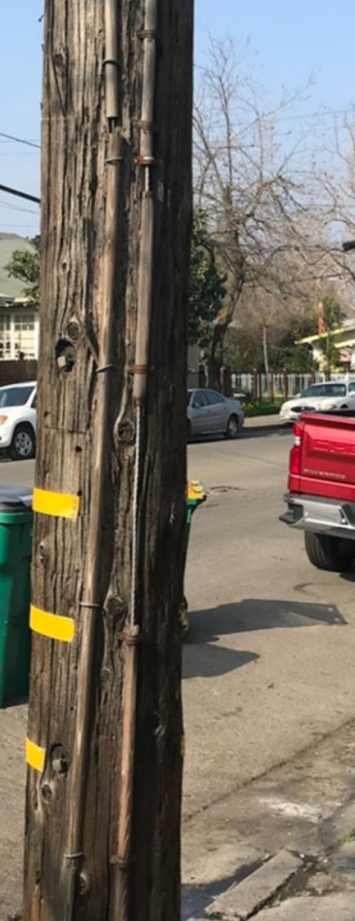
At this Location: Exposed grounds near sidewalk
	Perform Minor Work: Yes, at minimum make safe
	Write 3rd Party Notification: No
	Write EC Notification: Yes FDA= Ground / Exposed / Repair Priority= A Tag, emergency – due to High public exposure at ground level.

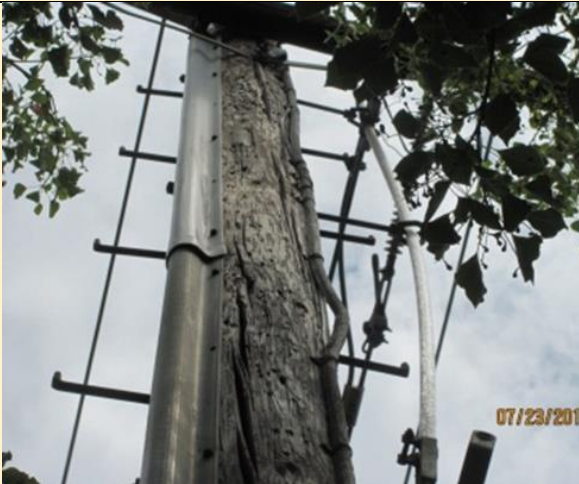
At this Location: Exposed ground at communications level. Wood molding broken in climbing space	At this Location: Exposed ground in wood molding.
Perform Minor Work: Yes, if safe to do so	Perform Minor Work: Yes, if safe to do so
Write 3rd Party Notification: No	Write 3rd Party Notification: No
Write EC Notification: Yes, only if unable to perform minor work.	Write EC Notification: Yes, only if unable to perform minor work.
FDA= Ground / Exposed / Repair	FDA= Ground / Exposed / Repair
Priority= F Tag At minimum – next inspection cycle; based on field condition and exposure, corrosion, etc.; prioritize as needed (A, B, E, or F)	Priority= F Tag At minimum – next inspection cycle; based on field condition and exposure, corrosion, etc.; prioritize as needed (A, B, E, or F)

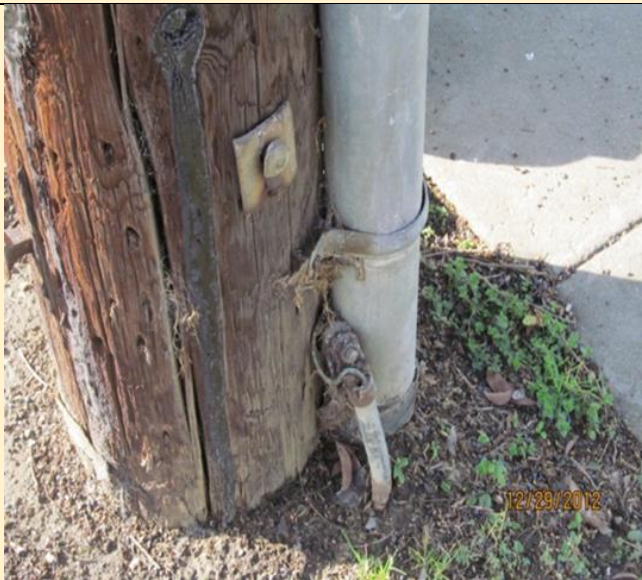
At this Location: Exposed ground rod, public exposure
	Perform Minor Work: Yes, at minimum make safe
	Write 3rd Party Notification: No
	Write EC Notification: Yes FDA= Ground / Exposed / Repair Priority= A Tag, emergency – due to public exposure at ground level, if minor work not done.

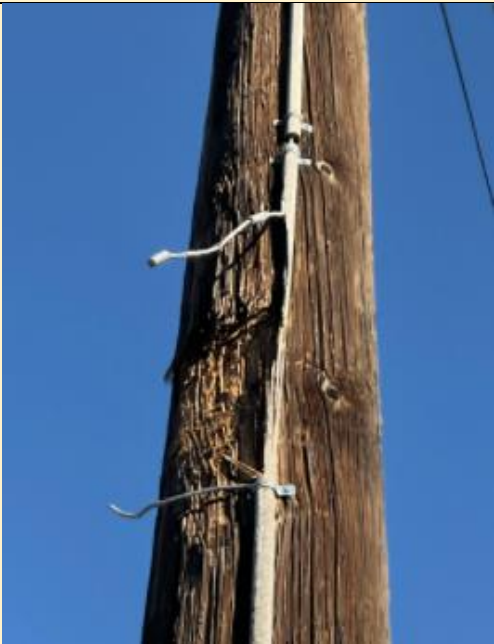
At this Location: Pole ground has broken, above 8', on a Common Neutral 1000' ground.
	Perform Minor Work: Yes, if safe to do so, Refer to TD-2990P-01 for repair.
	Write 3rd Party Notification: No
	Write EC Notification: Yes, if not able to be performed under minor work
	FDA= Ground / Broken / Damaged / Replace or Repair Priority= B Tag, 0-3 months, depending on exposure

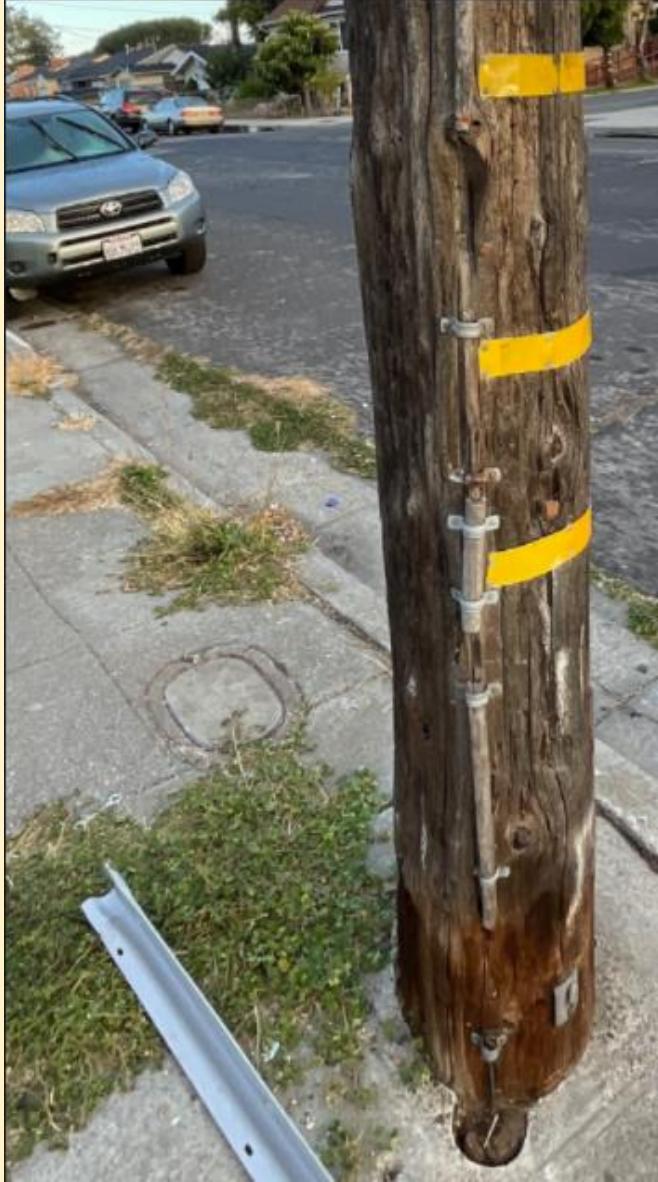
At this Location: Transformer ground has broken, below 8', in the sidewalk, exposed to the public

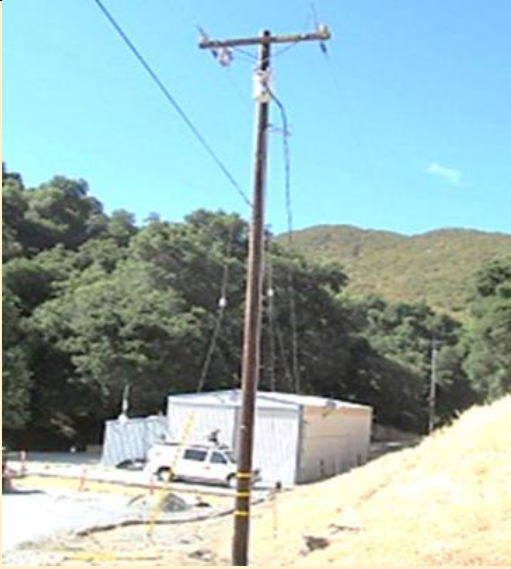
At this Location: Loose guy on left side
	Perform Minor Work: Yes
	Write 3rd Party Notification: No
	Write EC Notification: Yes, only if minor work is not possible
	FDA=Guy / Loose / Adjust Priority= F Tag at minimum, next inspection cycle; based on field condition and exposure, corrosion, etc.; prioritize as needed (A, B, E, or F)

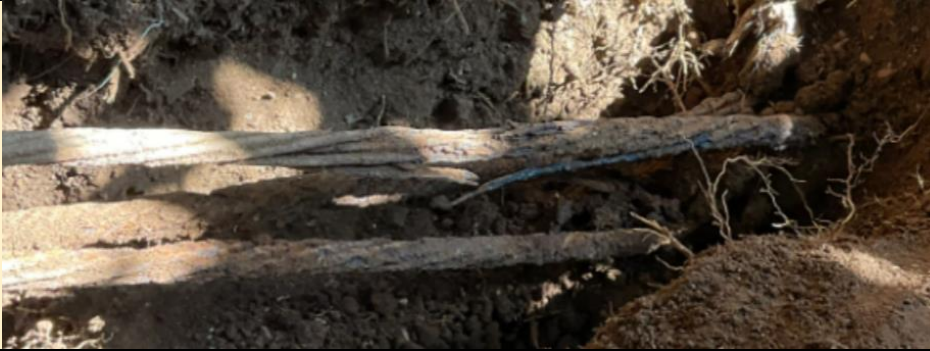
At this Location: Guy corroded and missing strands

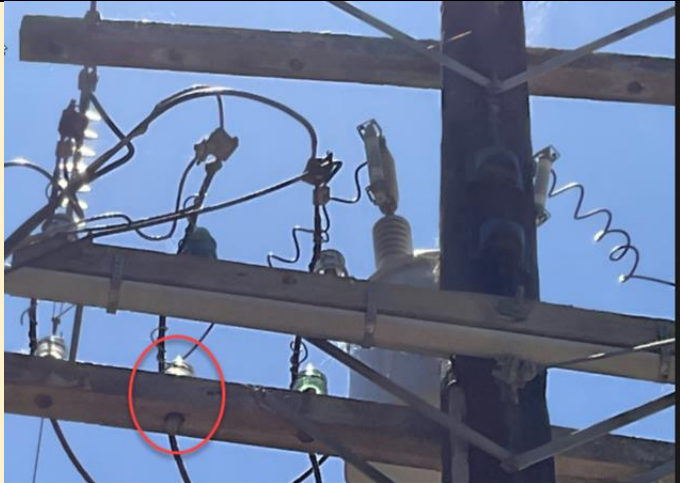
At this Location: Secondary Squatter, crossarm in good shape
	Perform Minor Work: No
	Write 3rd Party Notification: No
	Write EC Notification: Yes
	FDA= Secondary Squatter / Broken / Damaged / Replace Priority= E Tag, 3-12 months Depending on exposure

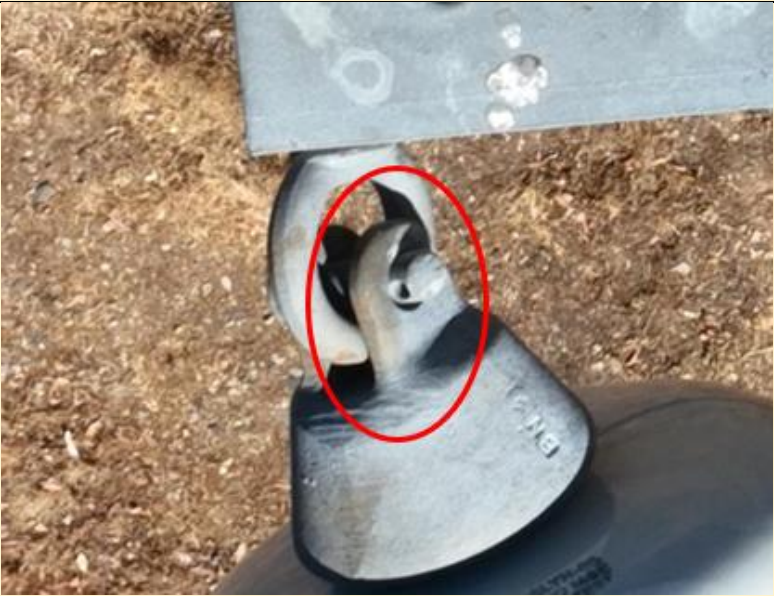
At this Location: Missing Cotter Key / Retainer Pin Fully Seated, may fall out
	Perform Minor Work: No
	Write 3rd Party Notification: No
	Write EC Notification: Yes FDA= Hardware / Missing / Install Priority= B Tag, 0-3 months, depending on exposure

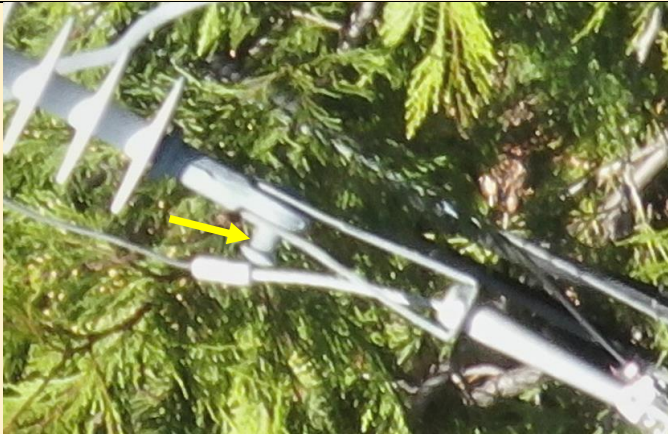
At this Location: Retainer Pin coming loose, almost pulled out

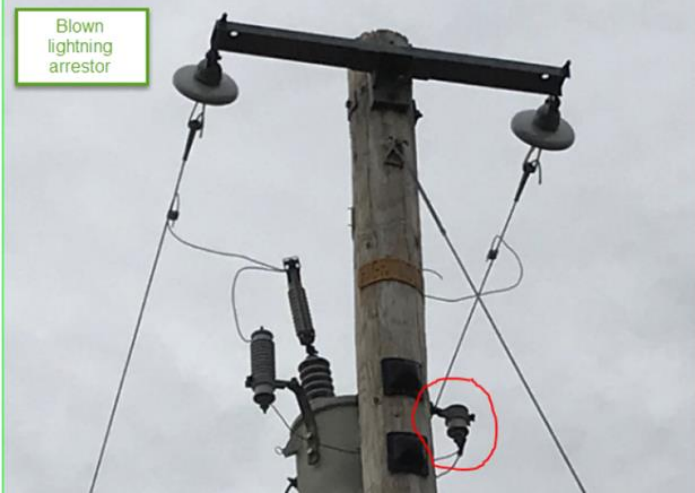
At this Location: Non-Exempt Surge Arrestor Blown	At this Location: Exempt ABB arrester operated / blown indicated by the orange marker sticking out the bottom
Perform Minor Work: No	Perform Minor Work: No
Write 3rd Party Notification: No	Write 3rd Party Notification: No
Write EC Notification: Yes FDA= Lightning Arrestor / Broken / Damaged / Replace Priority= E Tag, 3-12 months, depending on exposure	Write EC Notification: Yes FDA= Lightning Arrestor / Broken / Damaged / Replace Priority= E Tag, 3-12 months, depending on exposure

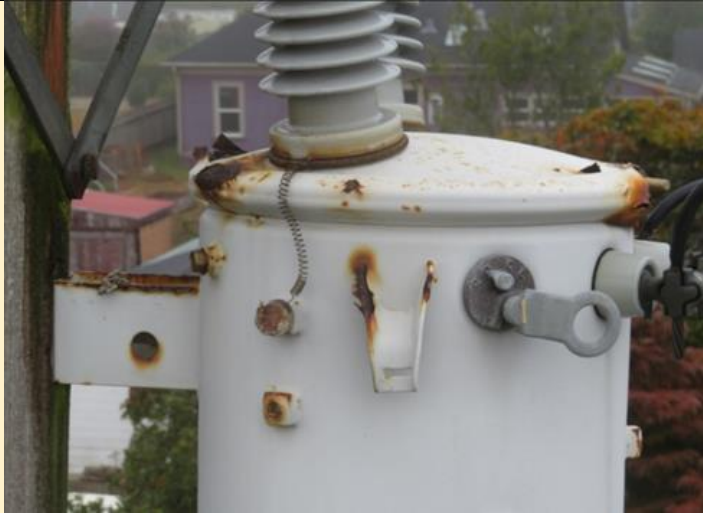
At this Location: Corrosion Weakening Integrity of Tank. Metal is separating into layers. Corrosion will breach tank
	Perform Minor Work: No
	Write 3rd Party Notification: No
	Write EC Notification: Yes FDA= Transformer / Corroded / Replace Priority= E Tag, 3-12 months depending upon exposure

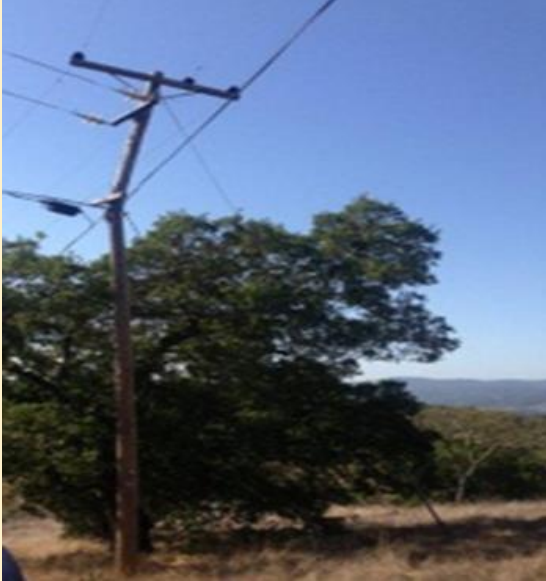
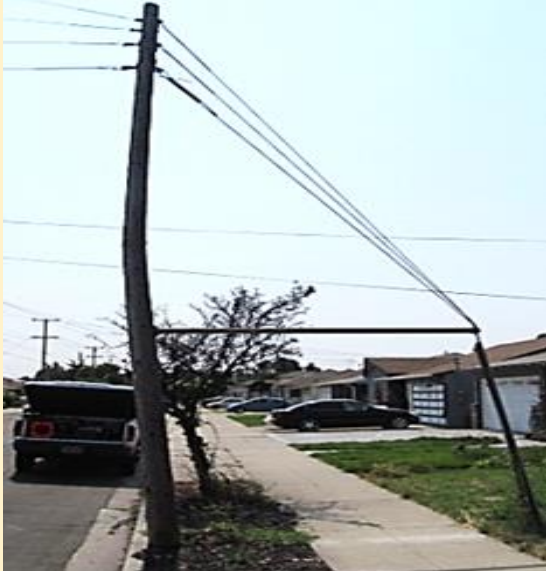
<p>At this Location: Pole broken at the communication level. Horizontal Crack. Greater than 30%</p> <p>Complete Pole Inspection Test Report</p>	<p>At this Location: Broken pole, Supported by guy.</p> <p>Complete Pole Inspection Test Report.</p>
Perform Minor Work: No	Perform Minor Work: No
Write 3rd Party Notification: No	Write 3rd Party Notification: No
<p>Write EC Notification: Yes</p> <p>FDA= Pole / Broken/Damaged / Replace</p>	<p>Write EC Notification: Yes</p> <p>FDA= Pole / Broken/Damaged / Replace</p>
Priority= A Tag, Follow the emergency process	Priority= B Tag, 3 months, depending on exposure

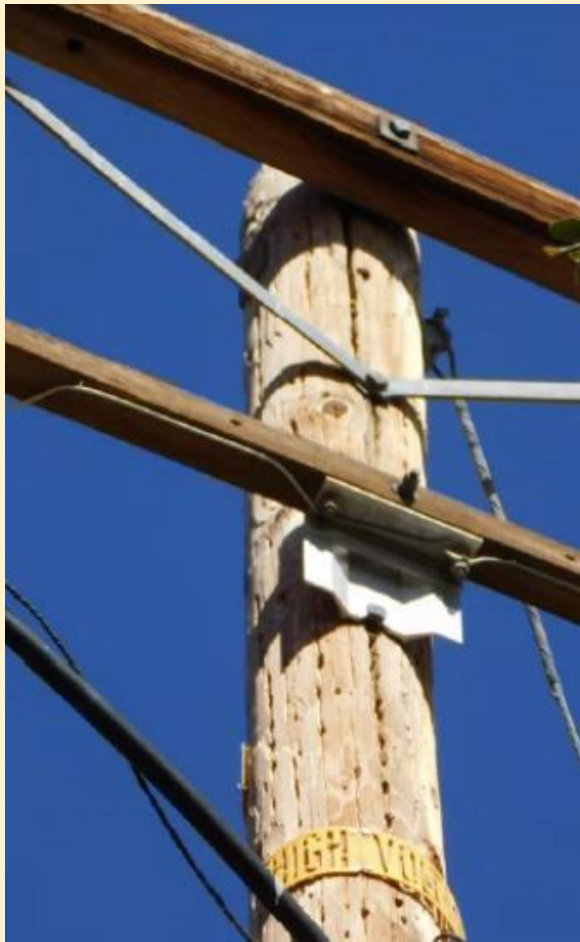
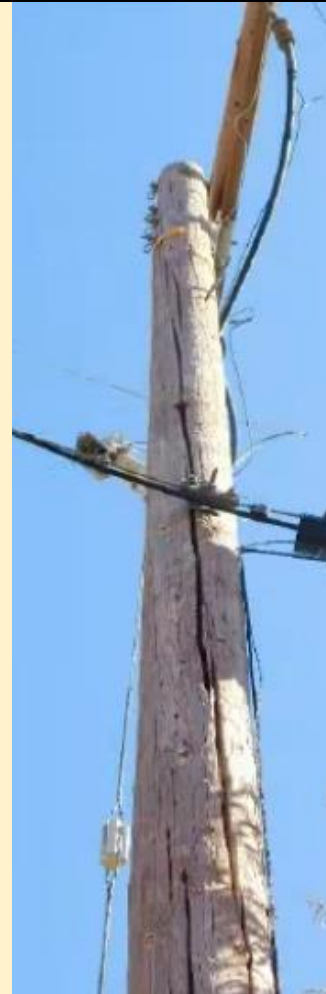
At this Location: Pole Checks. Down guy acting as split bolt. Multiple vertical cracks running down pole are not at the points of attachment affecting the hardware. No compelling abnormal conditions to report.

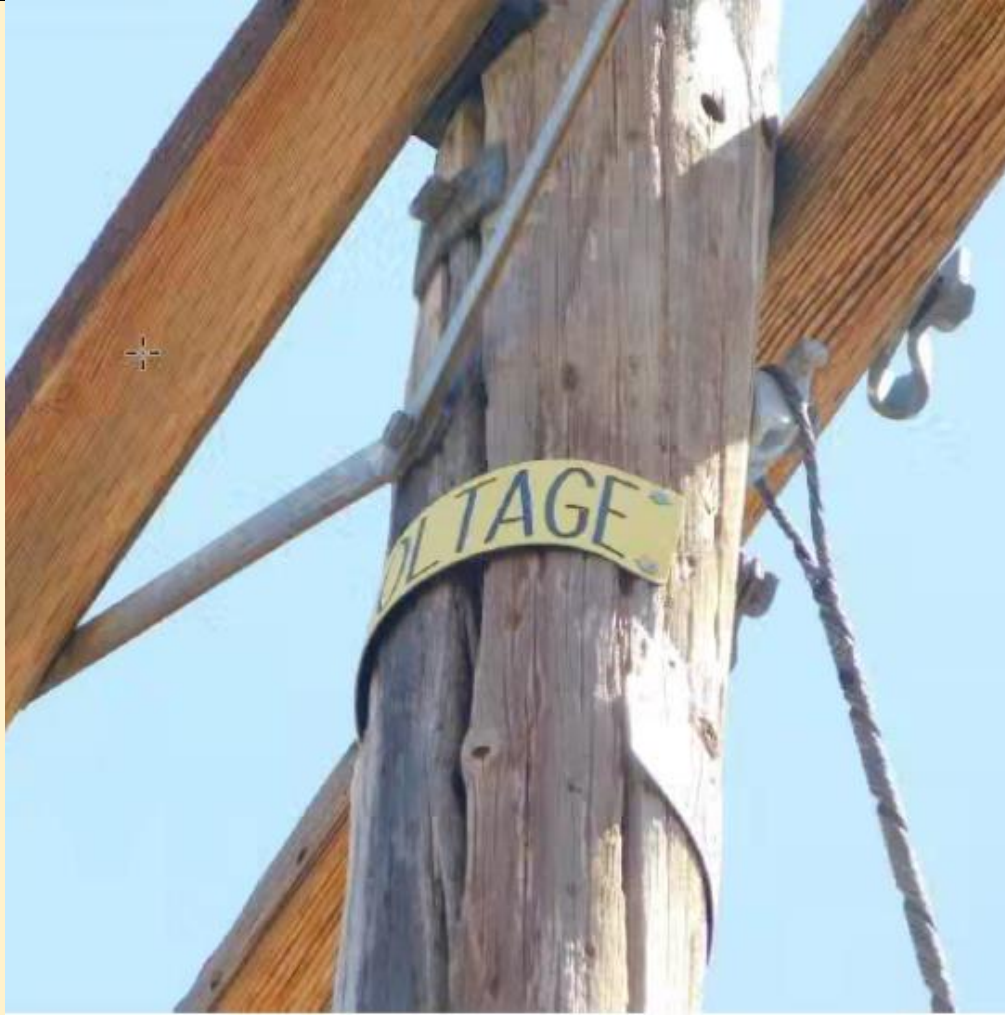
At this Location: Pole checks at the equipment level attachments but not affecting the hardware. Not a compelling abnormal condition, will last another 5 years.

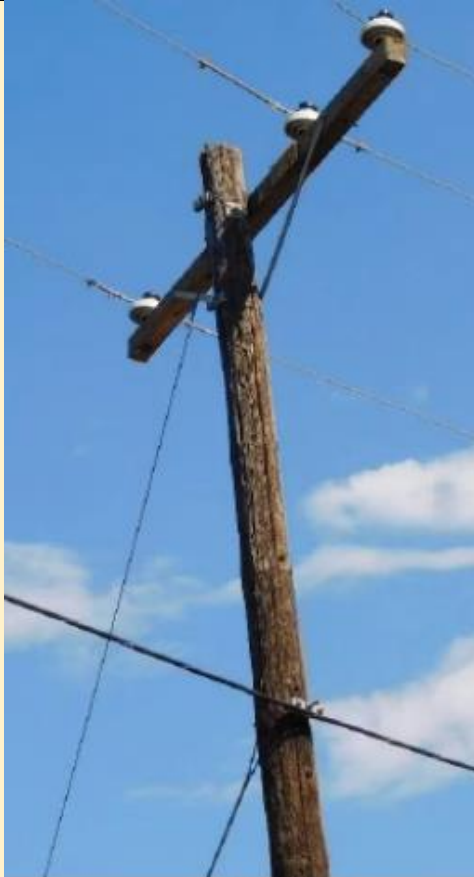
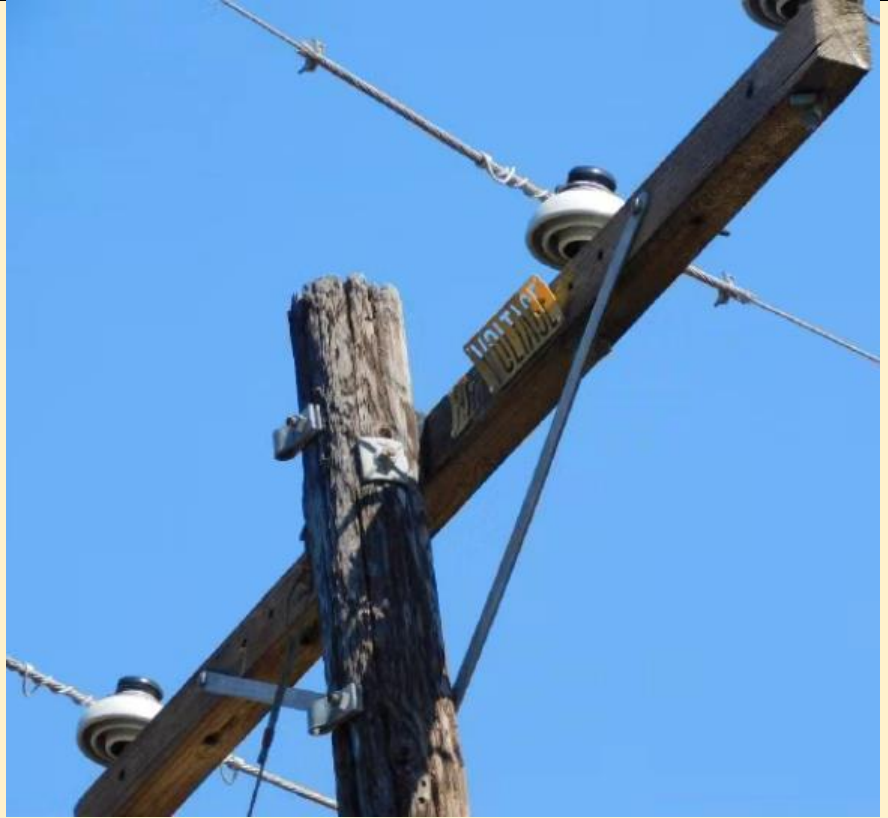
At this Location: Pole has multiple conditions: Pole in poor condition, decayed, and extensive weathering, and pole top rot. Pole checks alone are not a compelling abnormal condition, but in combination with all the other conditions, write EC tag.

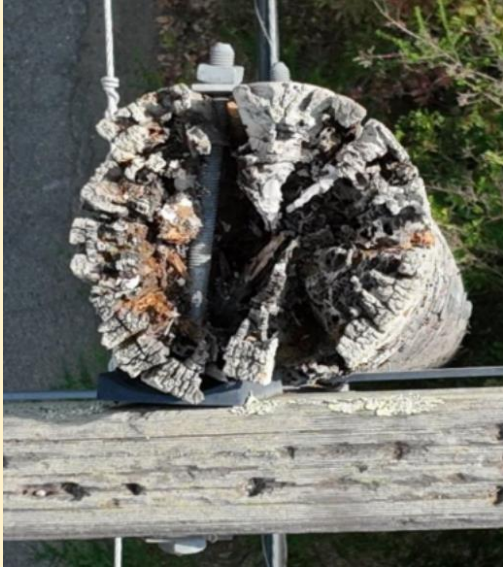
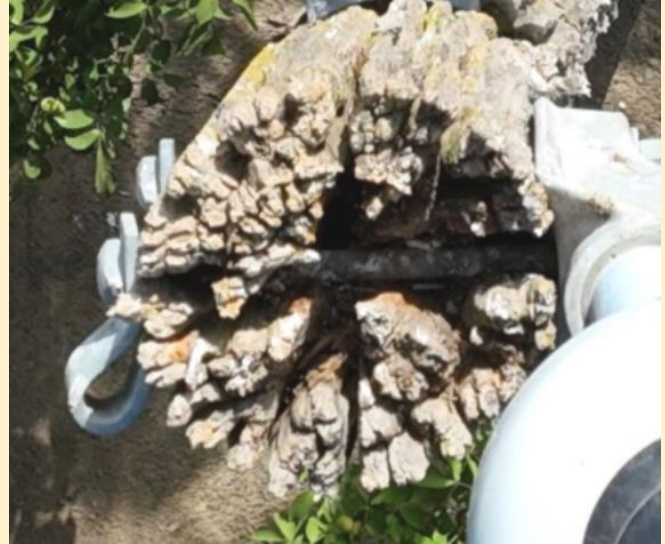
At this Location: Pole top decayed. Complete the Pole Inspection Test Report

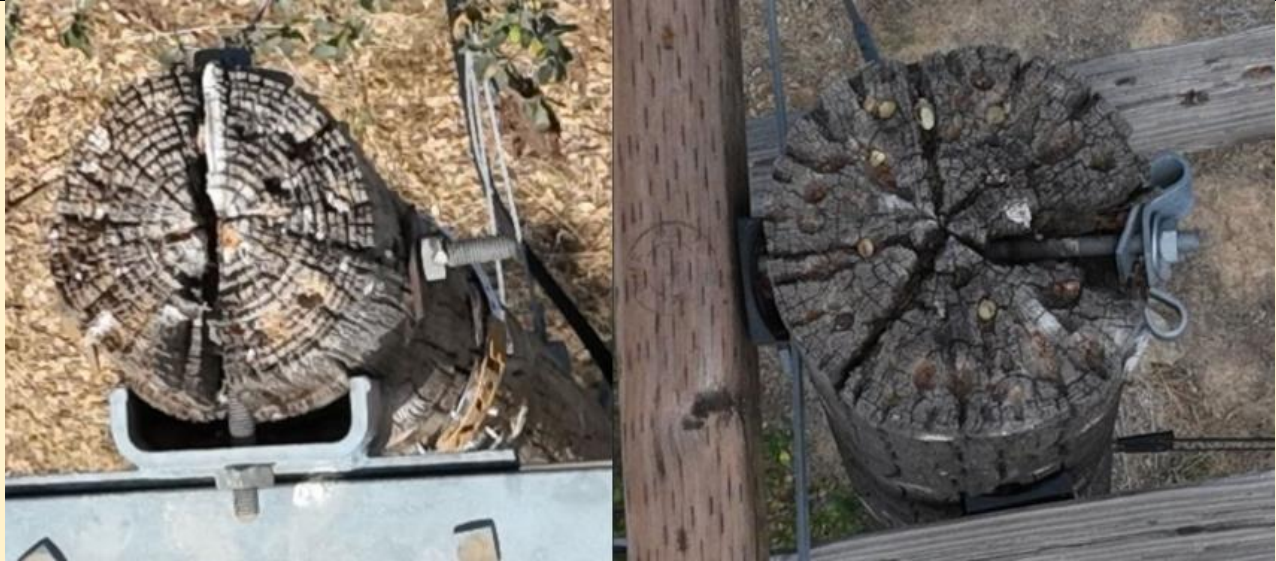
At this Location: Pole top decayed. Complete the Pole Inspection Test Report

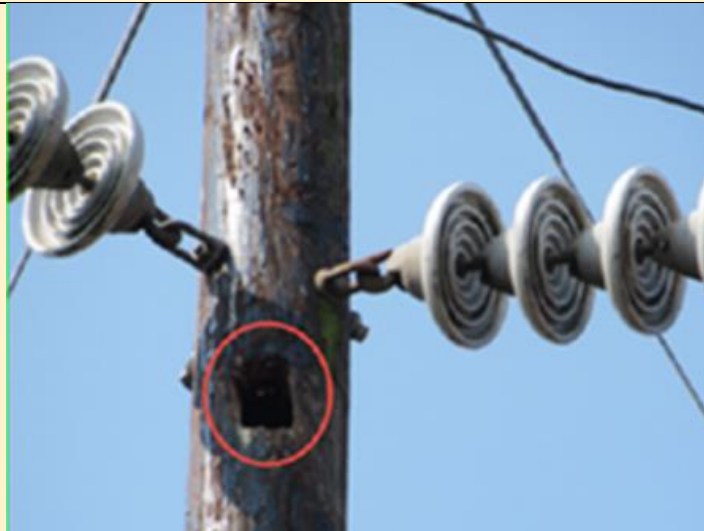
At this Location: Comparing to the insulators Woodpecker holes appear to be close to 7" per Guideline "Nesting cavities or other open pockets have an outside hole diameter that is less than 4 inches wide.". When in doubt, write notification
