Job Aid: Overhead Assessment

This job aid is designed to assist Electric Distribution Compliance Inspectors, PG&E Employees, and Contractors in assessing and prioritizing compelling **abnormal conditions** on overhead facilities, including but not limited to GO 165 Inspections. Compelling Abnormal Condition is defined as any electric distribution pole, equipment, component, conductors, vegetation, or third-party condition that causes a safety or fire ignition risk that, in the judgment of the field employee, may adversely impact public safety and/or service reliability **within 5 years**.

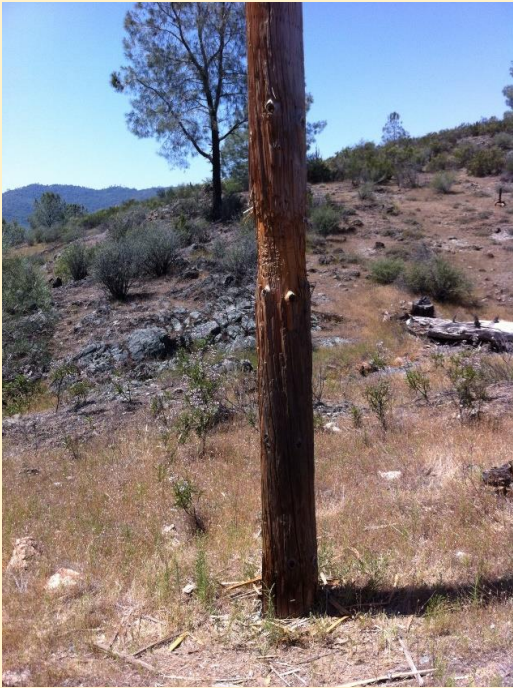
At this Location: Pole has reduced circumference, write EC notification for estimating to confirm pole loading.
	Perform Minor Work: No
	Write 3rd Party Notification: No
	Write EC Notification: Yes FDA= Pole / Overloaded / Test Priority= E Tag, 3-12 months depending on exposure

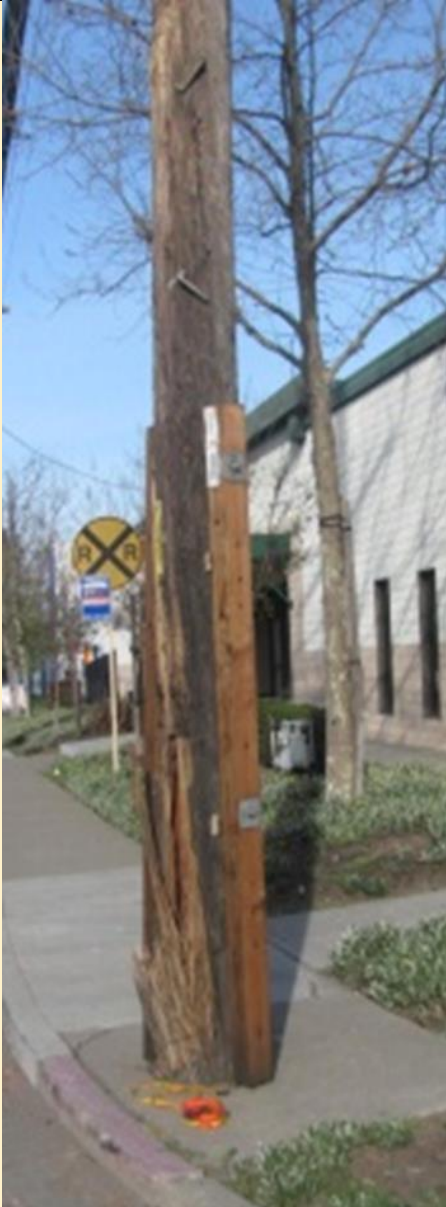
At this Location: Pole damaged by vehicle. Cross-arm acting as Splint installed as temporary repair
	Perform Minor Work: No
	Write 3rd Party Notification: No
	Write EC Notification: Yes FDA= Pole / Broken / Damaged / Replace Priority= E Tag, 3-12 Mo depending on exposure

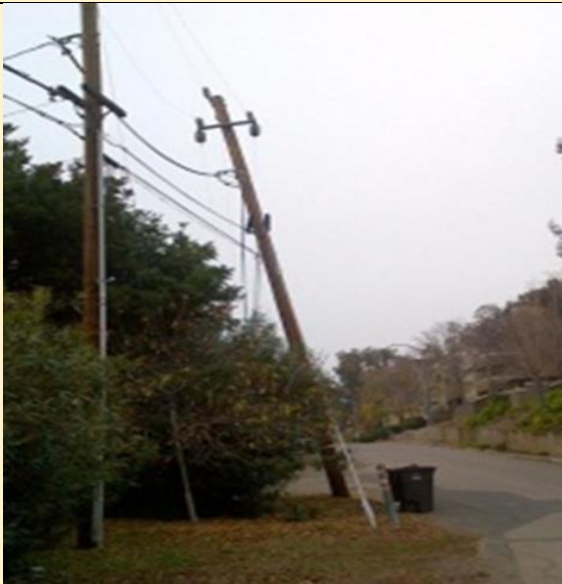
At this Location: Leaning pole greater than 10% out of plumb. Pole is stable. No equipment, in rural area. Causing reduced clearance.	At this Location: Leaning towards a tree more than 10% out of plumb. Inspector pulled plug and confirmed pole is solid below ground. Probability of equipment failure is moderate.
Perform Minor Work: No	Perform Minor Work: No
Write 3rd Party Notification: No	Write 3rd Party Notification: No
Write EC Notification: Yes FDA= Pole / Leaning / Adjust	Write EC Notification: Yes FDA= Pole / Leaning / Replace
Priority= E Tag, 3-12 months, depending on exposure	Priority= B Tag, 0-3 months, depending on exposure

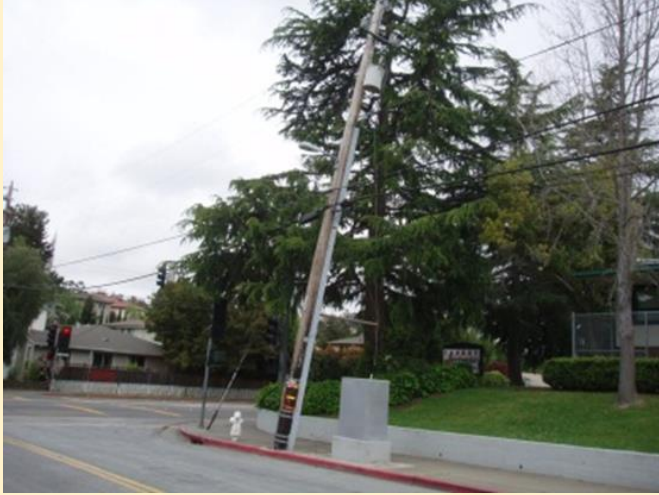
At this Location: Stubbed pole leaning towards school, supported by down guy. Pole Bands are loose due to additional deterioration of the pole.	At this Location Pole is leaning less than 10% out of plumb, leaning in direction of offset equipment.
Perform Minor Work: No	Perform Minor Work: No
Write 3rd Party Notification: No	Write 3rd Party Notification: No
Write EC Notification: Yes FDA= Pole / Decayed / Rotten / Replace Priority= B Tag, 0-3 months, depending on exposure	Write EC Notification: No

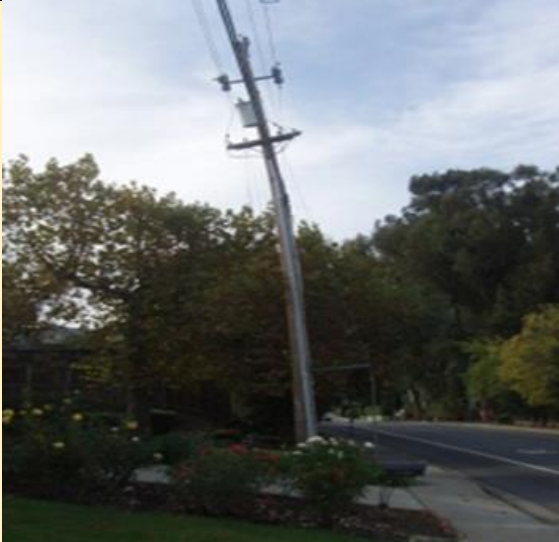
At this Location: Pole bent 4 feet out of line, less than 10% lean, deformed in the middle of the pole, towards vegetation
	Perform Minor Work: No
	Write 3rd Party Notification: No
	Write EC Notification: Yes FDA= Pole / Overload / Test Priority= B Tag, 0-3 months depending on exposure

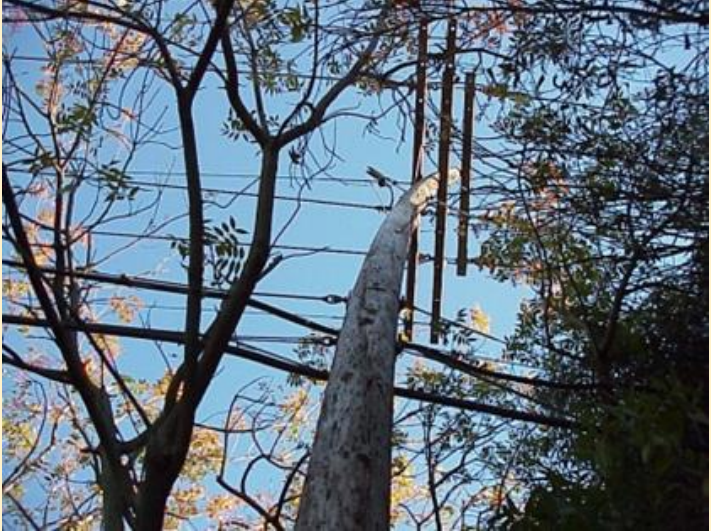
At this Location: Pole is twisted, cracked, due to communication. Field comments "overloaded by communications"	At this Location: Deformed pole with bowed top in line with conductor.
Perform Minor Work: No	Perform Minor Work: No
Write 3rd Party Notification: No	Write 3rd Party Notification: No
Write EC Notification: Yes FDA= Pole / Overloaded / Replace Pole Test Data Sheet is Required	Write EC Notification: Yes FDA= Pole / Overloaded / Replace Pole Test Data Sheet is Required
Priority= E Tag, 3-12 months, depending on exposure	Priority= E Tag, 3-12 months, depending on exposure

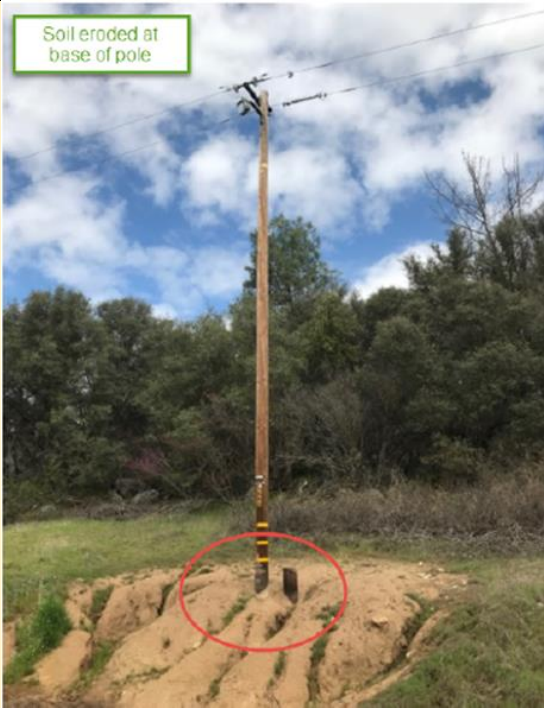
At this Location: a large amount of soil was washed or eroded away at the base of a pole, Not leaning.
	Perform Minor Work: No
	Write 3rd Party Notification: No
	Write EC Notification: Yes
	FDA= Pole / Soil Eroded / Graded / Replace
	Priority= E Tag, 12 months depending on exposure

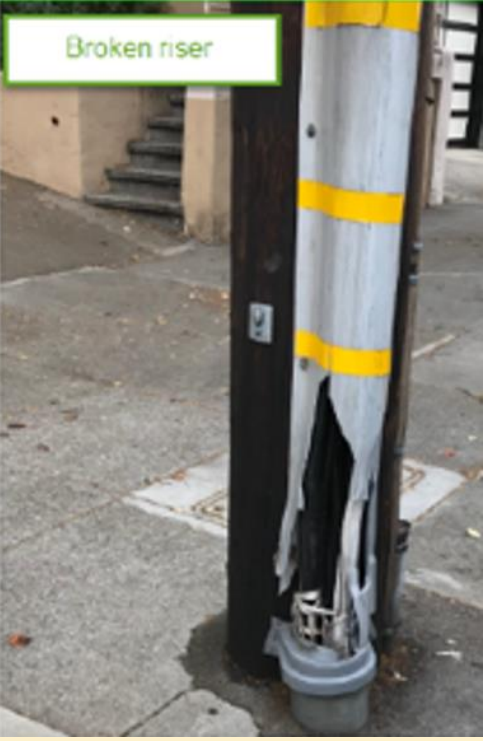
<p>A photograph of a white riser with a large tear in the outer jacket, revealing the internal components. A green label with the text 'Broken riser' is placed above the damage.</p>
At this Location: Cracked riser boot	At this Location: Broken riser
Perform Minor Work: Yes, if possible	Perform Minor Work: Yes, if possible
Write 3rd Party Notification: No	Write 3rd Party Notification: No
Write EC Notification: Yes, only if minor work cannot be performed FDA= Molding / Broken / Damaged Priority= F Tag, depending on exposure	Write EC Notification: Yes, only if minor work cannot be performed FDA= Molding / Broken / Damaged / Replace Priority= A Tag, follow emergency process

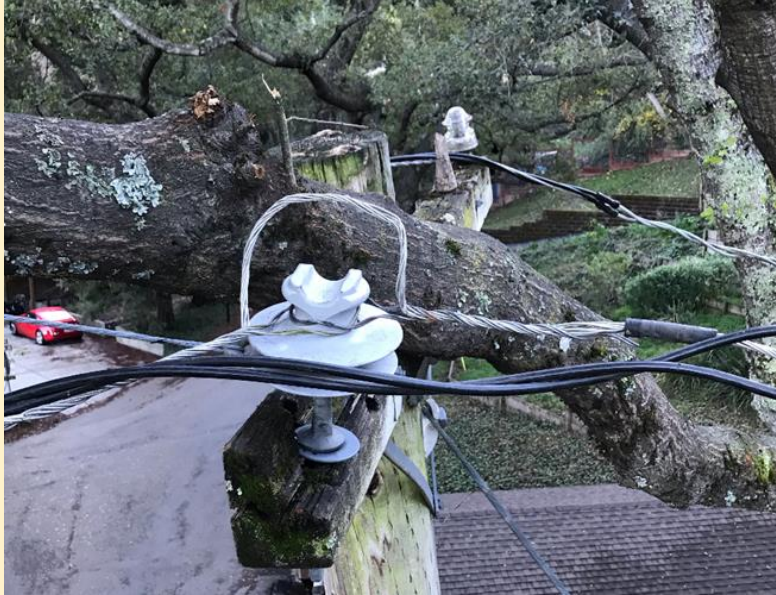
At this Location: Large branch broken on cross-arm. Cross-arm in poor condition, immediate response required.
	Perform Minor Work: No
	Write 3rd Party Notification: No
	Write Vegetation Notification: No
	Write EC Notification: Yes FDA= Cross-arm / broken / damaged / Replace FDA= Tree / clearance / Remove Priority= A Tag, follow the emergency process

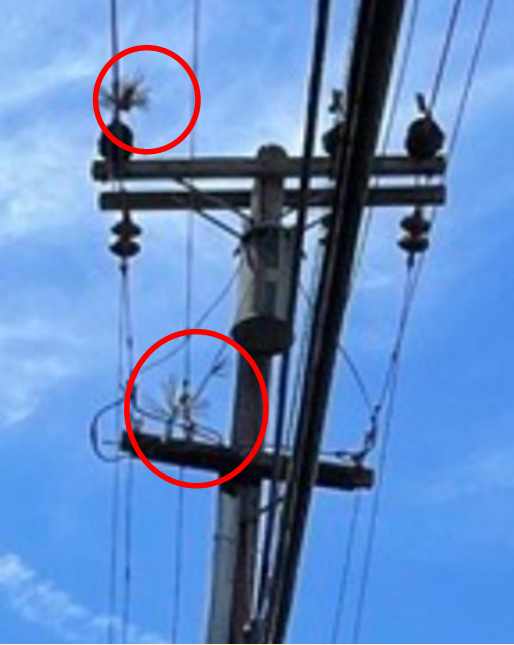
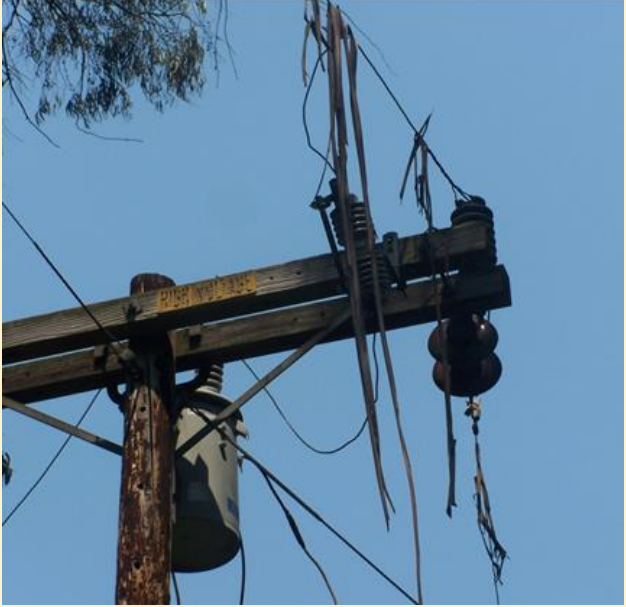
At this Location: Small branches on primary and secondary. Too small to cause a cross-phase or damage.	At this Location: Long tree bark strands, hanging from bare primary conductor, phase separation on single phase cross-arm far enough not to cause cross-phase
Perform Minor Work: Yes, if possible	Perform Minor Work: Yes, if possible
Write 3rd Party Notification: No	Write 3rd Party Notification: No
Write EC Notification: No	Write EC Notification: Yes, only when minor work not performed. FDA= Tree / Clearance / Remove Priority= B Tag, 3 months, depending on exposure

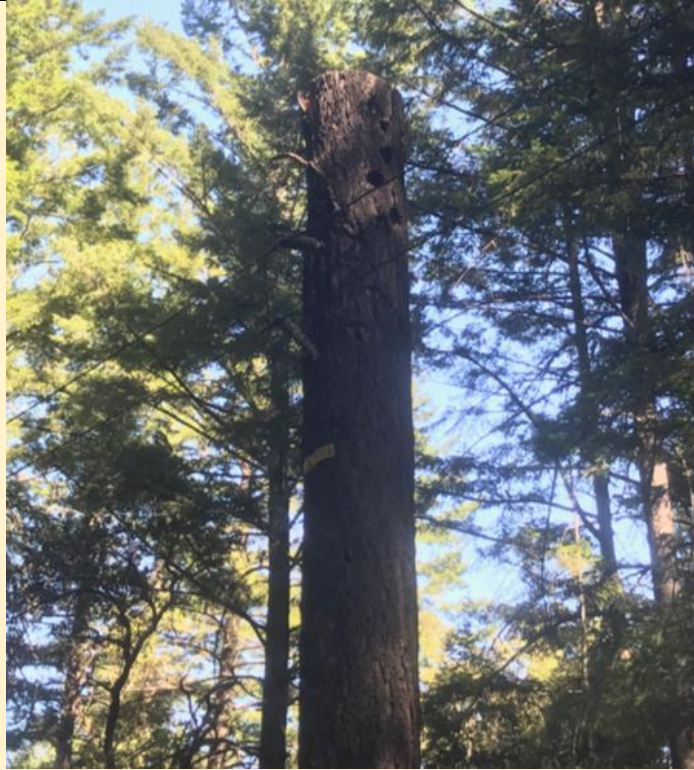
At this Location: Tier 2 area, tree connect on dead/dying tree with multiple woodpecker holes and damaged primary insulators

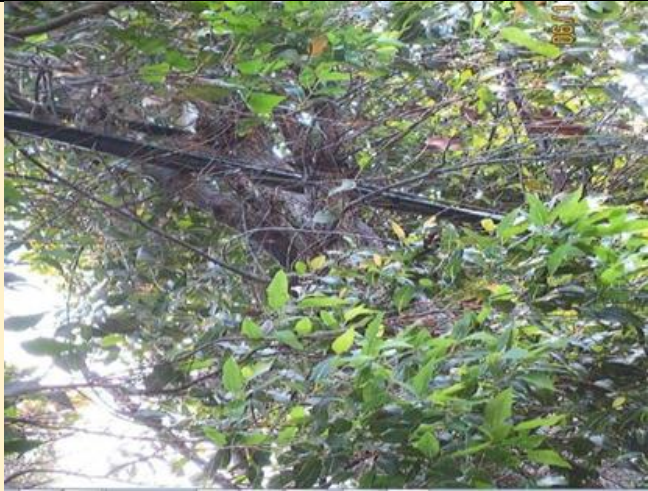
At this Location: Tree putting strain on the pole, due to communication line
	Perform Minor Work: No
	Write 3rd Party Notification: Yes
	Write EC Notification: No
