RE: Energy Safety NON ID: CAD\_PGE\_IAG\_20250731\_0946  
Notice of Violation: Government Code § 15475.1 and the California Code of Regulations, Title 14, Division 17 § 29302(b)(2)

## Violation

The NON was identified from a July 31, 2025 inspection by Energy Safety in the vicinity of the city of San Luis Obispo, CA, in High Fire Threat District (HFTD) Tier 2 of PG&E's Q4 QDR report for WMP Initiative 8.1.2.10.5 – Non-Exempt Expulsion Fuses, Utility Initiative GH-10:

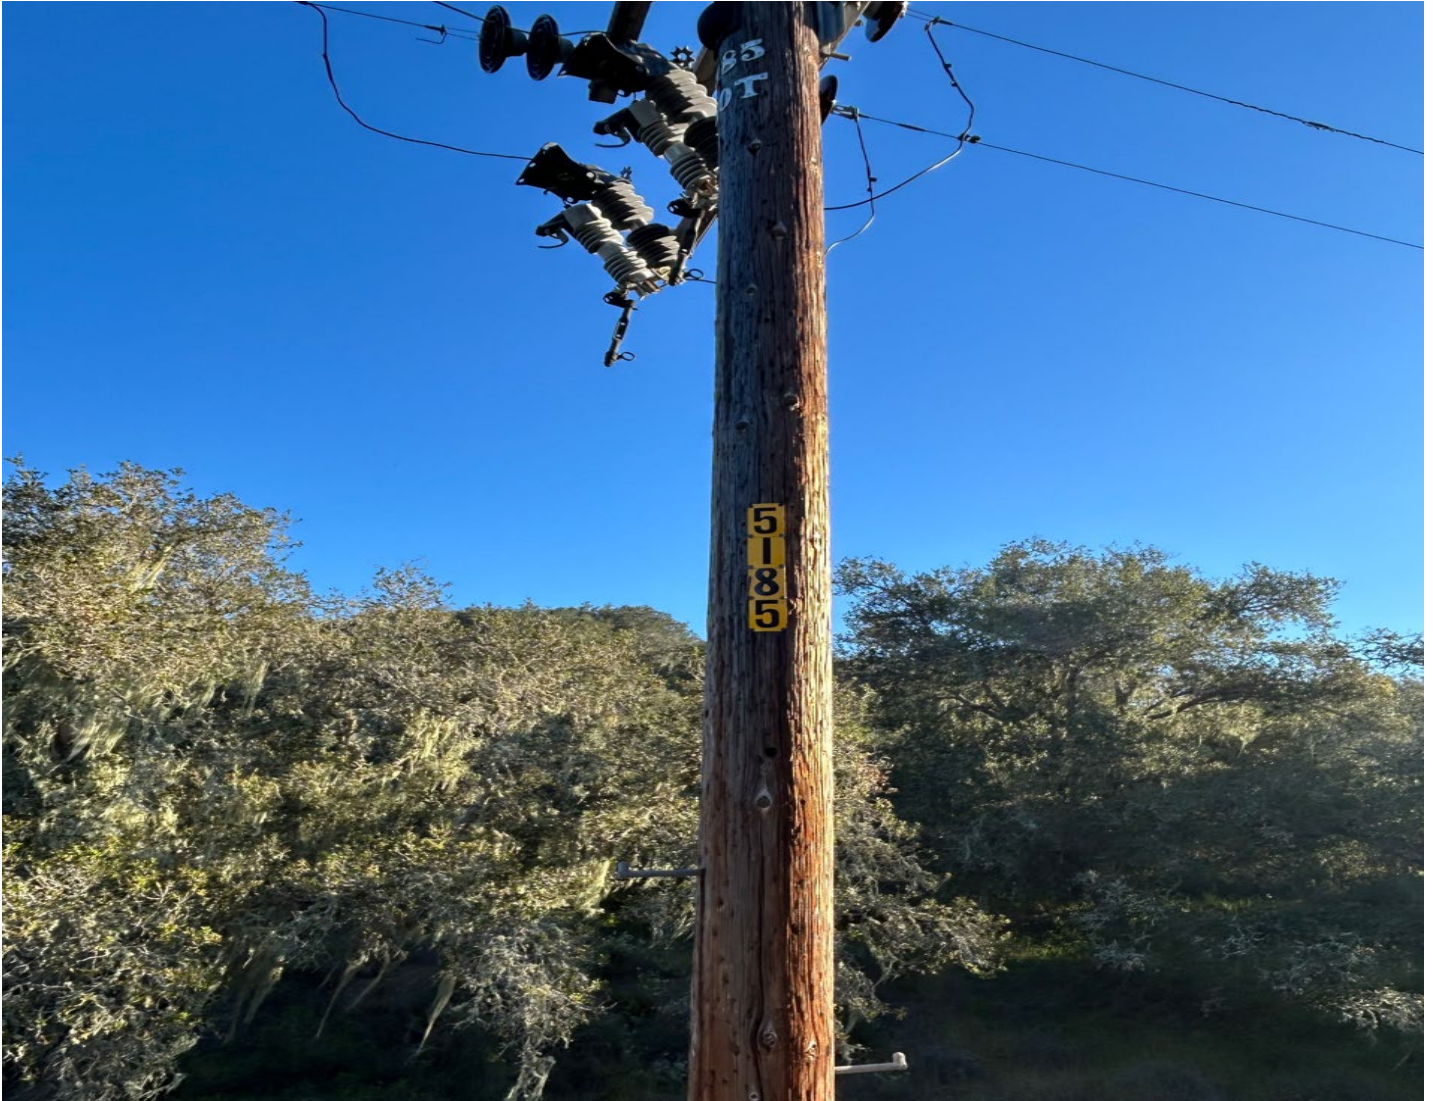
Please see the photo evidence below for removal of CalFire Exempt fuses from the pole step for testing. Due to the concerns expressed by Energy Safety, at this time, PG&E will not be placing fuses for storage on the pole step of the subject pole (pole ID 120193426).

The storage practice of hanging fuses on pole steps is not a component of the GH-10 commitment. During a consultation with Energy Safety on March 4, 2026, PG&E voluntarily decided to remove the fuses from the pole steps to initiate a testing protocol to confirm that the fuses are not compromised by water ingress and therefore that storing them on pole steps is appropriate when desired. All fuses passed the electrical test (low voltage ~1V and 350A applied) with no signs of water ingress
