June 18, 2026

Patrick Doherty  
Program Manager | Compliance Assurance Division  
Office of Energy Infrastructure Safety  
715 P Street, 20<sup>th</sup> Floor  
Sacramento, CA 95814

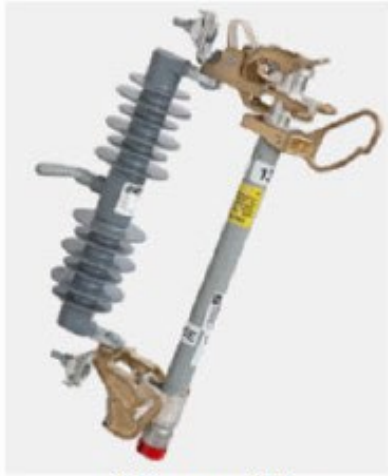
**Figure 16  
Part 63H**
