NOTICE OF NON-PERFORMANCE

INSPECTION REPORT

Electrical Corporation:	PG&E
Report Number:	NON_ESD_PGE_KJO_20260407_1125
Inspector:	Kelsea Jones
WMP Year Inspected:	2025
Quarterly Data Report (QDR) Referenced:	Quarter 4 (Q4) 2025
Inspection Selection:	Energy Safety inspected the locations based on PG&E’s Q4 QDR.
Relevant WMP Initiative(s):	8.2.3.4 Fall-In Mitigation
Date of inspection:	April 7, 2026
City and/or County of Inspection:	Pike, California

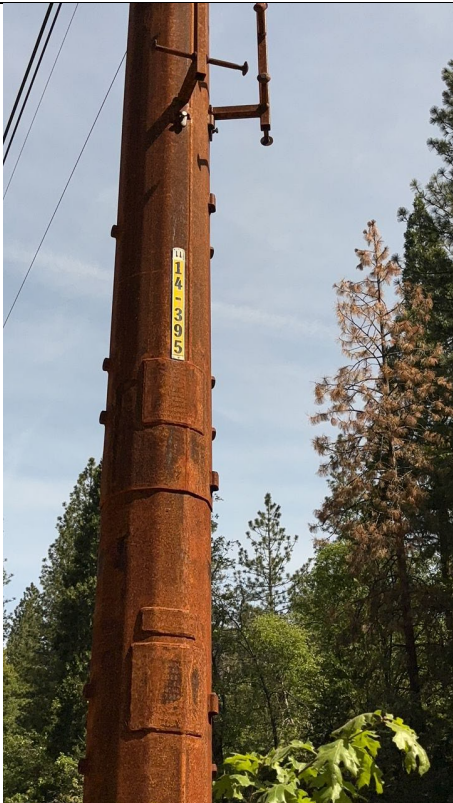
On April 7, 2026, Energy Safety conducted an inspection of PG&E's WMP's initiatives in the vicinity of Pike, California. During the inspection, Energy Safety identified a dying ponderosa pine tree near pole ID 14-395 and near coordinates 39.44066589295085, -120.99568533516796 along Pike City Road. The ponderosa pine tree is located within the SRA. The ponderosa pine tree has a diameter at breast height of approximately 11 inches and is approximately 52 feet tall. It is located at 0.5 span and is approximately 40 feet north of the conductors. The inspector's observations are documented in Exhibit A photographs, which are attached to this report. Photo 1 depicts pole ID 14-395. Photos 2 and 3 depict the dying ponderosa pine tree. Photo 4 depicts paint markings on the subject tree.

<p>Photo 1: Photo of pole ID 14-395, located approximately 40 feet south of the subject tree.</p>	<p>Photo 2: Photo of the dying ponderosa pine in relation to pole ID 14-395.</p>

Deficiency 1. Energy Safety observed that PG&E failed to implement its 2025 WMP initiative 8.2.3.4, which requires compliance with Public Resources Code section 4293, by not removing a dead, declining or dying tree near coordinates 39.44066589295085, -120.99568533516796. Energy Safety considers this non-performance to be in the Moderate risk category. PG&E must complete a corrective action for this non-performance by six months from the date of this notice.¹

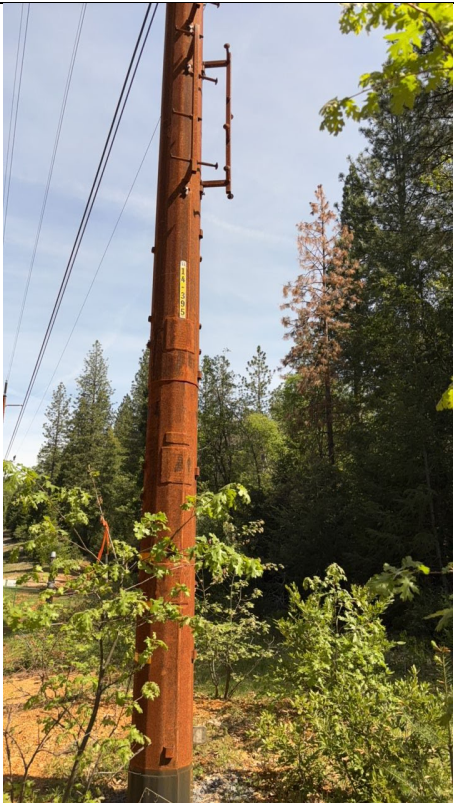
Energy Safety considers this deficiency as "Moderate" because PG&E has not removed the dying ponderosa pine tree located within striking distance of conductors, consistent with the requirements of Public Resources Code section 4293. The continued presence of this tree presents an ongoing wildfire risk.

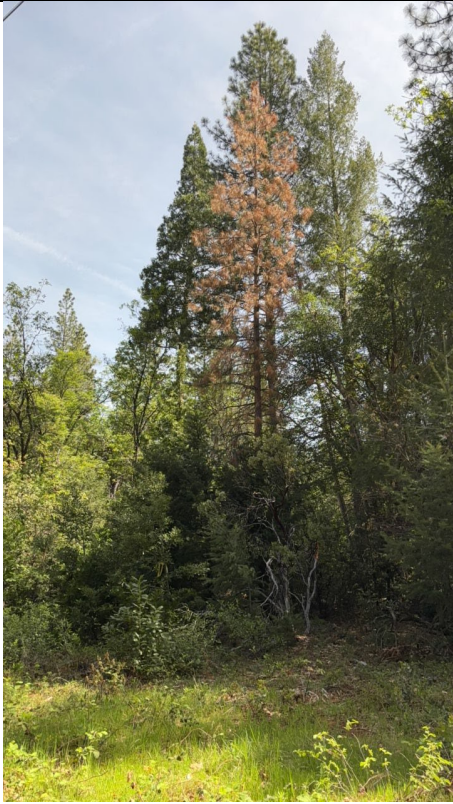
Photo 3: Photo of the dying ponderosa pine at the center of the image.

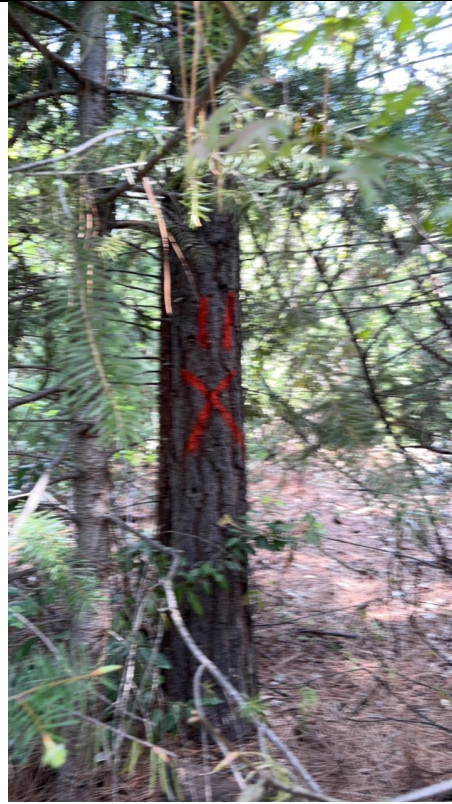
Photo 4: Photo of the trunk of the subject tree, with "11 X" painted in red.
