NOTICE OF NON-PERFORMANCE

INSPECTION REPORT

Electrical Corporation:	PG&E
Report Number:	NON_ESD_PGE_RGA_20260408_0849
Inspector:	Ricardo Garcia
WMP Year Inspected:	2025
Quarterly Data Report (QDR) Referenced:	Quarter 4 (Q4) 2025
Inspection Selection:	Energy Safety inspected the locations based on PG&E’s Q4 QDR.
Relevant WMP Initiative(s):	8.2.3.4 Fall-In Mitigation
Date of inspection:	April 8, 2026
City and/or County of Inspection:	Challenge, California

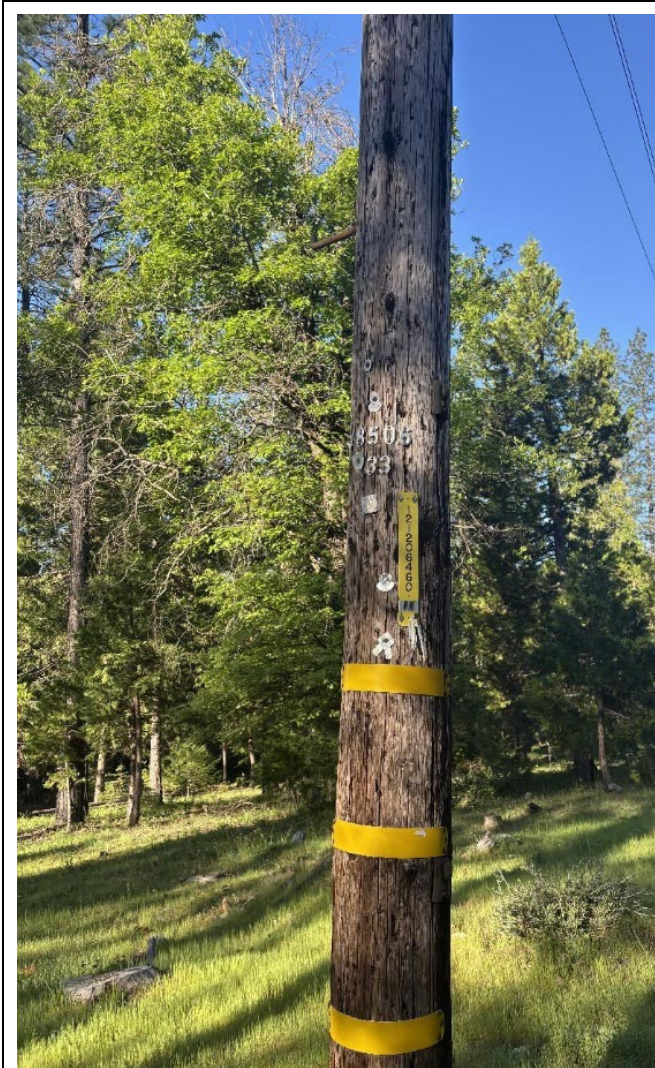
Photo1: Photo of pole ID 121206460 located approximately 175 feet north of the subject tree.

On April 8, 2026, Energy Safety conducted an inspection of PG&E's WMP's initiatives in the vicinity of Challenge, California. During the inspection, Energy Safety identified a dying pine tree near pole ID 121206460 and near coordinates 39.50091, -121.2778 along New York Flat Road. The pine tree is located within the SRA. The pine tree has a diameter at breast height of 17 inches and is approximately 80 feet tall. It is located approximately 175 feet south of pole ID 121206460 and 30 feet east of the conductors. The inspector's observations are documented in Exhibit A photographs which are attached to this report. Photo 1 depicts pole ID 121206460 and photo 2 depicts the dying pine tree (right).

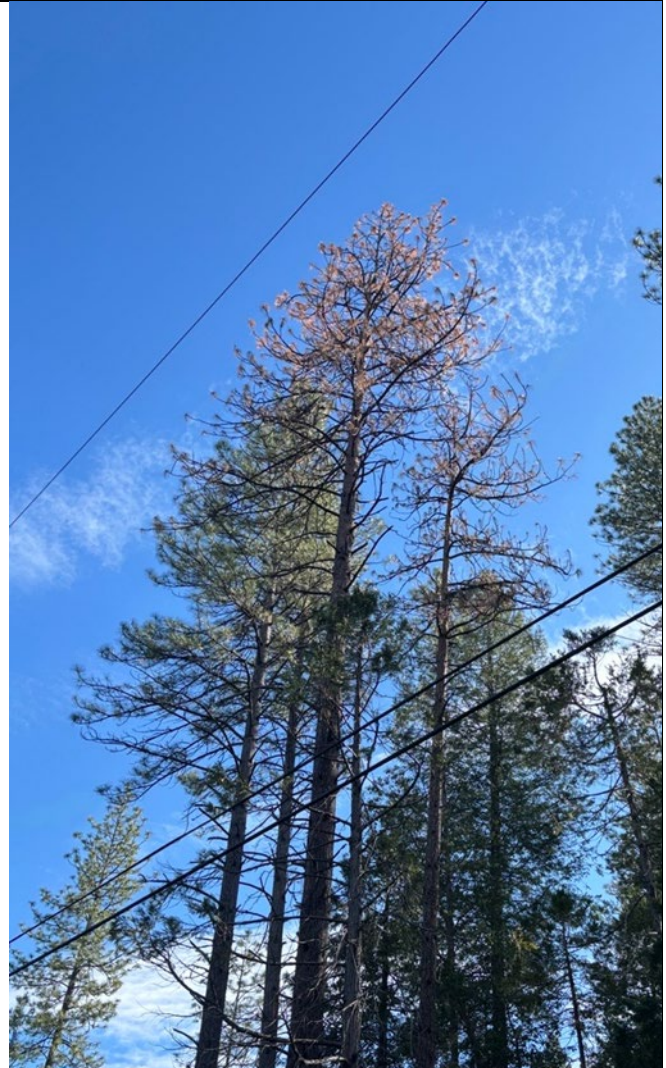
Photo 2: Photo of the dying pine tree (right). Refer NON_ESD_PGE_RGA_20260408_0836 regarding another dying pine tree shown on the left.

Energy Safety considers this deficiency as "Moderate" because PG&E has not removed the dying pine tree located within striking distance of conductors, consistent with the requirements of PRC section 4293. The continued presence of this tree presents an ongoing wildfire risk.

Deficiency 1. Energy Safety observed that PG&E failed to implement its 2025 WMP initiative 8.2.3.4, which requires compliance with Public Resources Code (PRC) section 4293 by not removing a dead, declining or dying tree near coordinates 39.50091, -121.2778. Energy Safety considers this non-performance to be in the Moderate risk category. PG&E must complete a corrective action for this non-performance by two months from the date of this notice.¹
