## NOTICE OF NON-PERFORMANCE

# INSPECTION REPORT

Electrical Corporation:	BVES
Report Number:	NON_ESD_BVES_RGA_20260505_1253
Inspector:	Ricardo Garcia
WMP Year Inspected:	2025
Quarterly Data Report (QDR) Referenced:	Quarter 4 (Q4) 2025
Inspection Selection:	Energy Safety inspected the locations based on BVES’s Q4 QDR.
Relevant WMP Initiative(s):	8.2.3.4 Fall-in Mitigation
Date of inspection:	May 5, 2026
City and/or County of Inspection:	Big Bear City, California

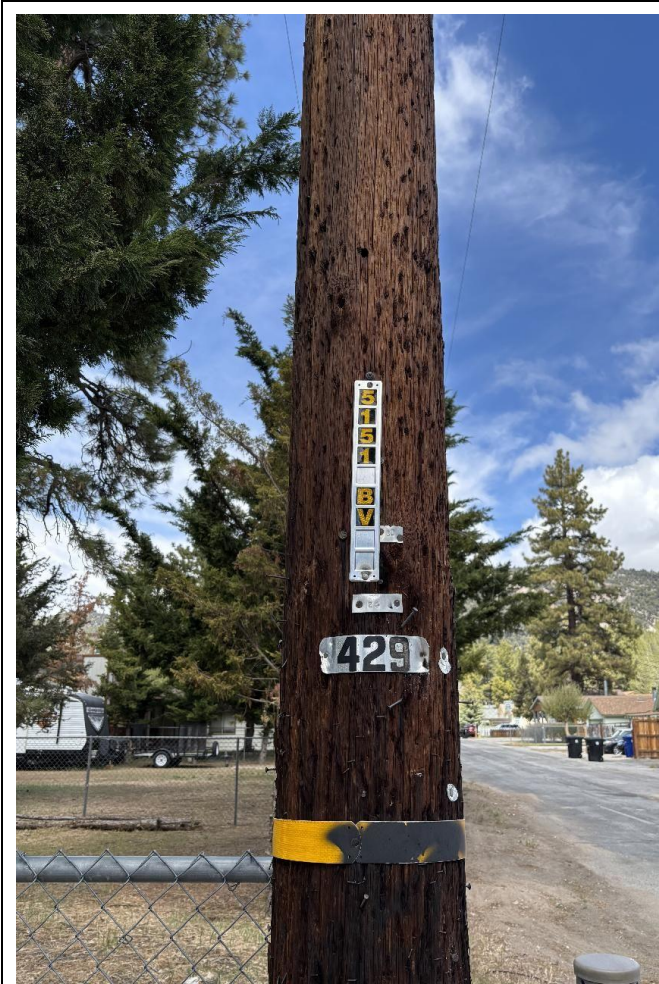
**Photo 1:** Photo of pole ID 5151BV, located 132 feet north of the subject tree.

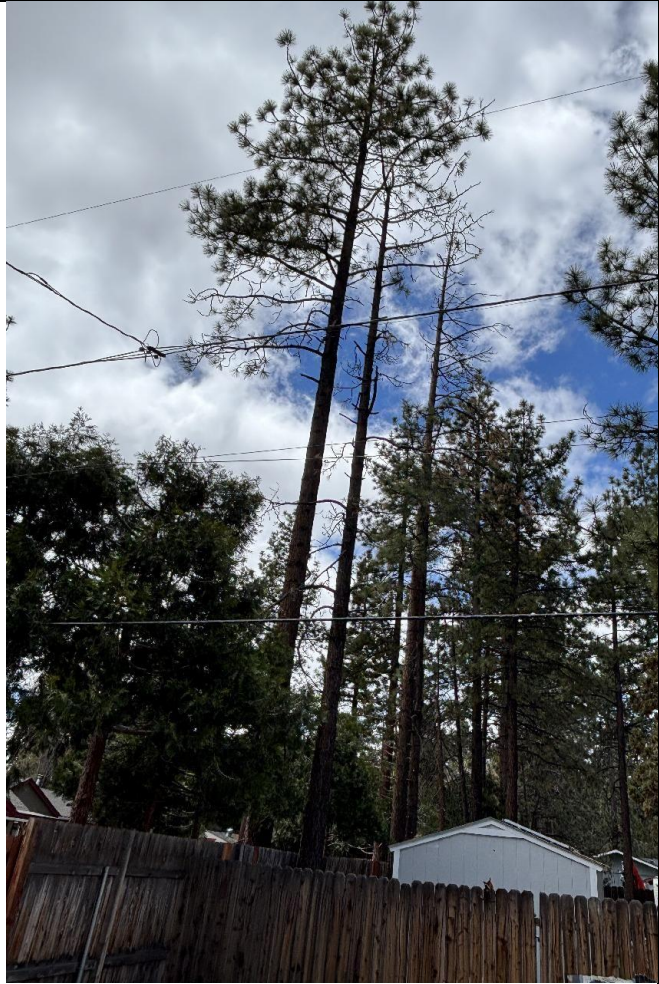
Energy Safety considers this deficiency as "Moderate" because BVES has not removed the dying pine tree located within striking distance of conductors. The continued presence of this tree presents an ongoing wildfire risk.

On May 5, 2026, Energy Safety conducted an inspection of BVES's WMP's initiatives in the vicinity of Big Bear City, California. During the inspection, Energy Safety identified a dead pine tree near pole ID 5151BV and near coordinates 34.26713531028709, -116.84599287356302 along Sierra Avenue. The pine tree is located within the SRA. The pine tree has an estimated diameter at breast height of 18 inches and is approximately 80 feet tall. It is located approximately 30 feet west of the conductors. The inspector's observations are documented in Exhibit A photographs, which are attached to this report. Photo 1 depicts pole ID 5151BV. Photos 2 and 3 depict the dead pine tree.

**Photo 2:** Photo of dead pine tree (right). Refer to NON\_ESD\_BVES\_RGA\_20260505\_1247 regarding another dead pine tree shown on the left.

Deficiency 1. Energy Safety observed that BVES failed to implement its 2025 WMP initiative 8.2.3.4 Fall-in Mitigation, by not removing a dead, rotten or diseased tree near coordinates 34.26713531028709, -116.84599287356302. Energy Safety considers this non-performance to be in the Moderate risk category. BVES must complete a corrective action for this non-performance by six months from the date of this notice.<sup>1</sup>

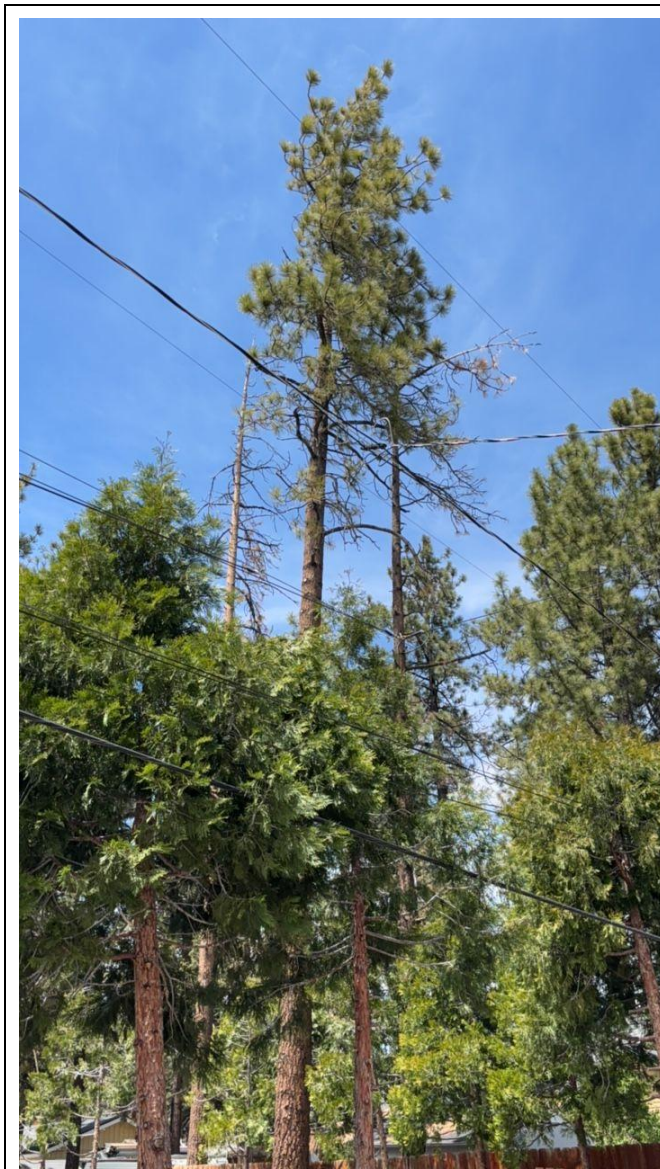
**Photo 3:** Photo of dead pine tree (left) from a different angle. Refer to [NON\\_ESD\\_BVES\\_RGA\\_20260505\\_1247](#) regarding another dead pine tree shown on the right.
