NOTICE OF NON-PERFORMANCE

INSPECTION REPORT

Electrical Corporation:	BVES
Report Number:	NON_ESD_BVES_RGA_20260505_1247
Inspector:	Ricardo Garcia
WMP Year Inspected:	2025
Quarterly Data Report (QDR) Referenced:	Quarter 4 (Q4) 2025
Inspection Selection:	Energy Safety inspected the locations based on BVES’s Q4 QDR.
Relevant WMP Initiative(s):	8.2.3.4 Fall-in Mitigation
Date of inspection:	May 5, 2026
City and/or County of Inspection:	Big Bear City, California

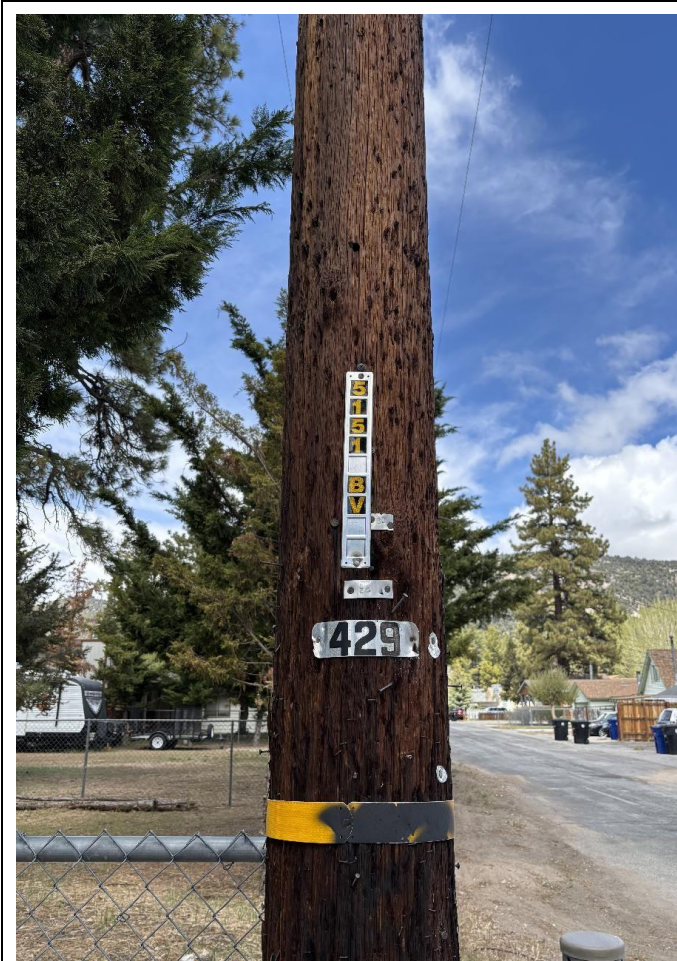
Photo 1: Photo of pole ID 5151BV, located 132 feet north of the subject tree.

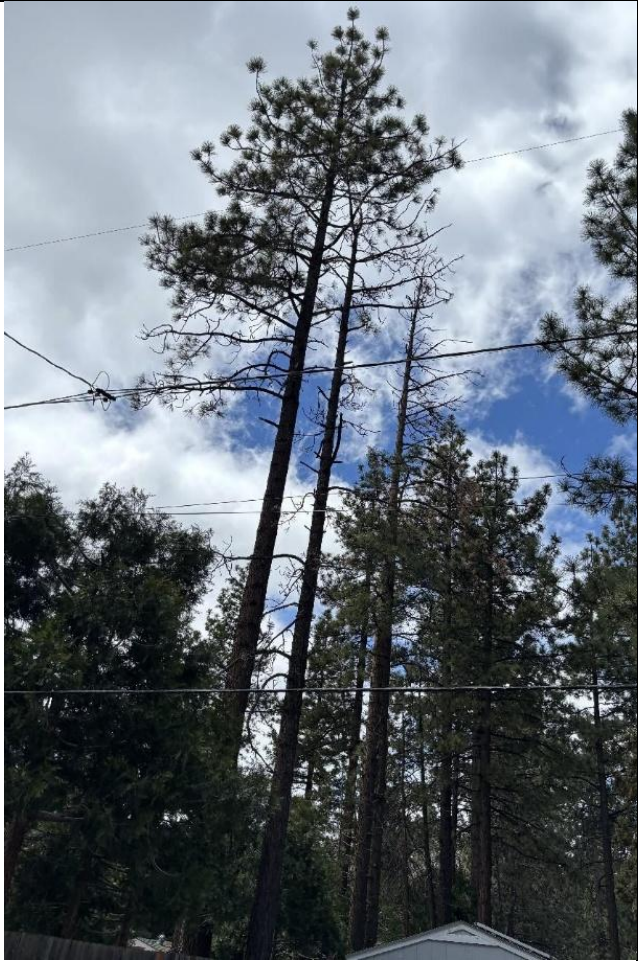
Energy Safety considers this deficiency as "Moderate" because BVES has not removed the dying pine tree located within striking distance of conductors. The continued presence of this tree presents an ongoing wildfire risk.

On May 5, 2026, Energy Safety conducted an inspection of BVES's WMP's initiatives in the vicinity of Big Bear City, California. During the inspection, Energy Safety identified a dead pine tree near pole ID 5151BV and near coordinates 34.26713531028709, -116.84599287356302 along Sierra Avenue. The pine tree is located within the SRA. The pine tree has an estimated diameter at breast height of 15 inches and is approximately 60 feet tall. It is located approximately 10 feet west of the conductors. The inspector's observations are documented in Exhibit A photographs, which are attached to this report. Photo 1 depicts pole ID 5151BV. Photos 2 and 3 depict the dead pine tree.

Photo 2: Photo of dead pine tree (left). Refer to NON_ESD_BVES_RGA_20260505_1253 regarding another dead pine tree shown on the right.

Deficiency 1. Energy Safety observed that BVES failed to implement its 2025 WMP initiative 8.2.3.4 Fall-in Mitigation, by not removing a dead, rotten or diseased tree near coordinates 34.26713531028709, -116.84599287356302. Energy Safety considers this non-performance to be in the Moderate risk category. BVES must complete a corrective action for this non-performance by six months from the date of this notice.¹

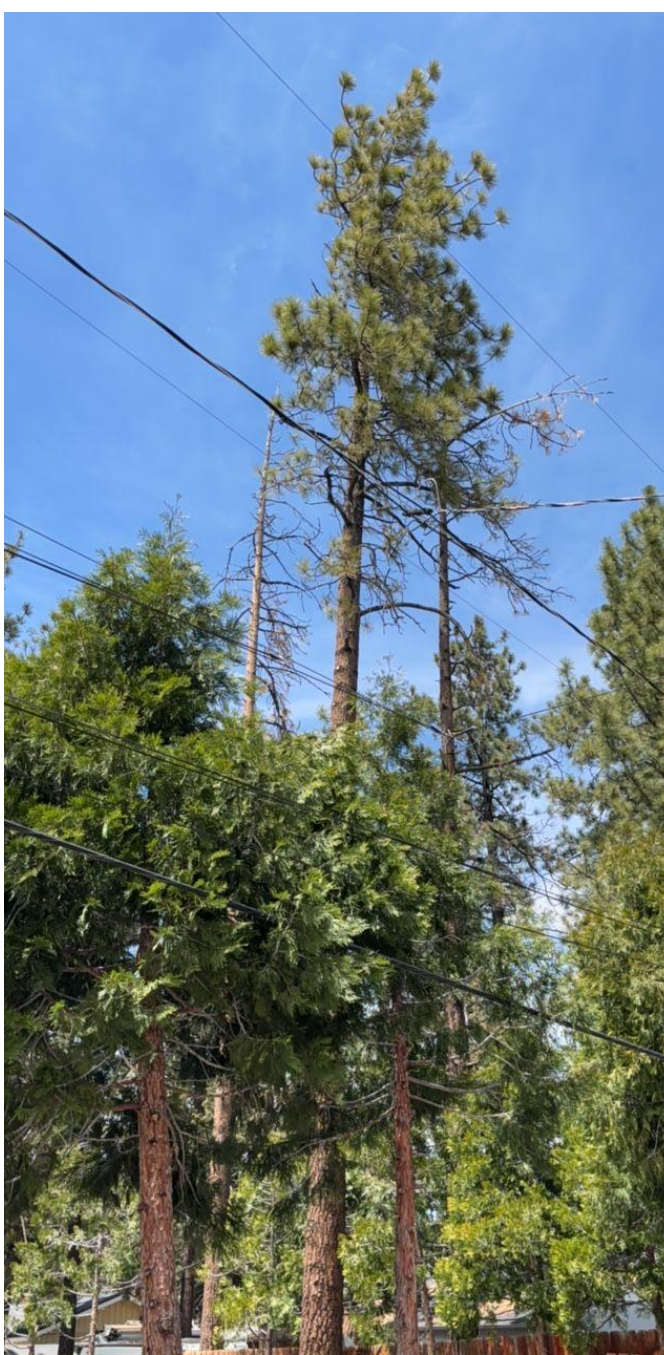
Photo 3: Photo of dead pine tree (right) from a different angle. Refer to [NON_ESD_BVES_RGA_20260505_1253](#) regarding another dead pine tree shown on the left.
