## NOTICE OF NON-PERFORMANCE

# INSPECTION REPORT

Electrical Corporation:	Liberty
Report Number:	NON_ESD_LU_AKM_20260429_1029
Inspector:	Akiko Masuda
WMP Year Inspected:	2025
Quarterly Data Report (QDR) Referenced:	Quarter 4 (Q4) 2025
Inspection Selection:	Energy Safety inspected the locations based on Liberty’s Q4 QDR.
Relevant WMP Initiative(s):	8.2.3.4 Fall-In Mitigation
Date of inspection:	April 29, 2026
City and/or County of Inspection:	Tahoma, California

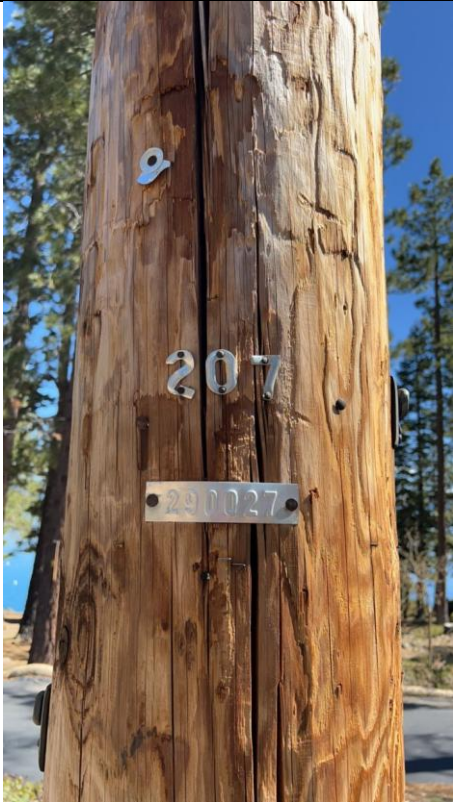
<p><b>Photo 1:</b> Photo of pole ID 290027 located approximately 26 feet northwest of the subject tree.</p>	<p><b>Photo 2:</b> Photo of the declining white fir tree (second tree from the right) in relation to the conductors.</p>

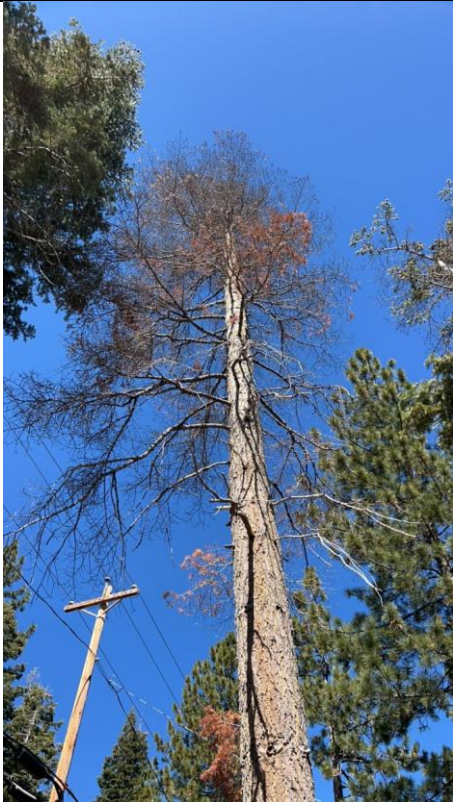
On April 29, 2026, Energy Safety conducted an inspection of Liberty's WMP's initiatives in the vicinity of Tahoma, California. During the inspection, Energy Safety identified a declining white fir tree near pole ID 290027 and near coordinates 39.033058, -120.116333 along Meeks Bay Avenue. The white fir tree is located within the SRA. The white fir tree has a diameter at breast height of 16 inches and is approximately 54 feet tall. It is located approximately 26 feet southeast of pole ID 290027. It exhibits yellowing needles throughout the canopy and visible crown dieback. The inspector also observed sap exudation and

discolored bark on the trunk, which are signs of a physiological stress. The inspector's observations are documented in Exhibit A photographs which are attached to this report. Photo 1 depicts pole ID 290027. Photos 2 and 3 depict the declining white fir tree. Photo 4 depicts sap exudation and discolored bark on the trunk.

**Photo 3:** Photo of the declining white fir tree with yellowing needles throughout the canopy and visible crown dieback.

Deficiency 1. Energy Safety observed that Liberty failed to implement its 2025 WMP initiative 8.2.3.4, which requires compliance with Public Resources Code section 4293, by not removing a dead, declining or dying tree near coordinates 39.033058, -120.116333. Energy Safety considers this non-performance to be in the Moderate risk category. Liberty must complete a corrective action for this non-performance by six months from the date of this notice.<sup>1</sup>

Energy Safety considers this deficiency as "Moderate" because Liberty has not removed the declining white fir tree located within striking distance of conductors, consistent with the requirements of Public Resources Code section 4293. The existence of this tree presents an ongoing wildfire risk.

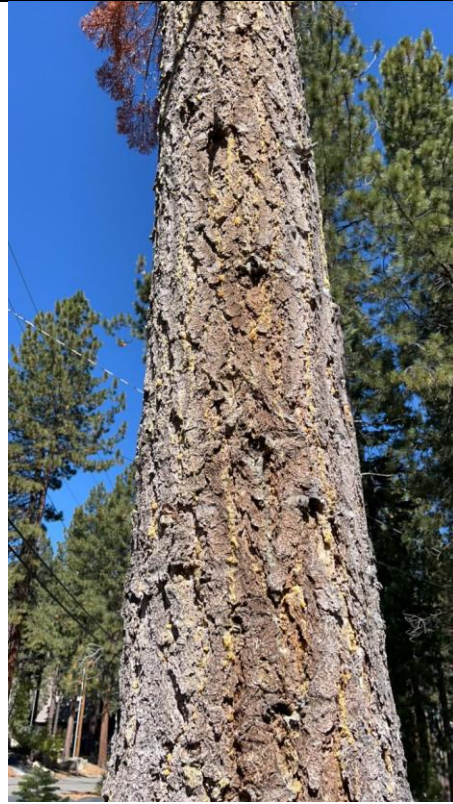
**Photo 4:** Photo showing sap exudation and discolored bark on the trunk.
