**Subject:** Liberty's Response to Notice of Non-Performance –  
NON\_ESD\_LU\_KJO\_20260428\_1248

Liberty Utilities (CalPeco Electric) LLC ("Liberty") appreciates the opportunity to clarify the information contained in the Office of Energy Infrastructure Safety ("Energy Safety") e finding(s) in "NON\_ESD\_LU\_KJO\_20260428\_1248" (Notice of Non-Performance or NON), on May 19, 2026, regarding Energy Safety's inspection of work completed by Liberty in accordance with its 2025 Wildfire Mitigation Plan ("WMP").

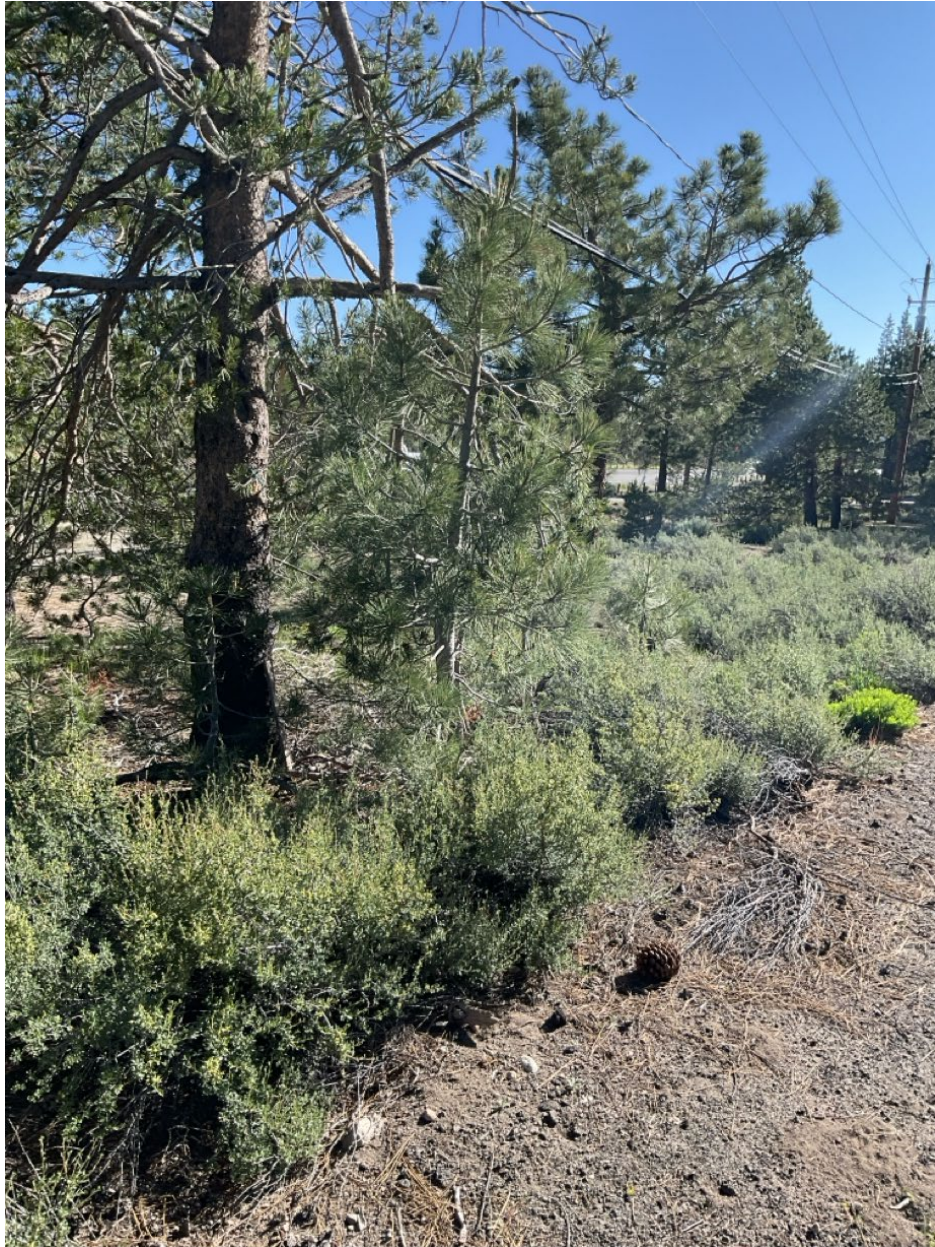
Picture 1: Tree ID W120024501N38849738\_2  
(brush removals at time of detailed inspection on June 17, 2025; removed November 7, 2025)

Liberty conducted a detailed inspection of vegetation along the subject span (span from pole 275576 to 259697) on June 17, 2025. During this inspection, Liberty identified two previously topped lodgepole pines, a small Jeffrey pine, and conifer brush encroaching beneath the distribution lines. Work orders were generated, and the identified vegetation was successfully mitigated on November 7, 2025.

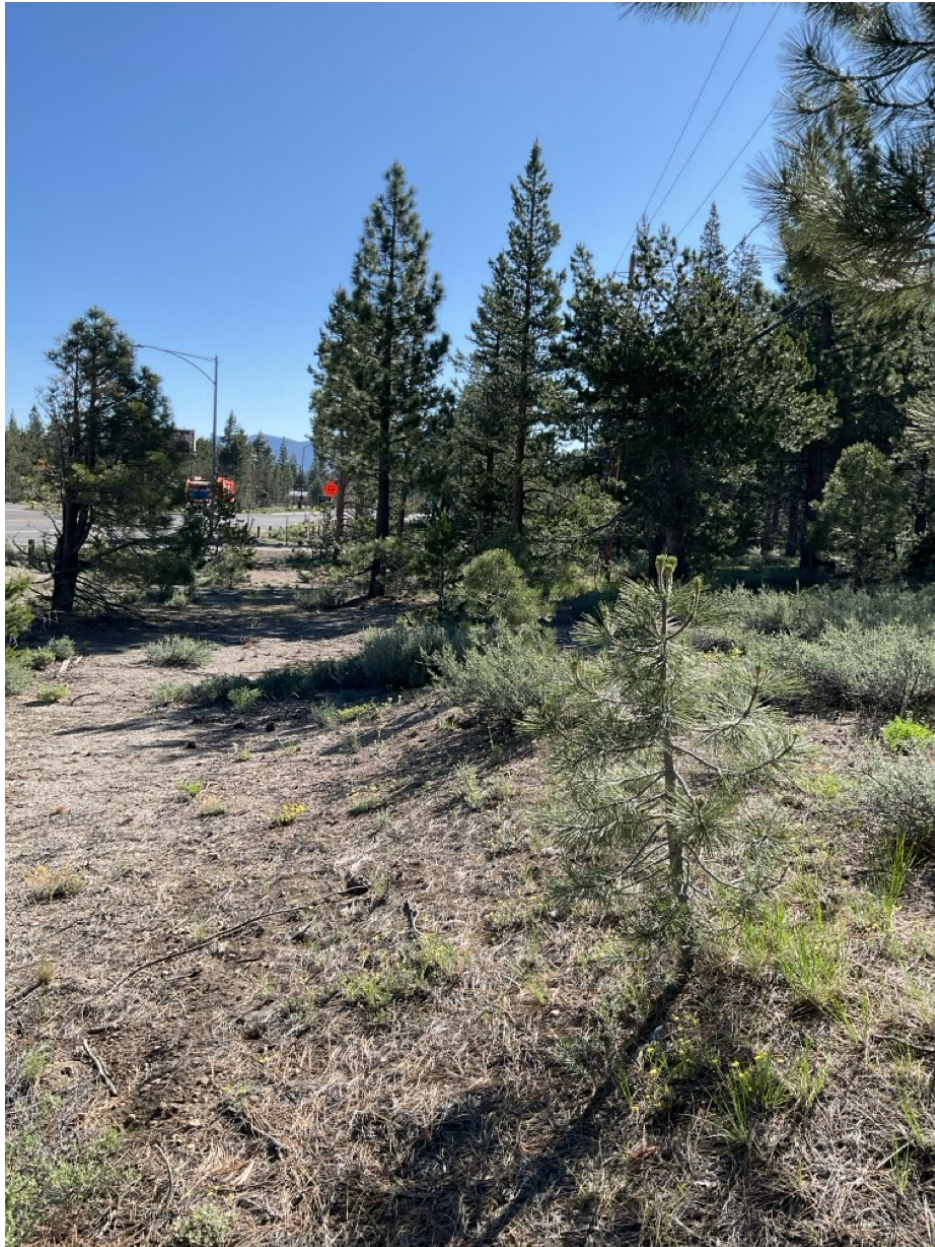
Picture 2: Tree ID W120024501N38849738\_2  
(brush removals at time of detailed inspection on June 17, 2025; removed November 7, 2025)

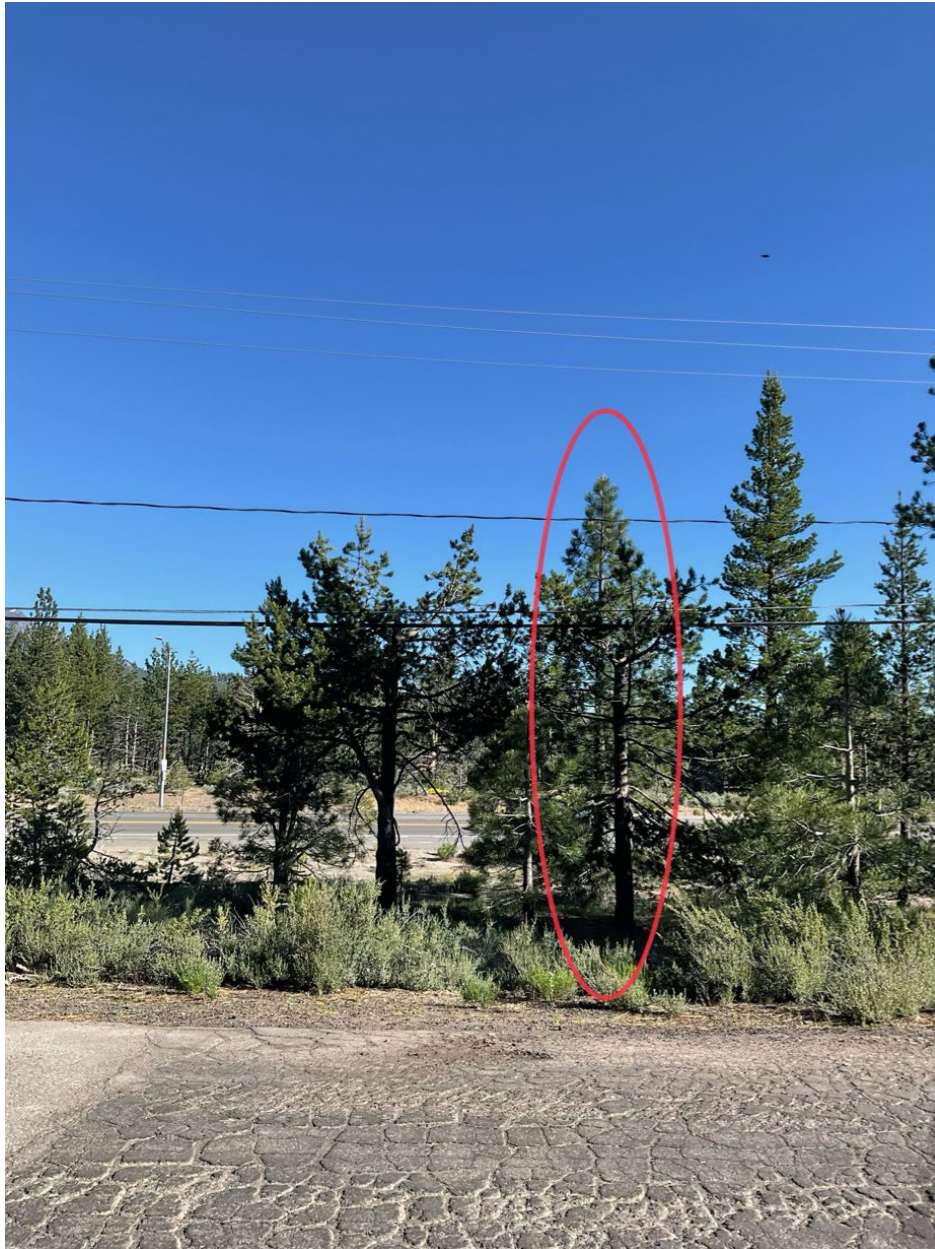
Picture 3: Tree ID W120024501N38849738\_2  
(at time of detailed inspection June 17, 2025; removed November 7, 2025)

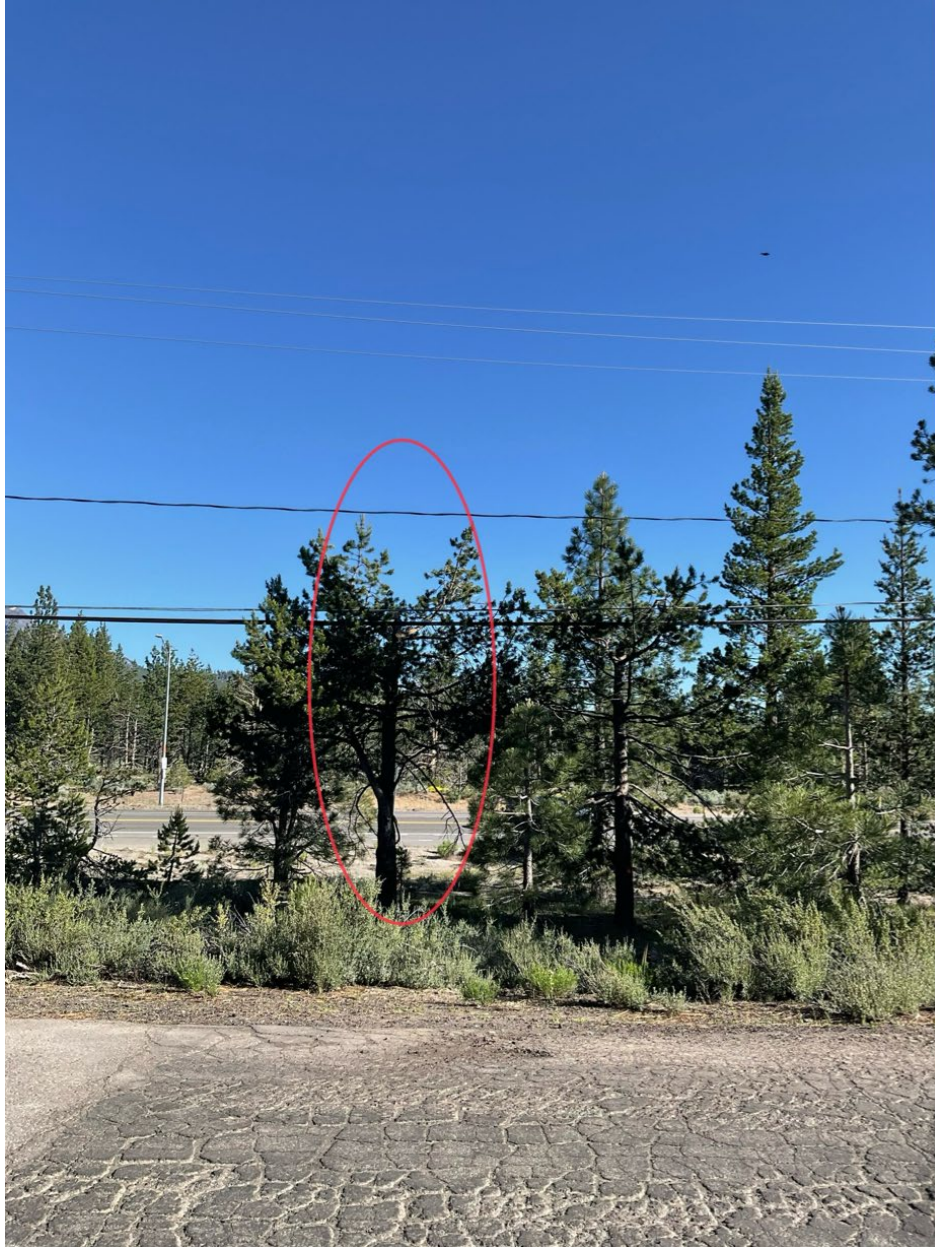
Picture 4: Tree ID W120024557N38849688  
(at time of detailed inspection June 17, 2025; removed November 7, 2025)

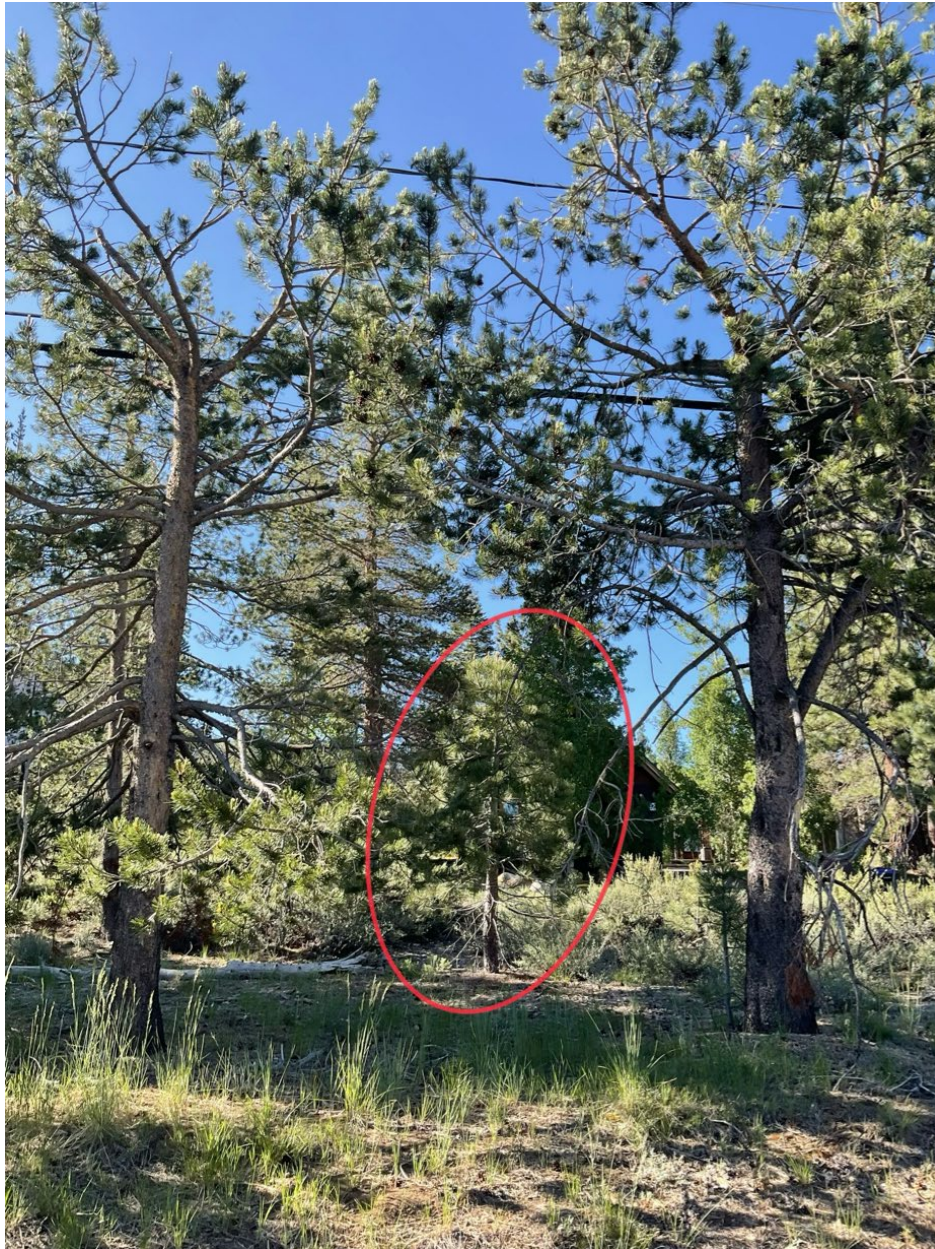
Picture 5: Tree ID W120024557N38849688\_2  
(at time of inspection June 17, 2025; removed November 7, 2025)

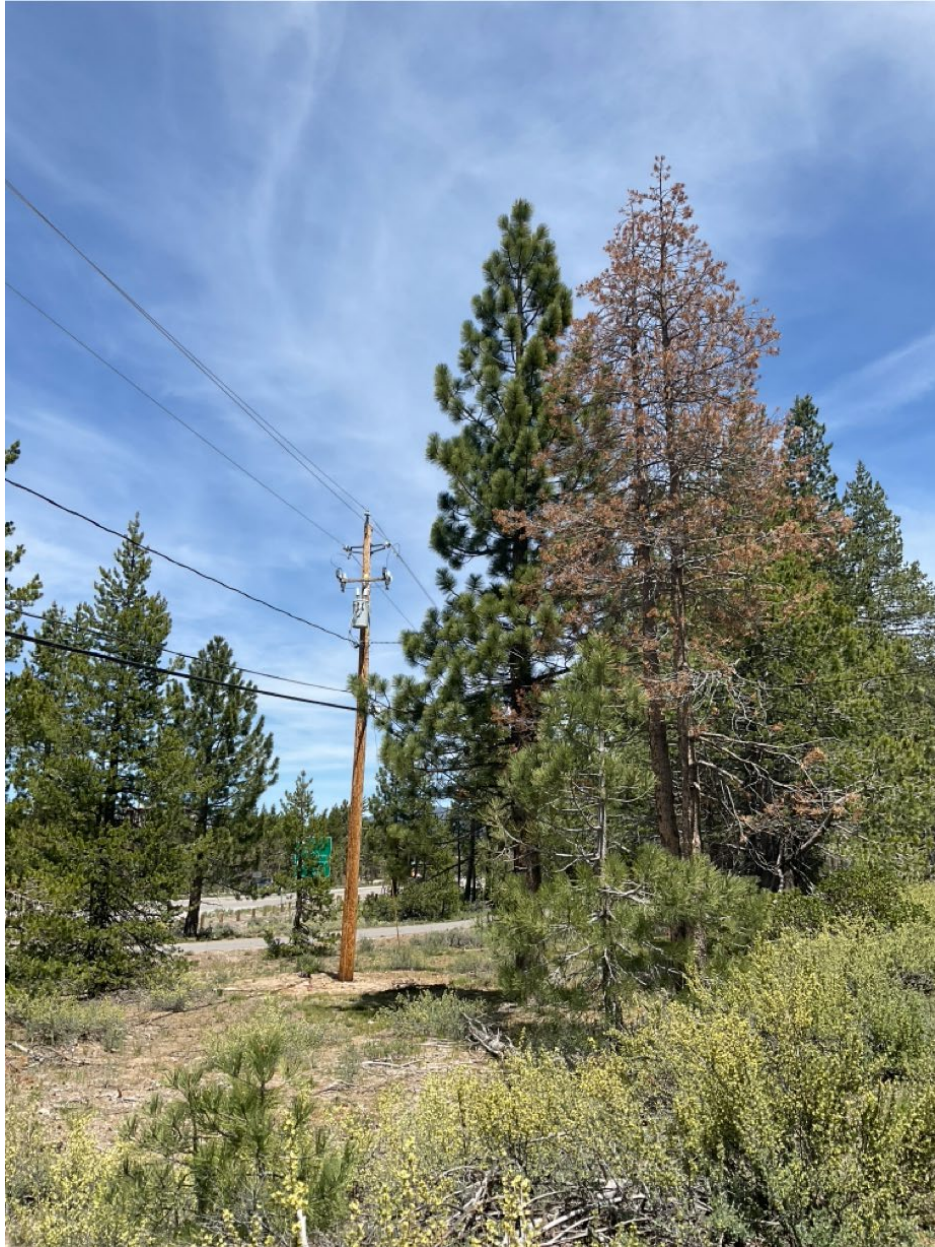
On April 28, 2026—more than 10 months after Liberty’s inspection and over five months after completion of the associated work—Energy Safety identified a declining lodgepole pine measuring approximately 38 feet in height with a combined diameter at breast height of 19 inches (two stems measuring 9 inches and 10 inches) (referred to herein as “Tree C”) in the same span and vicinity of the trees Liberty removed in 2025. At the time of Liberty’s 2025 inspection, Tree C did not meet criteria requiring mitigation; therefore, no work order was generated.

Picture 5: Tree found by Energy Safety  
(picture from May 20, 2026; removed June 15, 2026)

Tree conditions in Liberty’s service territory can change rapidly due to environmental stressors, including drought and insect activity. Tree C was determined to be a hazard based on its condition in 2026. T Liberty has since inspected Tree C, generated a work order, and completed mitigation on June 15, 2026, as part of its 2026 fall-in mitigation initiative.
