**Subject:** Liberty's Response to Notice of Non-Performance –  
NON\_ESD\_LU\_AKM\_20260429\_1029

## Liberty Response

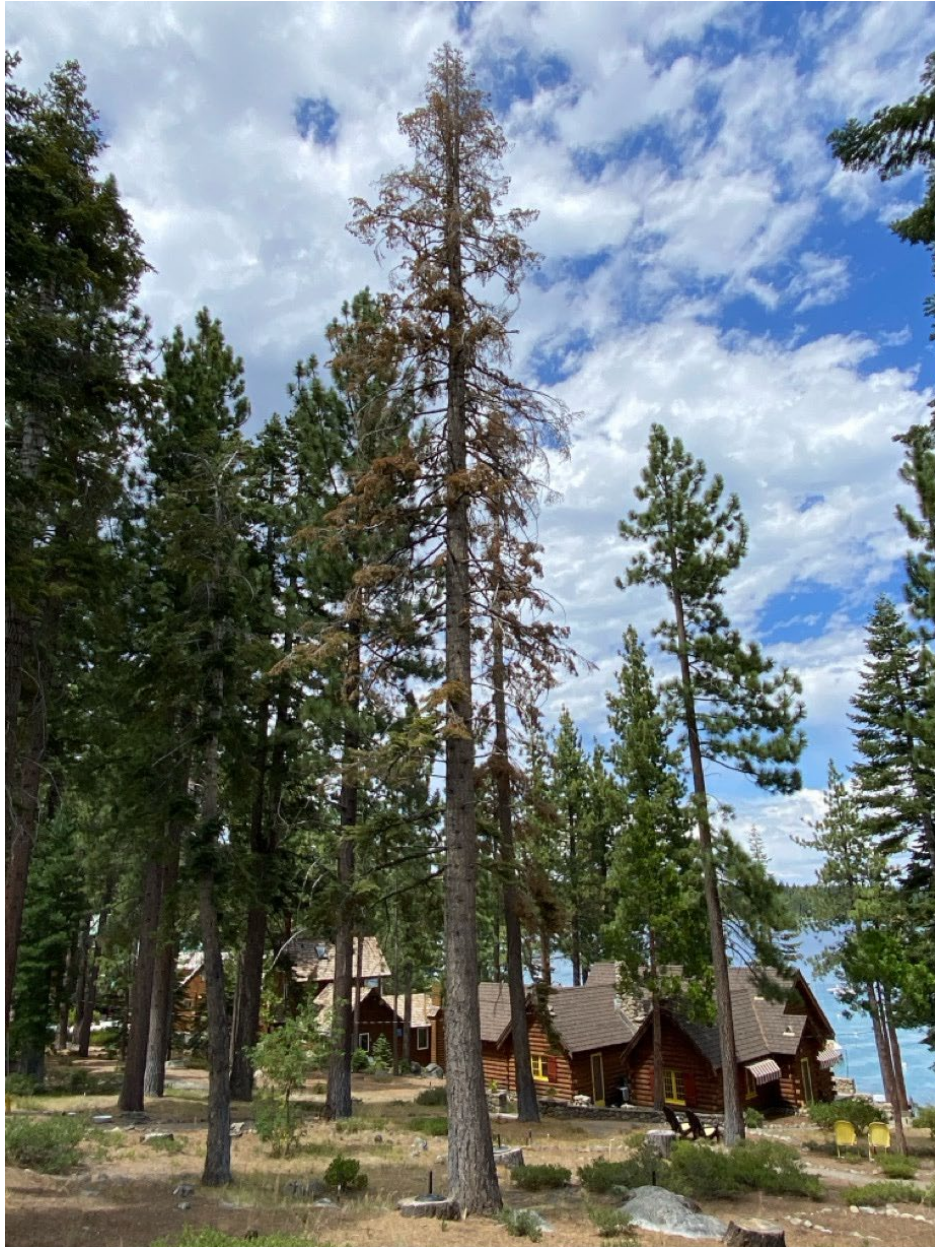
Liberty conducted a detailed inspection on July 30, 2025, during which a dead white fir tree (Tree ID W120116237N39033073) (referred to in this response as “Tree A”), measuring approximately 78 feet in height and 25 inches in diameter, was identified as a hazard tree. A work order was generated, and Tree A was mitigated on October 18, 2025.

Picture 1: Tree A (ID W120116237N39033073)  
at time of detailed inspection on July 30, 2025

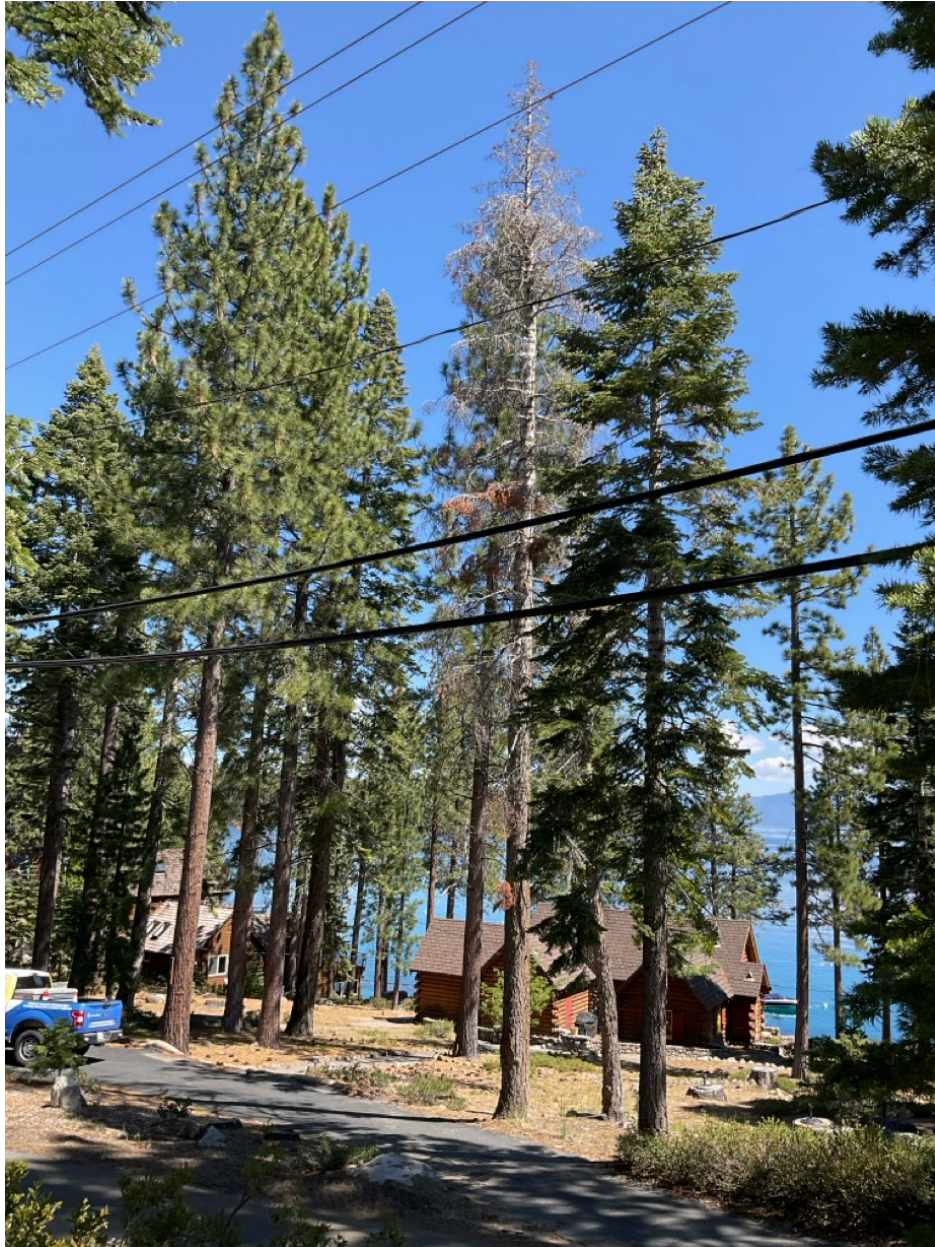
On April 29, 2026 - more than eight months after Liberty’s inspection and over six months after completion of the associated work - Energy Safety identified a different white fir tree measuring approximately 54 feet in height and 16 inches in diameter (referred to in this response as “Tree B”). At the time of Liberty’s 2025 inspection, Tree B did not meet the criteria requiring mitigation. Therefore, no work order was generated.

Tree B is not Tree A. Tree B is a different tree that appears to have deteriorated after Liberty’s 2025 inspection. Tree conditions in Liberty’s service territory change rapidly due to environmental factors and stressors, including but not limited to drought conditions and insect activity. While Tree B did not meet the mitigation criteria in 2025, it did in 2026. Liberty has since inspected Tree B, generated a work order, and is addressing it as part of its 2026 fall-in mitigation initiative.

Picture 2: Tree B  
(picture from May 21, 2026; stump from Tree A (ID W120116237N39033073) visible)
