NOTICE OF VIOLATION

On January 16, 2025, Energy Safety conducted an inspection of SCE's WMP initiatives in the vicinity of the city of Newhall, California. The inspection report is enclosed. Energy Safety found the following violation:

Violation 1. Energy Safety observed that in implementing 2024 WMP initiative 8.1.3.1 - Distribution Detailed Inspections and Remediations (IN-1.1), SCE failed to complete remediation of a buried down guy anchor on pole ID 4263497E, Grid Hardening ID 413733488-4263497E, at coordinates 34.375031, -118.542017. Energy Safety considers this completeness violation to be in the Moderate risk category.

INSPECTION REPORT

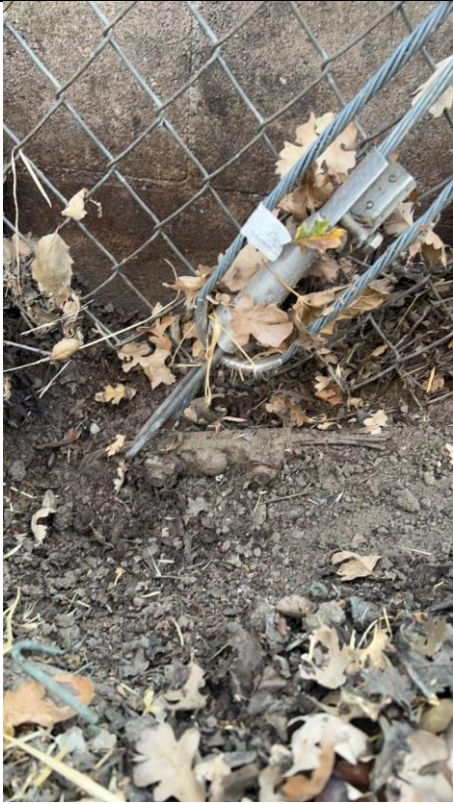
Item1IA1img1: Observed buried guy anchor below grade.

1. The anchor head was observed below grade.
2. The automatic is not secured to the anchor eye.
3. The existing anchor shows significant signs of corrosion.
4. The supporting guy anchor of the subject pole is located within HFTD 3 and a heavily trafficked residential neighborhood.
5. The anchor remediation was reported as completed on May 9, 2024. Should extreme winds or other environmental conditions occur, the guy anchor rod is more likely to fail.

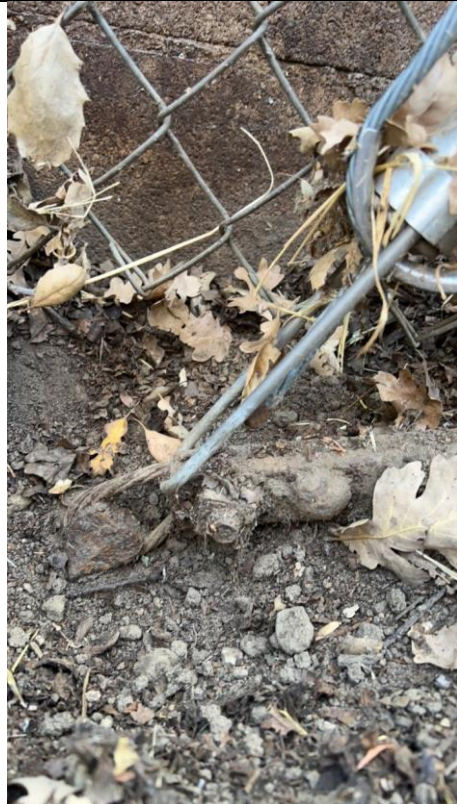
Item1IA1img2: Down guy wire preform is connected to an automatic and not directly to the down guy anchor eye. The automatic is connected to an existing severed down guy loop fastened together by a three-bolt clamp.

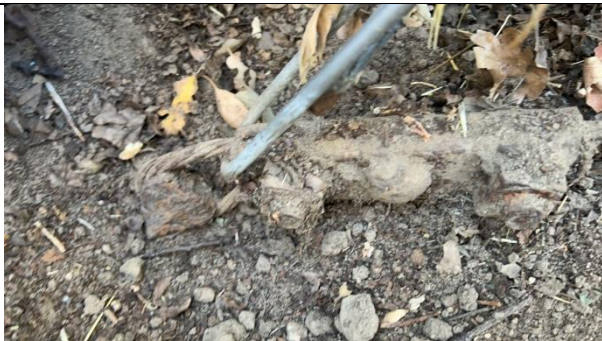
Item1IA1img3: Close up of excavated anchor head below grade.

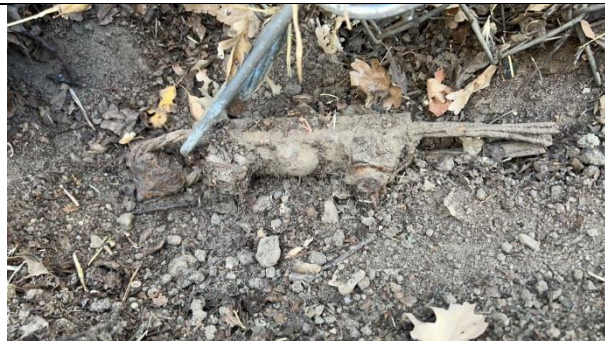
Item1IA1img4: Severed pre-existing down guy loop fastened by a three-bolt clamp.
