NOTICE OF VIOLATION

On March 25, 2025, Energy Safety conducted an inspection of SCE's WMP initiatives in the vicinity of the city of Chino Hills in High Fire Threat District (HFTD) Tier 3. The inspection report is enclosed herewith. Energy Safety found the following violation:

INSPECTION REPORT

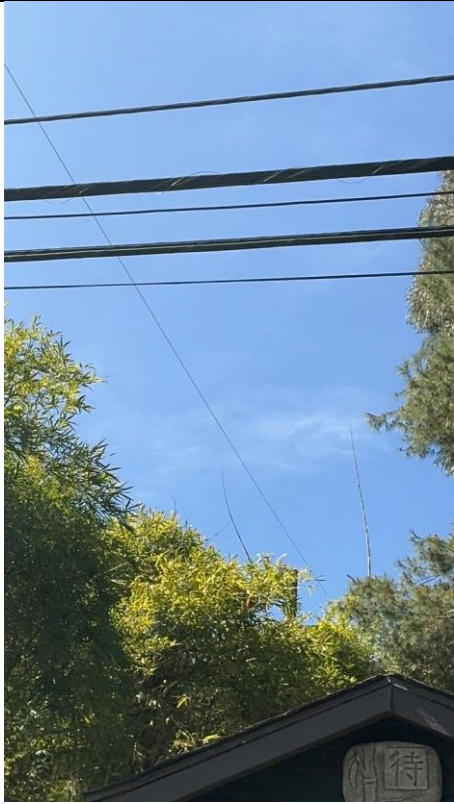
<p>Item1: Pole ID 1598146E.</p>	<p>ItemV1: Bamboo behind residence</p>

ItemV2: The bamboo culm (left culm) within two feet of the conductor behind the residence.

Energy Safety concludes that Violation 1 is "Moderate" because the vegetation is encroaching into the minimum clearance requirements.

The inspector measured both the bamboo and conductor height with the Nikon Forestry Pro II laser rangefinder. The bamboo measured 51 feet in height to the tallest bamboo culm (stock) directly under the conductor and the conductor height measured 53 feet. The distance between the highest bamboo culm directly underneath the conductor and the conductor itself was two feet, which is within the minimum clearance distance of four feet required by in SCE's WMP. The inspector's observation is documented in Violation 1 photographs, which are exhibits to this report. The pole nearest to the bamboo plant is depicted in photo number Item1. Photo numbers ItemV1, ItemV2, ItemV3, depict the subject bamboo culm within four feet of the conductors.

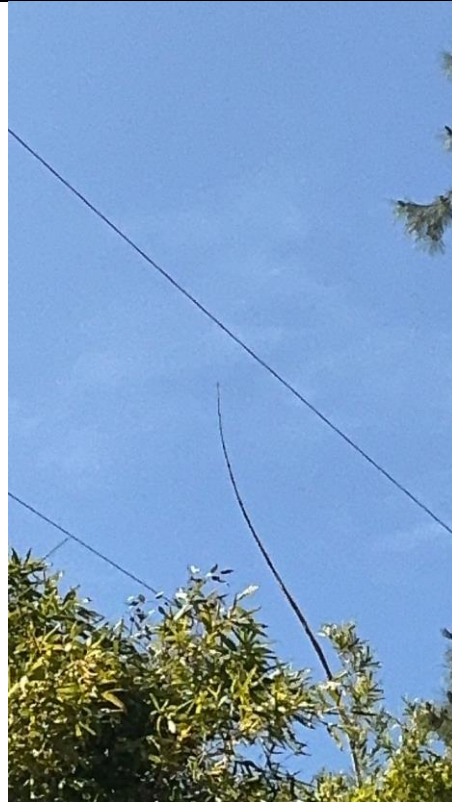
ItemV3: Closer view of the bamboo within 2 feet of the conductor.
