## NOTICE OF VIOLATION

On February 25, 2025, Energy Safety conducted an inspection of PG&E's WMP initiatives in the vicinity of the city of Sebastopol in High Fire District (HFTD) Tier 2. The inspection report is enclosed herewith. Energy Safety found the following violation:

Violation 1. Energy Safety observed that in implementing 2024 WMP initiative 8.2.2.2.3 VM for Operational Mitigations (VMOM), PGE failed to adhere to its protocol of wood and slash management near pole ID 102009724 near coordinates 38.403608, -122.896853. Energy Safety considers this violation for adherence to protocol to be in the "Minor" risk category.

# INSPECTION REPORT

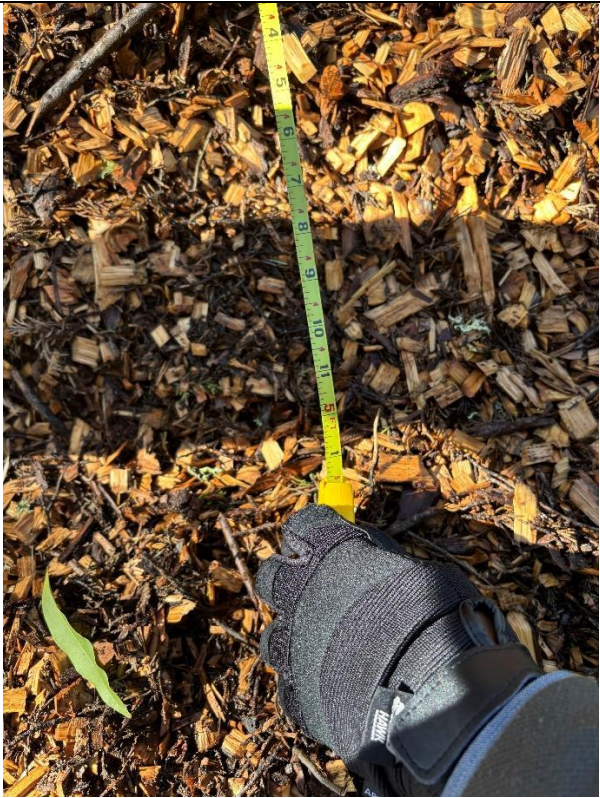
Energy Safety considers Violation 1 "Minor" because the slash pile is over 18-inches in height, creating a potential fuel source for wildfire.

**Item1IA1img0:** Photo of measurement tape showing the pile of slash at approximately 5 feet (60 inches) in height.

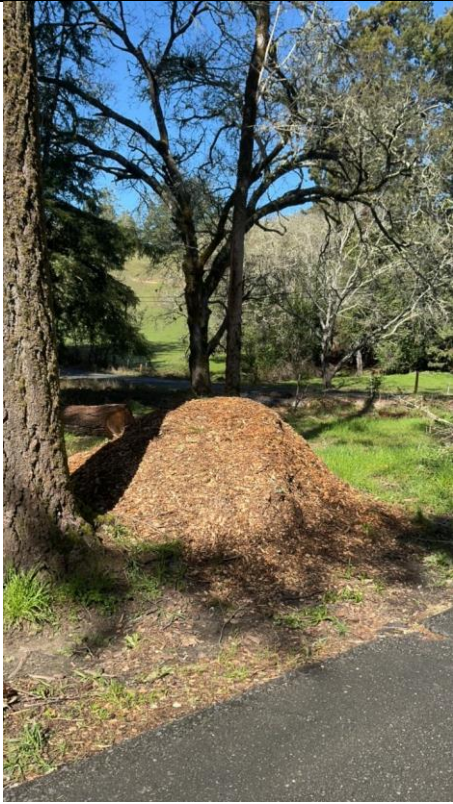
Energy Safety's inspector observed slash, wood chips, and woody debris from these Douglas firs, most of which appeared to have been felled and left in place. Additionally, the inspector observed a pile of slash debris, which was approximately 60 inches in height. The inspector's observation is documented in Violation 1 photographs, which are exhibits to this report. Photo numbers Item1IA1Img0, Item1IA1Img1, Item1IA1Img2, depict a slash pile approximately 60 inches in height, and Item1IA1Img3, Item1IA1Img4 depict several other slash piles, chips and woody debris associated with PG&Es work.

**Item1IA1img1:** Photo of the pile of slash measured at approximately 5 feet (60 inches) in height.

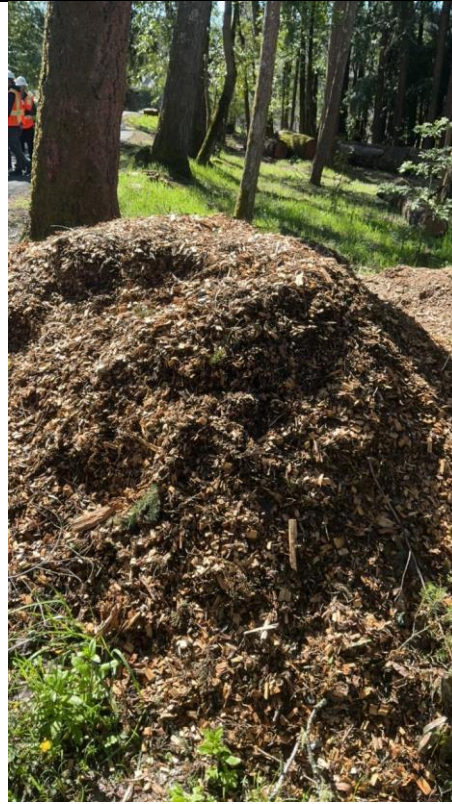
**Item1IA1img2:** Closer view of the pile of slash measured at approximately 5 feet (60 inches) in height.

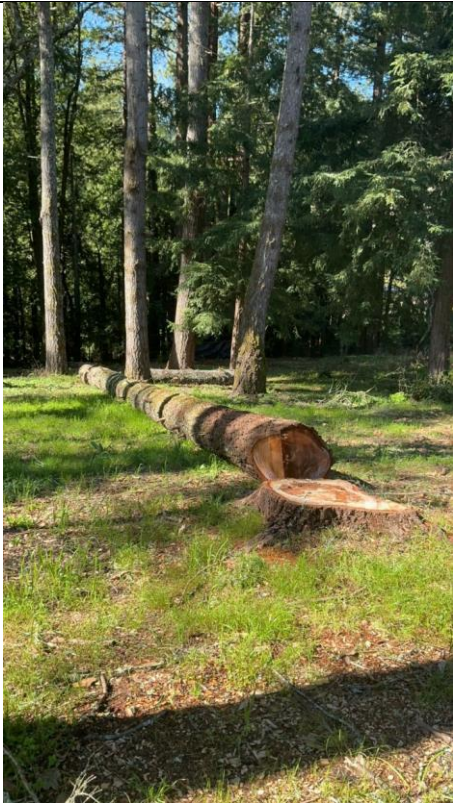
**Item1IA1img3:** Photo of the second Douglas fir cut down

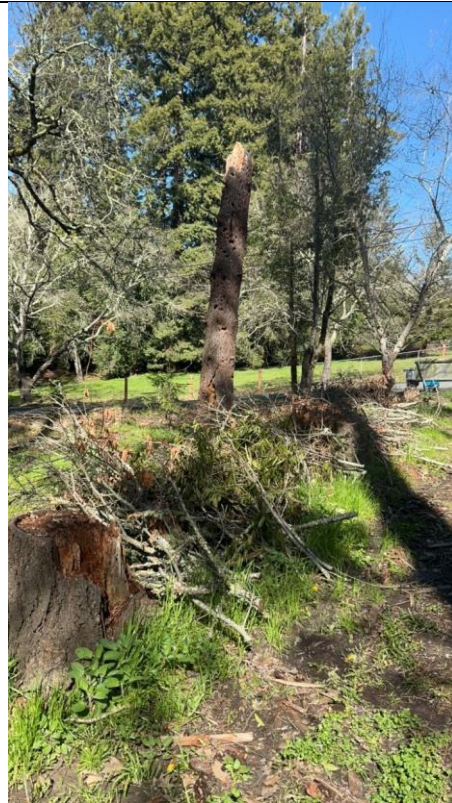
**Item1IA1img4:** Photo of the third Douglas fir cut down and the area showing slash and wood debris left near the coordinates.
