NOTICE OF VIOLATION

INSPECTION REPORT

Electrical Corporation:	Southern California Edison Company
Report Number:	CAD_SCE_CAC20_20250312_0949
Inspector:	CAC20
WMP Year Inspected:	2024
Quarterly Data Report (QDR) Referenced:	Quarter 3 (Q3)
Inspection Selection:	Energy Safety reviewed the contents of the Q3 QDR and performed an analysis that resulted in the selection of the WMP initiatives and locations referenced in this report.
Relevant WMP Initiative(s):	8.1.3.1 - Distribution Detailed Inspections and Remediations (IN-1.1)
Date of inspection:	March 12, 2025
City and/or County of Inspection:	Mammoth Lakes, Mono County
Inspection Purpose:	Assess the accuracy of Southern California Edison Company’s QDR data, completeness of its work, compliance with WMP requirements, and compliance with its protocols.

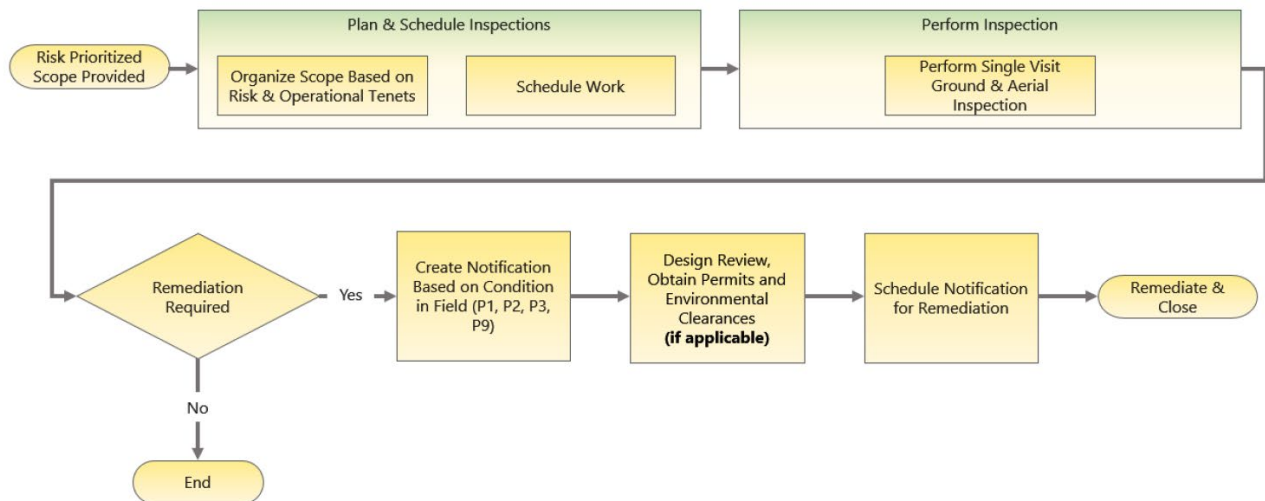
Figure 8-1a - Distribution Detailed Inspections and Remediations Workflow

1. "The frequency of [High Fire Risk-Informed inspections] varies by the location-specific risk... within SCE's [High Fire Risk Area] and emergent conditions. Issues identified by inspectors during the detailed inspections are prioritized for remediation to be completed within [General Order 95] compliance timelines. Remediations can be repairs to or replacements of existing assets depending on asset condition. For example, SCE repairs ground molding with that is found to be broken/damaged with an exposed ground wire at the public level. Also, SCE replaces wood guy guards if found to be missing, damaged or outdated."⁷
2. The following is a workflow diagram from SCE's WMP showing the conditions under which SCE will execute remediations under initiative number 8.1.3.1:⁸

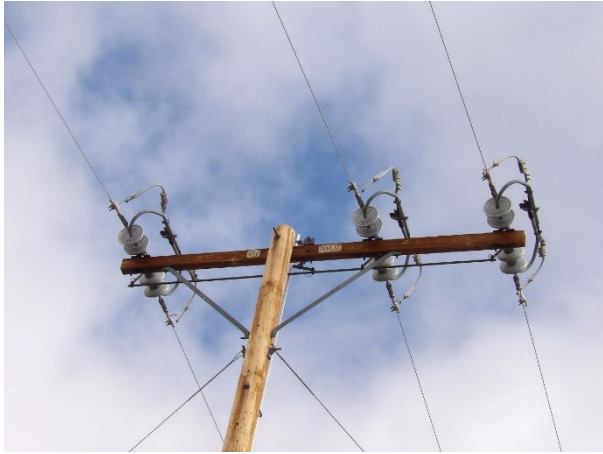
Violation 1

A close-up photograph of a weathered wooden utility pole. A yellow identification tag is attached to the pole, displaying the number '1827781E' in black text. Below the tag is a circular metal fastener with the text 'USMOSE' and 'MAY 2011' visible.	  A photograph showing a tall wooden utility pole standing in a field. The pole is supported by cross-arms and has several power lines attached. The background shows a cloudy sky and a flat landscape with some distant hills.
<p>Item1Gimg1: Pole ID.</p>	<p>Item1Gimg2: Overall pole.</p>

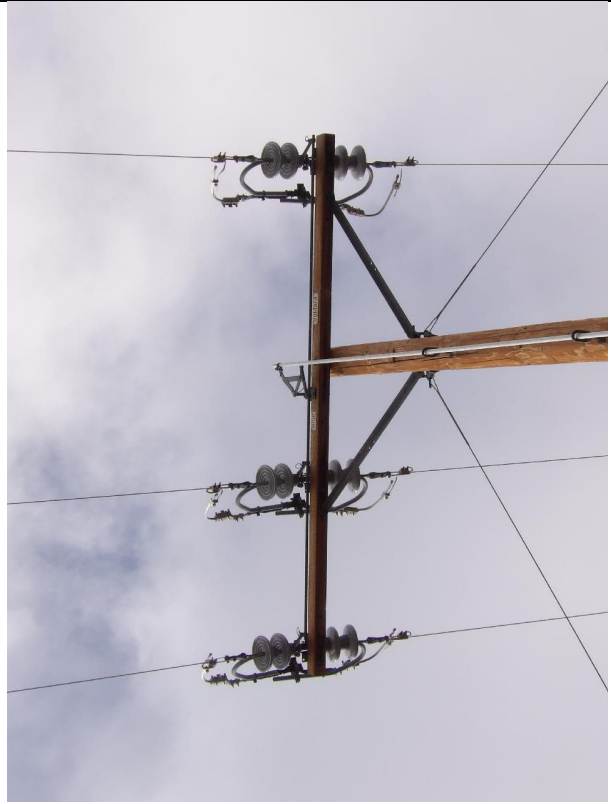
On Pole ID 1827781E, Grid Hardening ID 410891934-1827781E, at 3507-4141 Convict Lake Rd, Mammoth Lakes, CA, 93546, USA, 37.619692, -118.841513, the inspector observed that no wildlife covers (aka bird guards) were installed. The inspector's observation is documented in Violation 1 photographs, which are attachments to this report. Photo numbers Item1IA1Img1 and Item1IA1Img2 depict that no wildlife covers are installed. Per information provided by SCE to the Compliance Inbox on January 3, 2025, at 10:22 am, bird guards were installed.

1. Pursuant to Southern California Edison Company's 2023 WMP 8.1.3.1 Distribution Detailed Inspections and Remediations work, bird guard installation was identified as complete at this location.
2. Wildlife covers are not installed.

Item1IA1mg1: View showing no wildlife covers installed
