SUBJECT: Southern California Edison Company's Response to Notice of Violation
- NOV_CAD_SCE_YLO_20250507_1307

SCE Response

Finding: Completeness

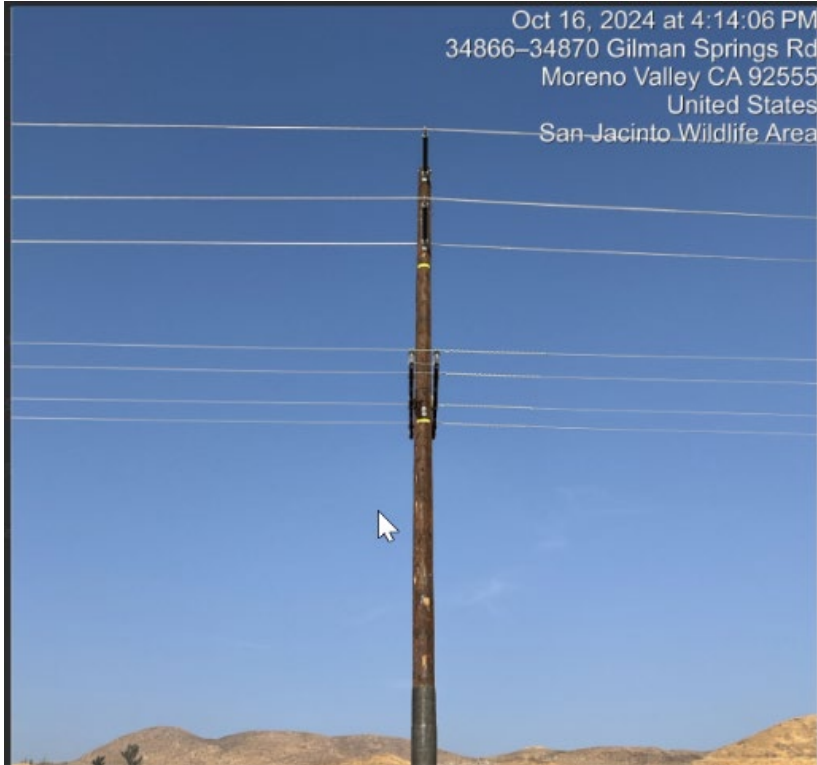
Photo 1 – Covered Conductor Installation Structure ID 4491276E

Violation 1. Energy Safety’s Notice states that in implementing 2024 initiative WMP 8.1.3.1 - Distribution Detailed Inspections and Remediations (IN-1.1), SCE failed to complete the installation of wildlife covers on pole ID 4491276E, Grid Hardening ID 410890030-4491276E at coordinates 33.8801406636701, -117.057241119606.

The notification for structure IDs 4491276E, 4409343E, 4491270E, and 4491271E specified the installation of bird guards to address potential avian contact risks. Upon further evaluation, SCE personnel determined that the installation of covered conductor on the center phase would provide a more effective solution. As shown in the photos below, the covered conductor was installed in October 2024 in place of the originally planned bird guards.

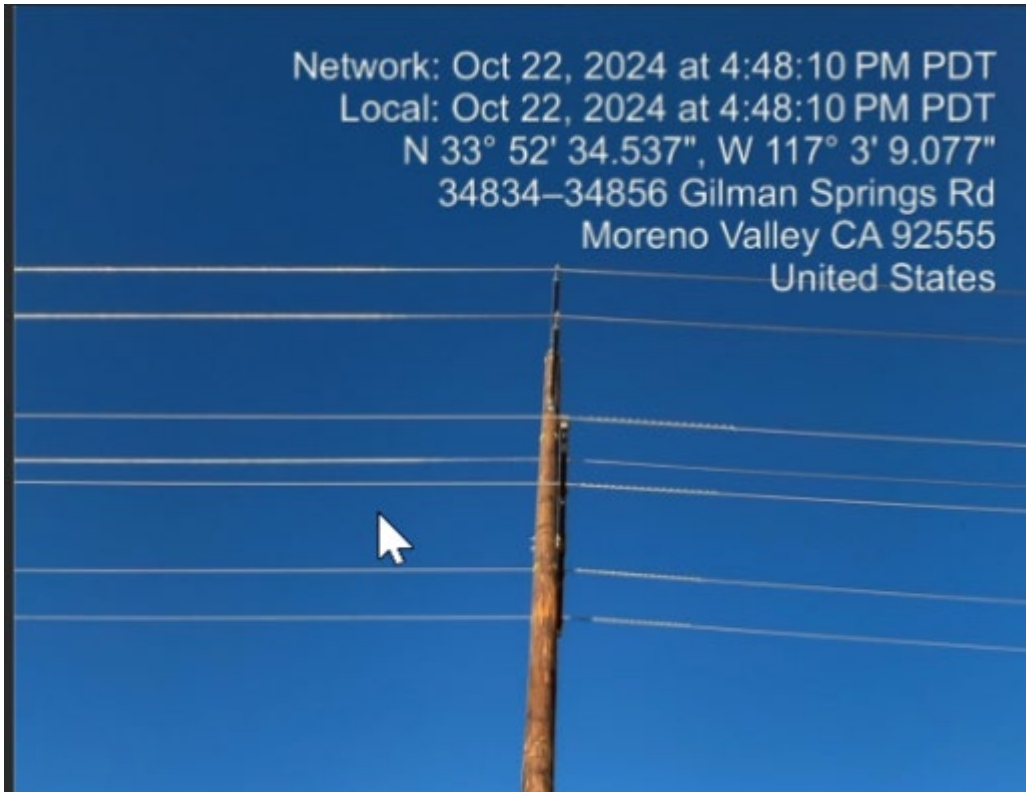
Photo 2 – Covered Conductor Installation Structure ID 4409343E

Violation 2. Energy Safety observed that in implementing 2024 WMP initiative Distribution High Fire Risk-Informed (HFRI) Inspections and Remediations, SCE failed complete the installation of wildlife covers on pole ID 4409343E, Grid Hardening ID 410902966-4409343E at coordinates 33.8762343885424, -117.052504766644.

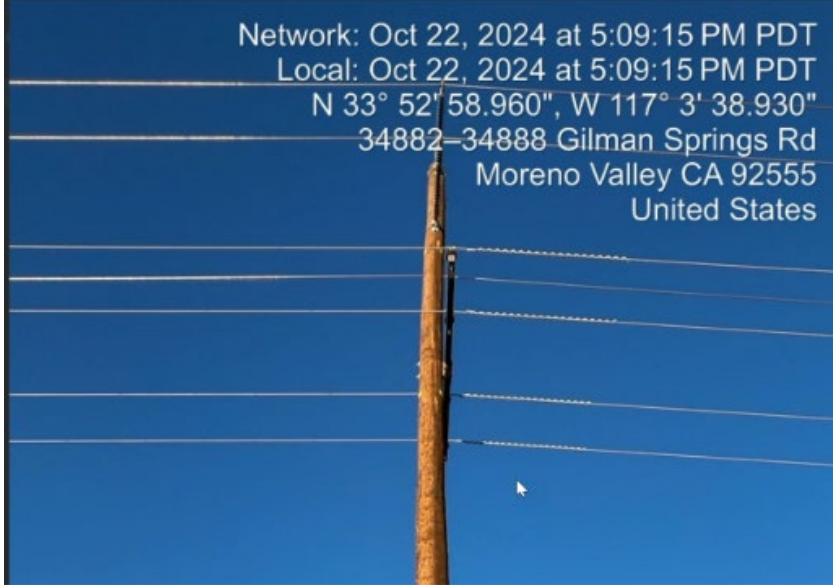
Photo 3 – Covered Conductor Installation Structure ID 4491270E

Violation 3. Energy Safety observed that in implementing 2024 WMP initiative Distribution High Fire Risk-Informed (HFRI) Inspections and Remediations, SCE failed to complete the installation of wildlife covers on pole ID 4491270E, Grid Hardening ID 410903697-4491270E at coordinates 33.8830308626952, -117.060798967357.

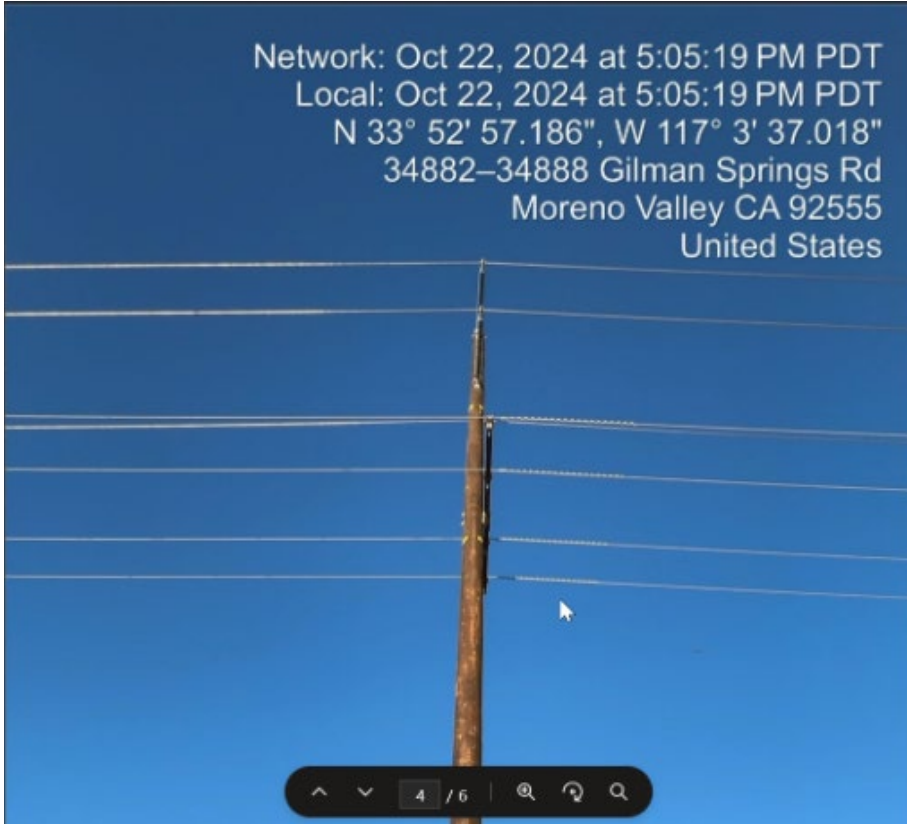
Photo 4 – Covered Conductor Installation Structure ID 4491271E

Violation 4. Energy Safety observed that in implementing 2024 WMP initiative Distribution High Fire Risk-Informed (HFRI) Inspections and Remediations, SCE failed to complete the installation of wildlife covers on pole ID 4491271E, Grid Hardening ID 410903698-4491271E at coordinates 33.8825732020637, -117.060211493416.
