October 9, 2025

Patrick Doherty, Compliance Program Manager
Compliance Assurance Division
Office of Energy Infrastructure Safety
California Natural Resources Agency
715 P Street 20th Floor
Sacramento, CA 95814

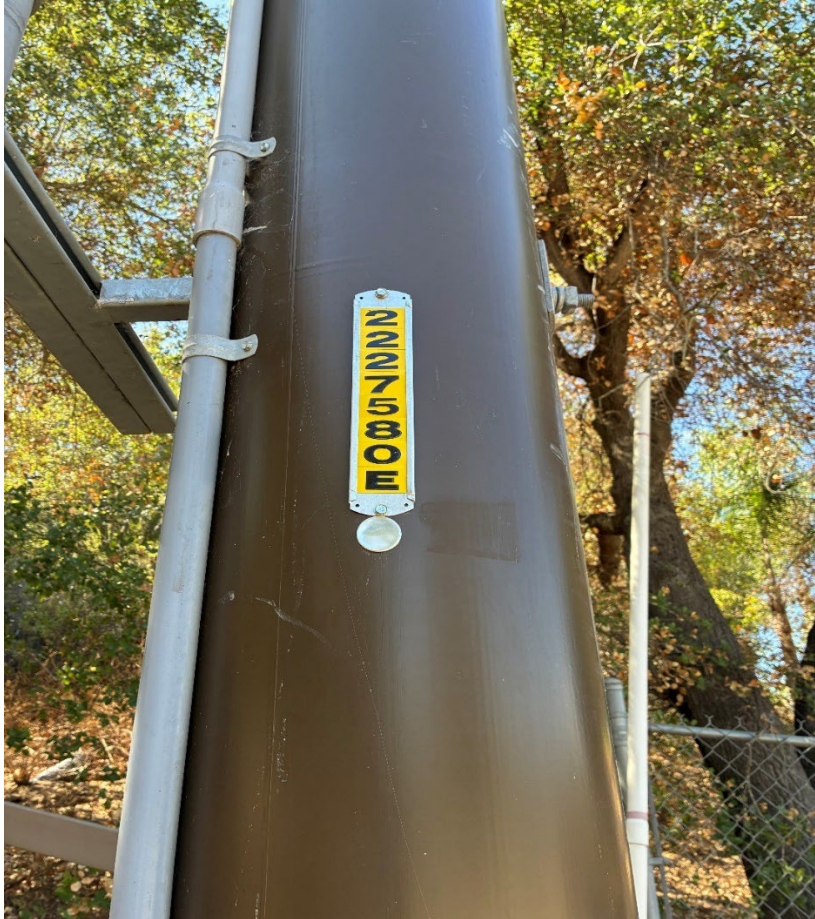
Please find photo evidence below from SCE's May 16, 2025 and September 24, 2025 inspections, documenting the avian protection in its secured condition.
