**SUBJECT:** Southern California Edison Company's Response to Notice of Violation  
NOV\_CAD\_SCE\_SIS\_20250618\_1028

Notice	Violation	Structures
NOV_CAD_SCE_SIS_20250618_1028	1	4234530E

Energy Safety's Notice states that in implementing 2024 initiative WMP 8.1.3.1 - Distribution Detailed Inspections and Remediations (IN-1.1), SCE failed to complete the installation of wildlife covers on Pole ID 4234530E, Grid Hardening ID 409911517-4234530E at coordinates 33.698648, -117.390164

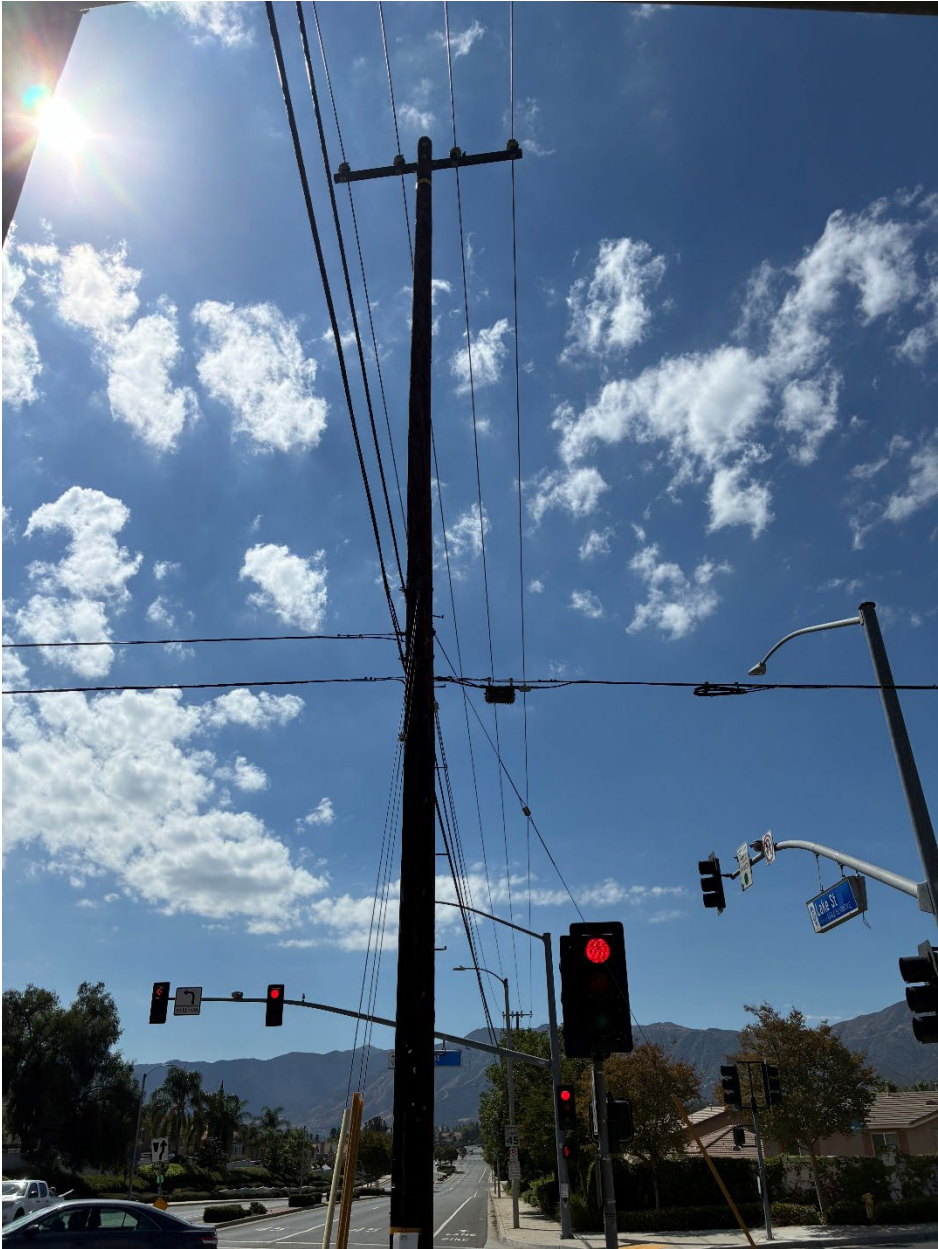
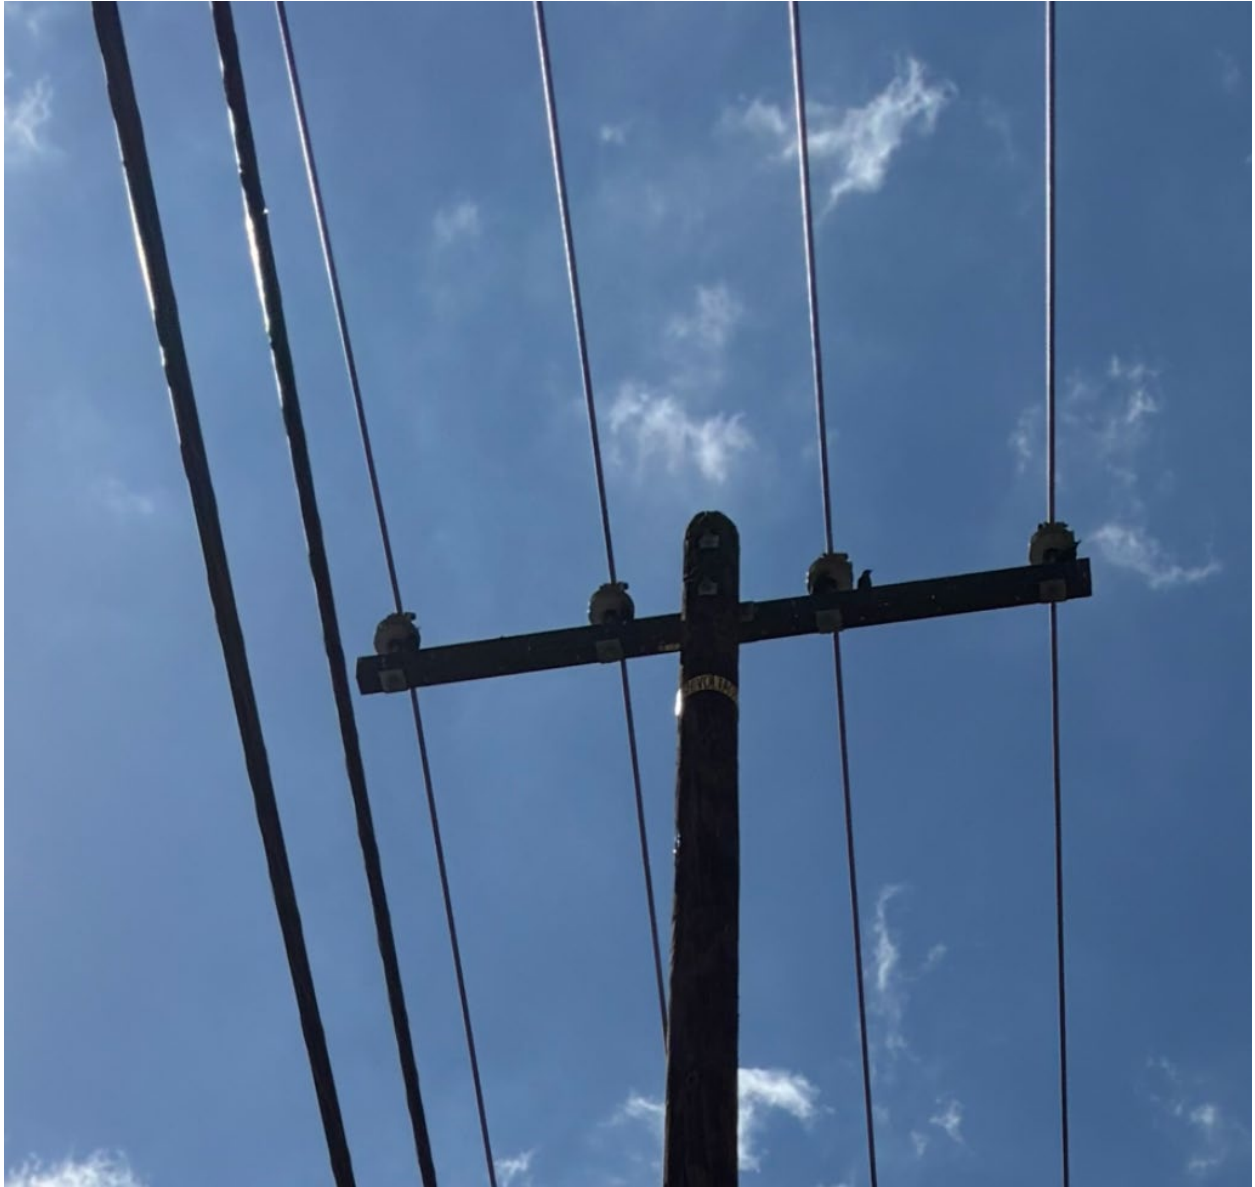
The notification for structure ID 4234530E specified the installation of a bird guard to address potential avian contact risks. Upon further evaluation, SCE personnel determined that the installation of covered conductor on the center phase would provide a more comprehensive mitigation. As shown in the photos below, the covered conductor was installed on December 5, 2024. As explained below, the covered conductor installation obviated the need for the originally planned bird guard.

Covered conductor serves the same core function as a bird guard—preventing wildlife contact and mitigating avian related outages—but it does so by fully insulating the energized conductor, rather than shielding a localized jumper connection. This continuous insulation offers enhanced protection by eliminating exposed energized surfaces along the span, thereby exceeding the original scope and intent of the bird guard remediation.

Additionally, per Section DC 535, Sheet 1 of 35 of SCE's Distribution Overhead Construction Standards (DOH), wildlife hoods are not required when covered conductor

is installed. This standard recognizes that covered conductor systems eliminate the need for additional wildlife mitigation equipment.
