## **NOTICE OF DATA INACCURACY**

## INSPECTION REPORT

Electrical Corporation:	Liberty Utilities
Report Number:	CAD_LU_BKA_20250923_1509
Date of inspection:	September 23, 2025
City and/or County of Inspection:	Coleville, Mono County
Inspector:	Babak Kaviani
WMP Year Inspected:	2025
Quarterly Data Report (QDR) Referenced:	Quarter 1 (Q1)
Inspection Selection:	Energy Safety viewed the contents of the Q1 QDR and performed an analysis that resulted in the selection of the WMP initiatives and locations referenced in this report.
Relevant WMP Initiative(s):	8.1.2.3 - Distribution pole replacements and reinforcements
Inspection Purpose:	Assess the accuracy of Liberty Utilities' QDR data, completeness of its work, compliance with WMP requirements, and compliance with its protocols.

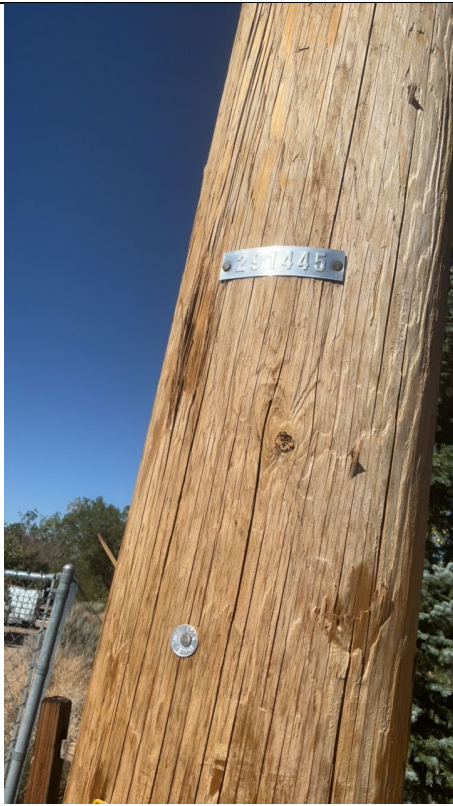
On Pole ID 300302, Grid Hardening ID 21bc2383-892d-417e-9302-876fad1b6305 at 114 W Mill Creek Ln, Coleville, CA, 96107, USA, 38.5159677796637, -119.472614, the inspector observed that a new pole was installed at this location. The inspector's observation is documented in Data Inaccuracy 1 photographs, which are attached to this report as Exhibit A. In the 2025 Q1 Quarterly Data Report submission, LU reported that work on WMP initiative 8.1.2.3 - Distribution pole replacements and reinforcements were completed at this location On Pole ID 300302, Grid Hardening ID 21bc2383-892d-417e-9302-876fad1b6305.

1. No pre-existing distribution pole was identified at this location that would require replacement or reinforcement.
2. Inspection findings indicate a newly installed distribution pole functioning as a service drop pole between an existing distribution pole and an existing residential structure.

A photograph showing a wooden utility pole standing on a dirt road. In the background, there is a small white building with a dark roof, surrounded by dry vegetation and hills under a clear blue sky. The front of a white vehicle is visible in the bottom right corner.	  A close-up photograph of the wooden utility pole. A blue tag with the number '300302' is attached to the pole. The wood shows signs of weathering and decay. A yellow reflective band is visible at the bottom of the pole.
<b>G1mg1:</b> Overall Structure	<b>G1mg2:</b> Pole ID

Within 30 days from the issuance date of this NODI, LU should provide a response advising Energy Safety of corrective actions taken or planned to remedy the identified data inaccuracy or inaccuracies.

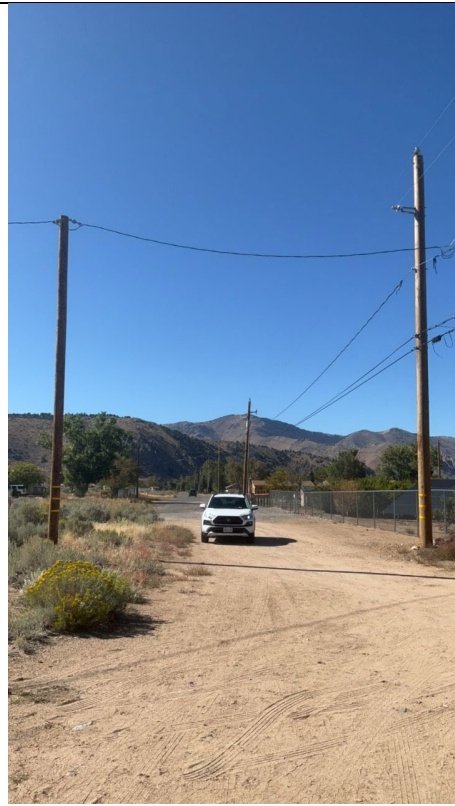
**G1mg3:** Older pole and pole ID that was not replaced or reinforced
