RE: Energy Safety ID: CAD_PGE_BKA_20250129_1136
Notice of Violation: Government Code § 15475.1 and the California Code of Regulations, Title 14, Division 17 § 29302(b)(2)

This letter is in response to the above referenced Notice of Violation (NOV) dated March 21, 2025, (NOV Letter) regarding the Office of Energy Infrastructure Safety (Energy Safety) inspection of Pacific Gas and Electric Company's 2024 Wildfire Mitigation Plan Initiatives in the vicinity of the city of Applegate, California in HFTD Tier 2 on January 29th, 2025.

Violation 1. Energy Safety observed that in implementing 2024 WMP initiative 8.1.2.10.5 – Non-Exempt Expulsion Fuses, PG&E failed to complete the work on pole ID 067349, Grid Hardening ID 31659986 at coordinates 39.014956, -120.982036. Energy Safety considers this completeness violation to be in the Minor risk category.

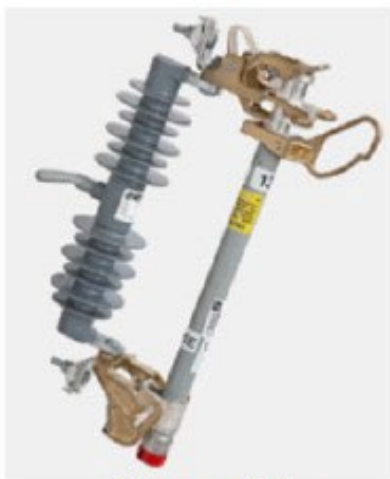
Figure 16
Part 63H

The exempt fuses are shown hanging on the poles steps and conform to PG&E guidance document 15225 (1.C.1) for care and handling of Type E Power fuses. As shown in Image 1 and Image 2 below, both the Part63H cutout and the Type E Power Fuse have distinct features that distinguish them from Part 44H cutouts and the non-exempt universal fuses they can accept. Part63H cutouts are noticeably larger than Part 44H cutouts, and the Type E Power Fuses have an oblong ring to support installation and removal. Another identification characteristic is the cap installed on the bottom of the fuse and the absence of a visible fuse element exiting the fuse holder.

Image 1: Part 63H cutout with CalFire Exempt Type E Power fuse (Labeled Figure 16)

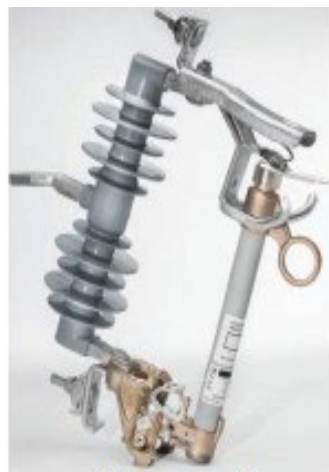
Figure 1
Parts 44H and 44HSB

Image 2: Part 44H Cutout with Non-Exempt Universal Fuse (Labeled Figure 1)

In contrast, Part 44H cutouts are smaller than Part 63H, and universal fuses have a round pull ring and a visible fuse element visible existing at the bottom of the fuse holder. The excerpt below details the care and handling of Type E power fuses.

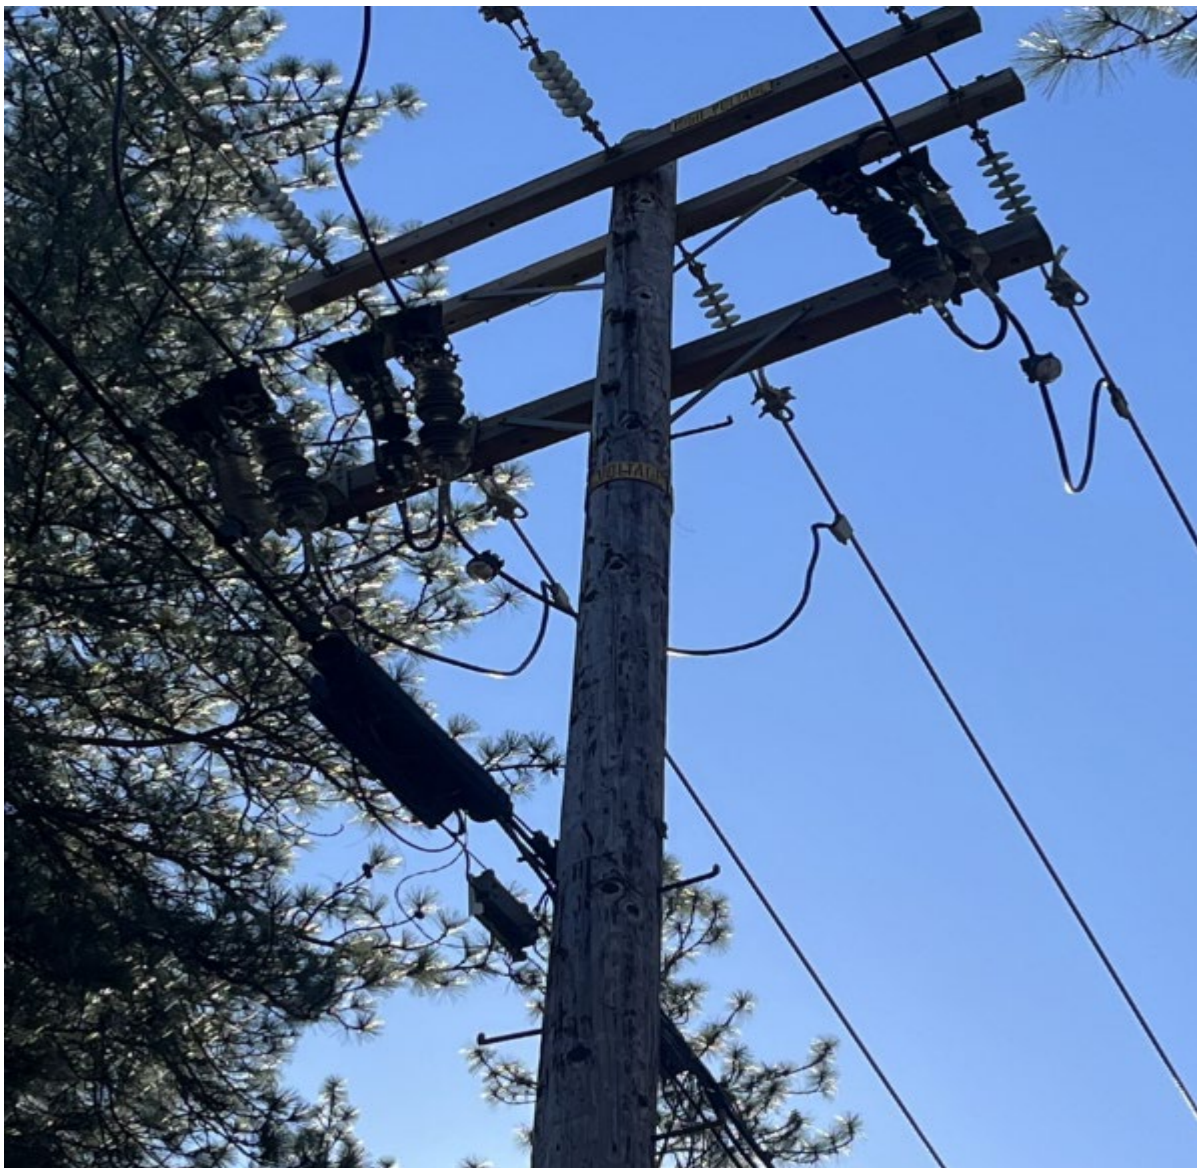
Please see the photo evidence below for removal of CalFire Exempt fuses from the pole step.

The storage practice of hanging fuses on pole steps is not a component of the GH-10 commitment. During a consultation with Energy Safety on March 4, 2026, PG&E voluntarily decided to remove the fuses from the pole steps to initiate a testing protocol to confirm that the fuses are not compromised by water ingress and therefore storing them on pole steps is appropriate, when desired. As communicated to Energy Safety, we believe the storage of the fuses on the pole steps is safe and compliant with our standards; this testing protocol will enable us to demonstrate this storage method is appropriate. Once testing and analysis are complete, PG&E will update Energy Safety on the results of the testing and any forthcoming changes to future operations or guidance documents.
