## **NOTICE OF NON-PERFORMANCE**

On March 10, 2026, Energy Safety conducted an inspection of PG&E's WMP initiatives in the vicinity of the city of Wilseyville, California within High Fire Threat District (HFTD) Tier 3 and the State Responsibility Area (SRA). The inspection report is enclosed herewith. Energy Safety found the following deficiency:

# INSPECTION REPORT

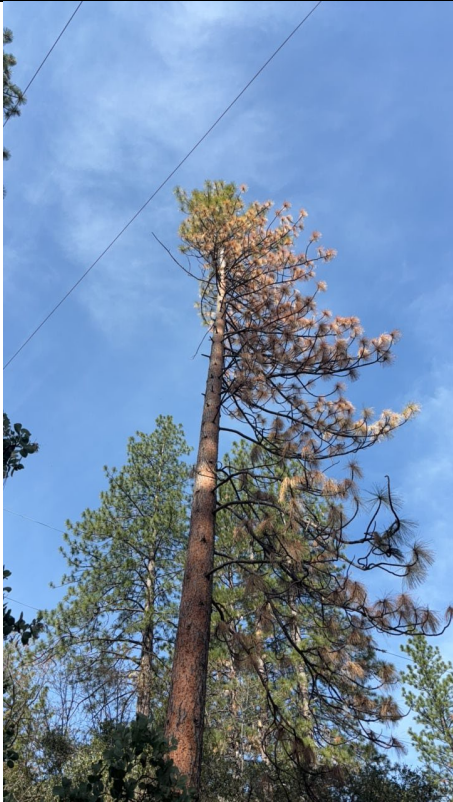
**Photo 1:** Photo of the dying pine tree near the conductors.

Energy Safety considers this deficiency as a "Moderate" because PG&E has not removed the dying tree located within striking distance of conductors, consistent with the requirements of Public Resources Code section 4293. The continued presence of this tree presents ongoing wildfire risk.

On March 10, 2026, Energy Safety conducted an inspection of PG&E's WMP's initiatives in the vicinity of Wilseyville, California. During the inspection, Energy Safety identified a dying pine tree near pole ID 122142062 and near coordinates 38.37407283102526, -120.50554002118581 at 3702 Blue Mountain Road. The pine tree has a diameter at breast height of 19 inches and is approximately 126 feet tall. It is located north of pole ID 122142062, east of the conductors and has a "No Trespassing" sign attached. The pine tree is located within the State Responsibility Area (SRA). It exhibits dying and thinning needles, and the trunk shows orange bark discoloration possibly due to insect infestation as well as multiple insect burrowing holes. The inspector's observations are documented in photos 1 and 2, which are exhibits to this report.

Deficiency 1. Energy Safety observed that PG&E failed to implement its 2025 WMP initiative 8.2.3.4, which requires compliance with Public Resources Code section 4293, by not removing a declining or dying pine tree near coordinates 38.37407283102526, -120.50554002118581. Energy Safety considers this non-performance to be in the Moderate risk category. PG&E must complete corrective action for this non-performance by two months from the date of this notice.<sup>1</sup>
