**CALIFORNIA UNDERGROUND FACILITIES SAFE EXCAVATION BOARD
INVESTIGATION DIVISION
INCIDENT INVESTIGATION REPORT**

Case Number: 20LA1086	Report Date: August 20, 2020
Subject Name: Southern California Gas Company	Notification Date: February 4, 2020

Location of Incident: 11200 Olive Drive, Bakersfield, CA

Facility Type Damaged: Six-inch plastic gas main

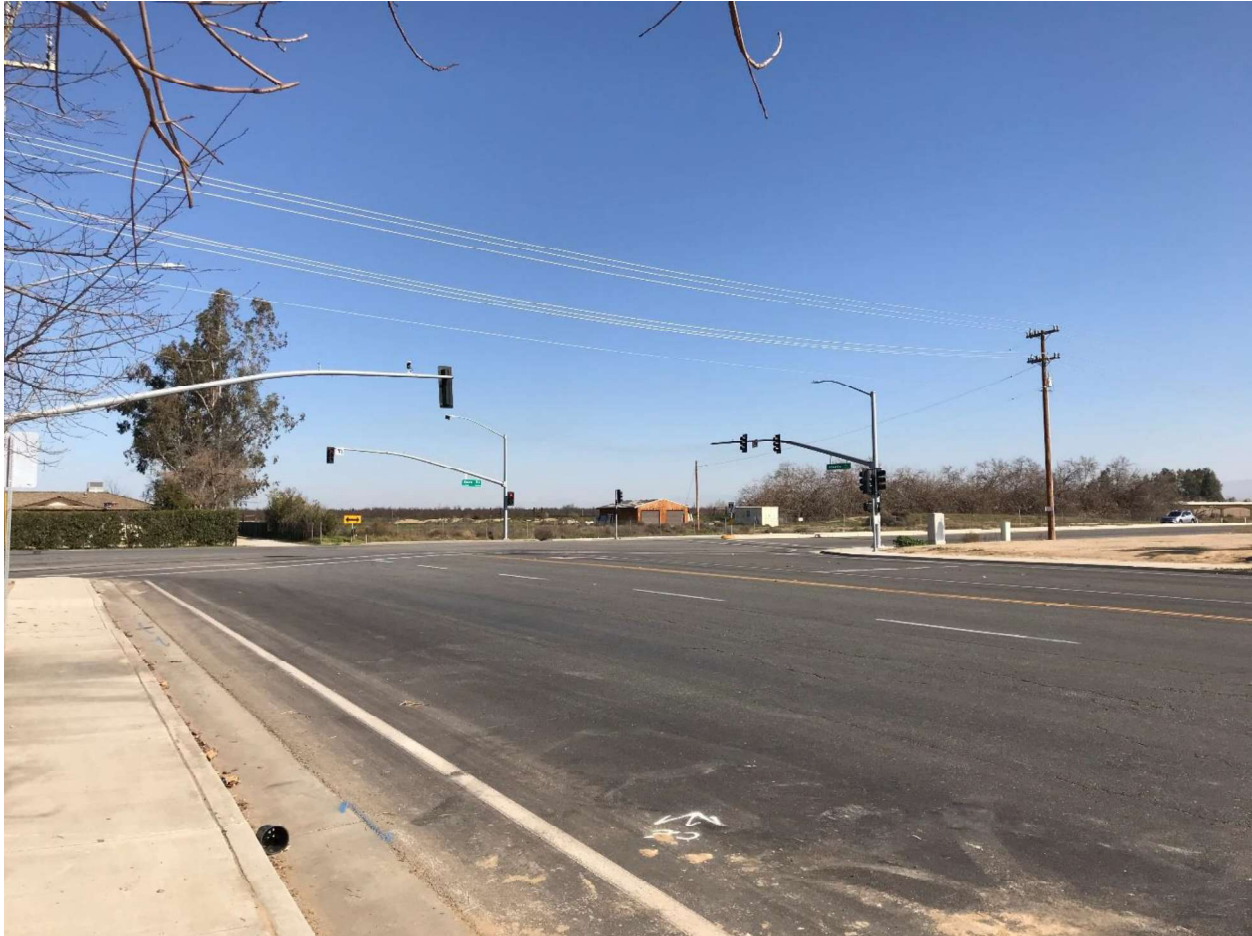
Photo 1

On February 10, 2020, I visited the incident site and took photos of the area. (**Photo 1, 2, 3, 4**).

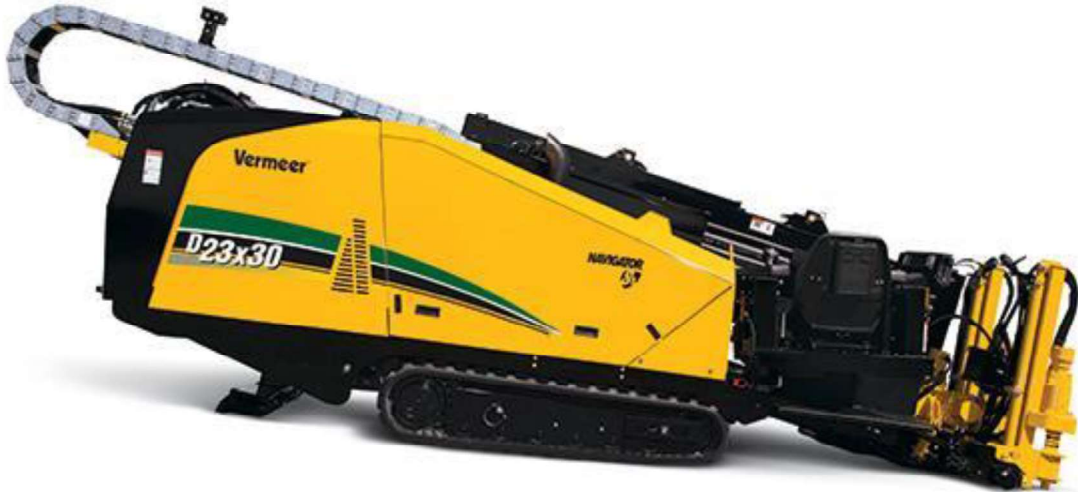
Image 2

CCE commenced work on or about February 3, 2020 at or around 1130 hours. One of its Vermeer directional drills (**Image 2**) made a contact with a six-inch plastic gas main and bored through it (**Photos 5, 6, 7, 8, 9**).

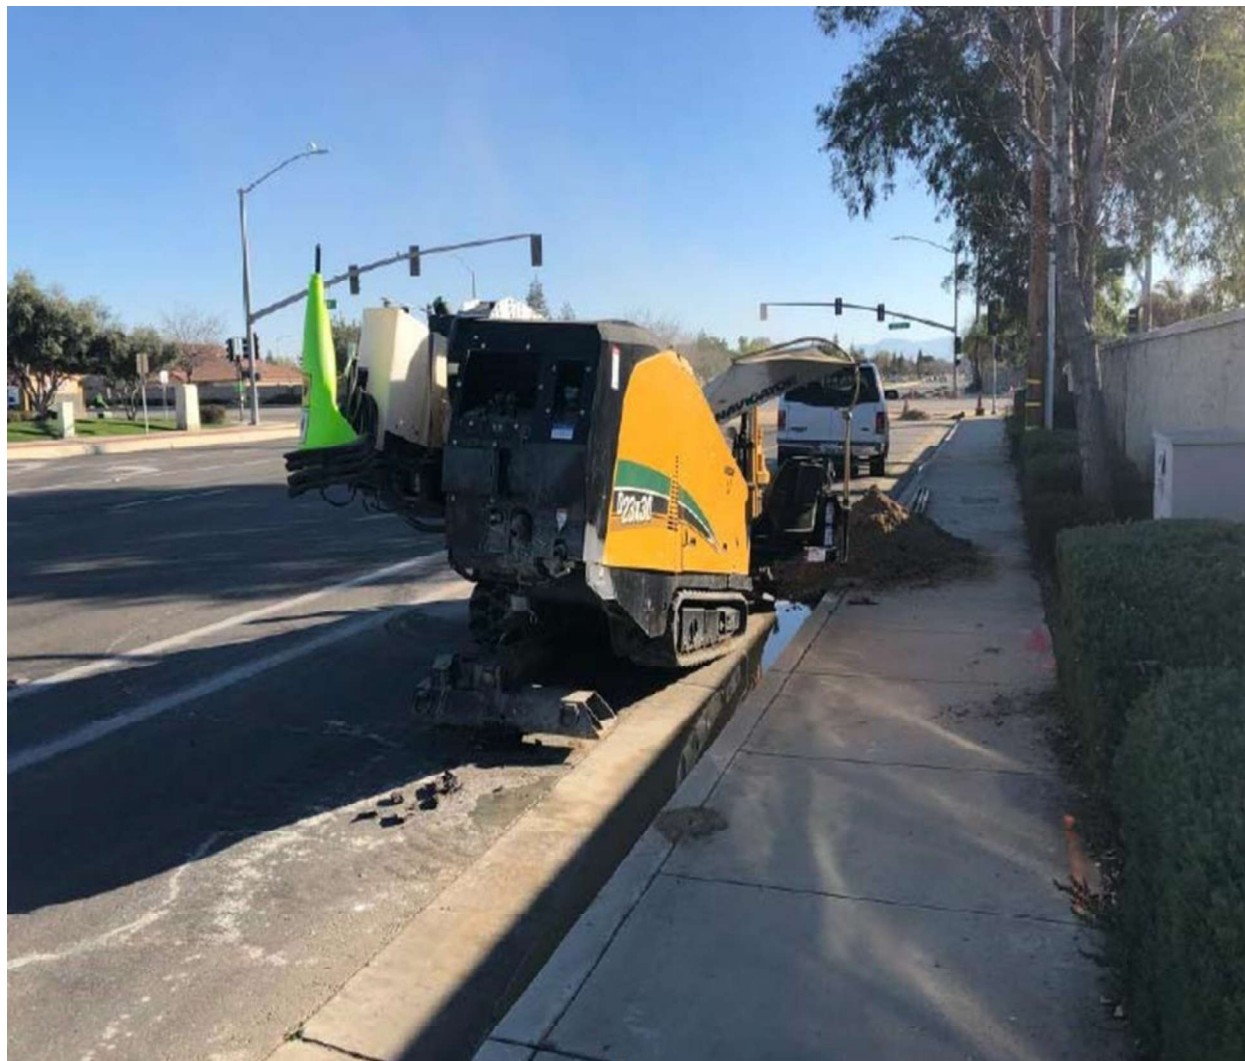
Photo 5: Directional Drill made contact with six-inch gas main

SCGC's locator did not complete the markings, yet indicated the job was completed on the operator's KORTERRA System. Because CCE does not have access to the KORTERRA System and SCGC does not use electronic positive response yet, CCE commenced excavation based on the presence of SCGC markings as well as the fact that the legal start date had passed. As a result, on February 3, 2020, the excavator made contact with and bored through a six-inch gas pipeline causing a gas release. Nearby neighborhoods were evacuated; the area was blocked off and the traffic rerouted as a precaution. The operator repaired the gas pipeline damage. There was no gas supply outage to affected customers as a result of this incident. Gas flow was ceased February 3, 2020 at 1630 hours and restored on February 4, 2020 at 0351 hours.

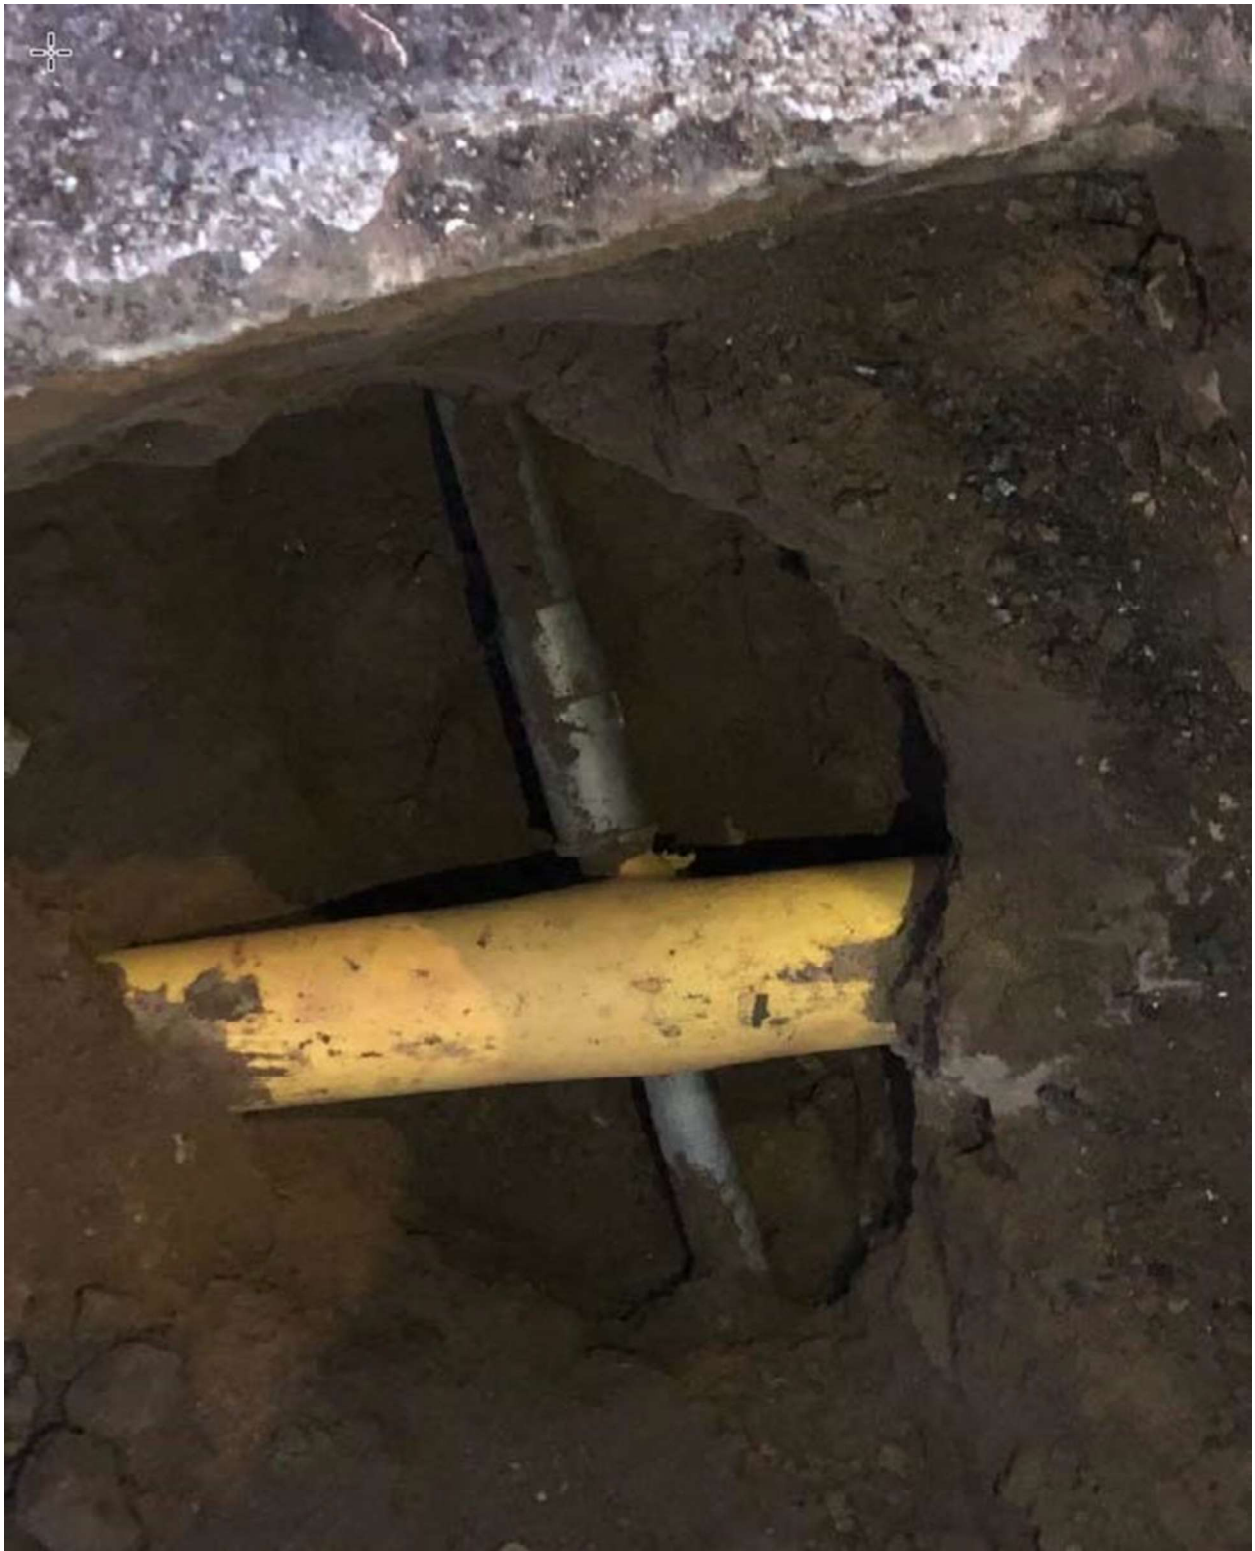
Photo 6: Directional Drill bored through the six-inch gas main

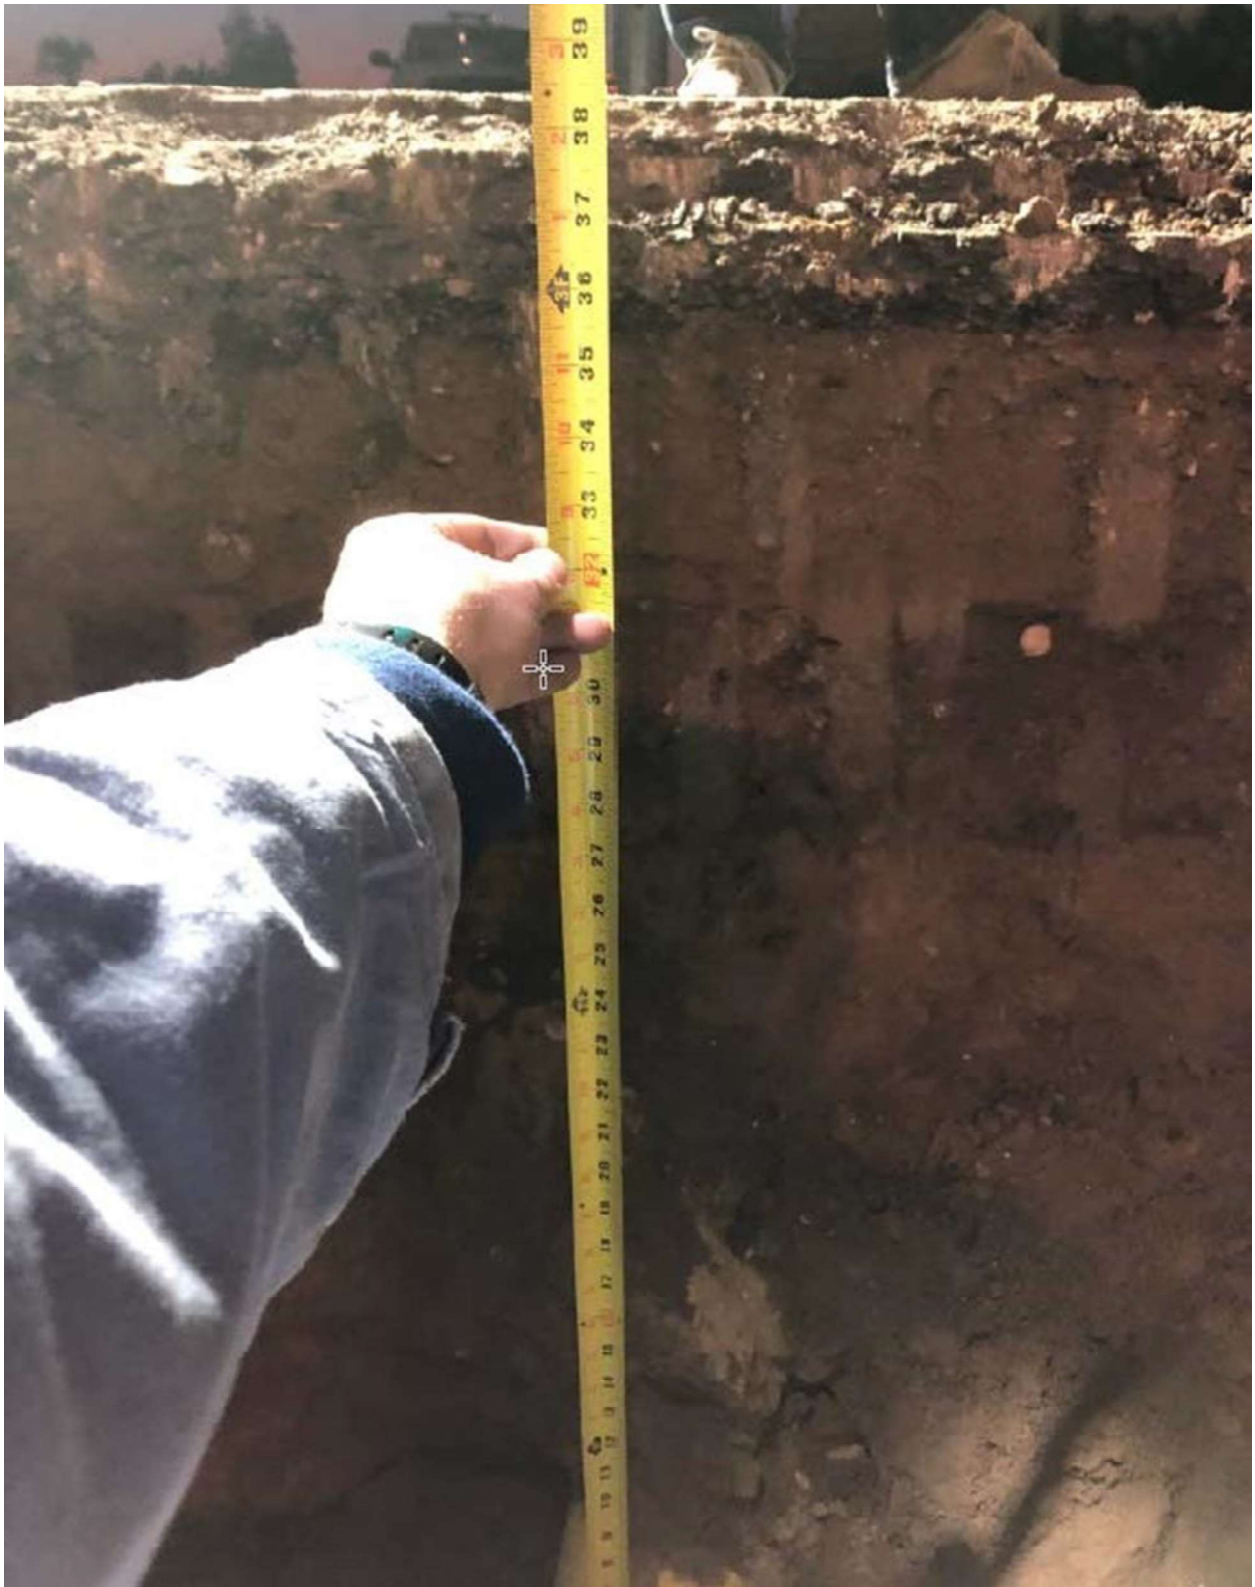
Photo 7: Damaged gas main located approximately 38.5 inches below ground surface

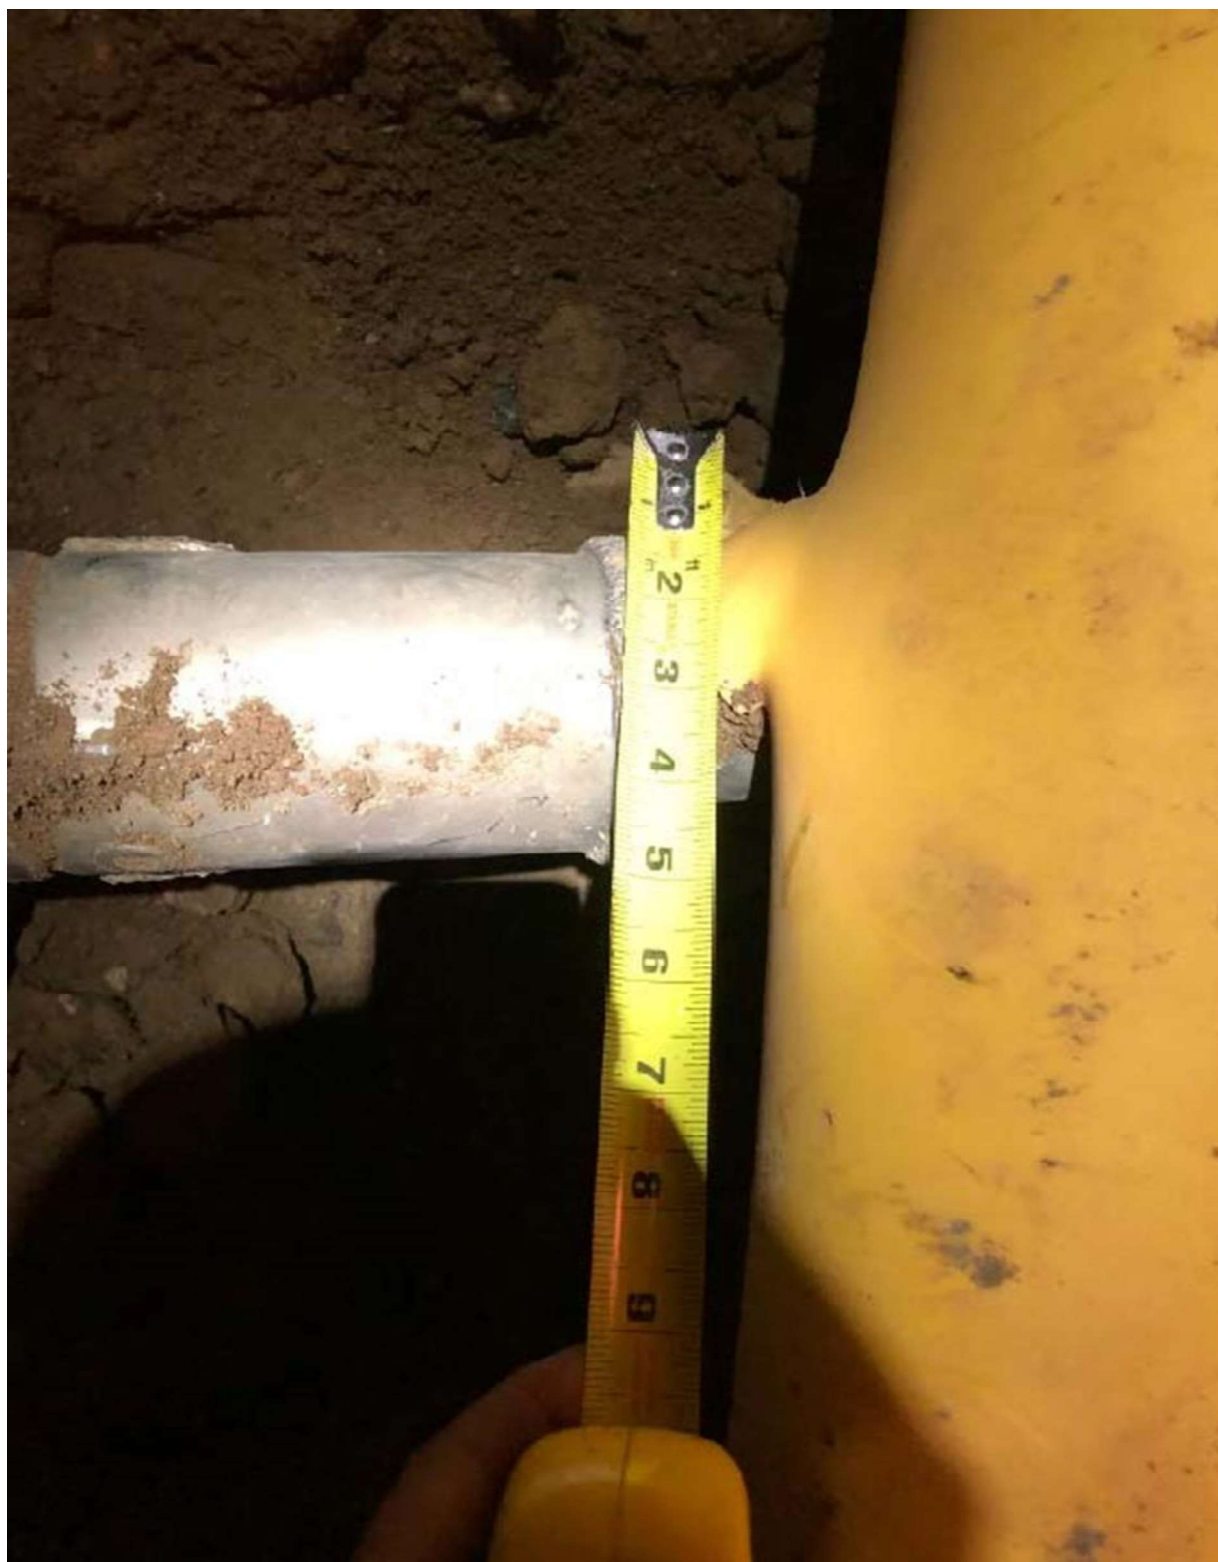
Photo 8: Drill penetrated the pipe

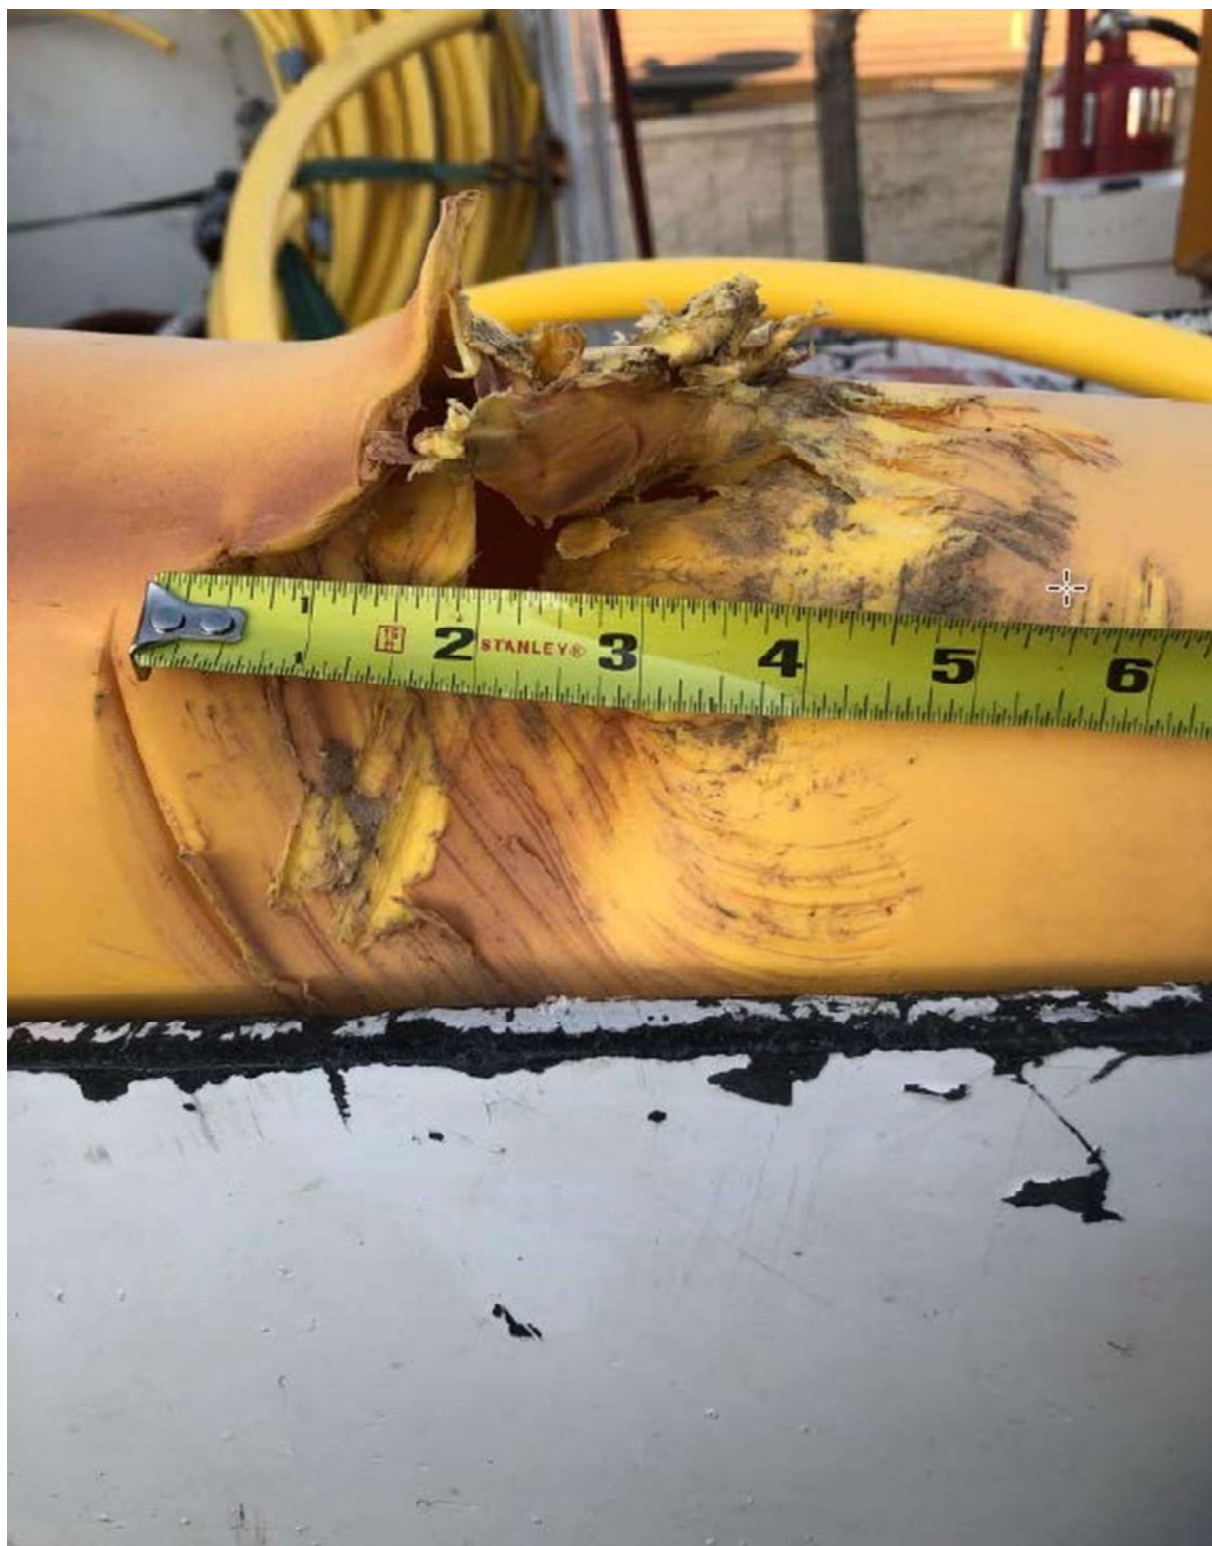
Photo 9: Damaged six-inch plastic gas main
