# Underground Safety Board

Board Meeting of the California Underground Facilities Safe Excavation Board

July 10, 2023

# Item 18: Potholing Standards Development Update

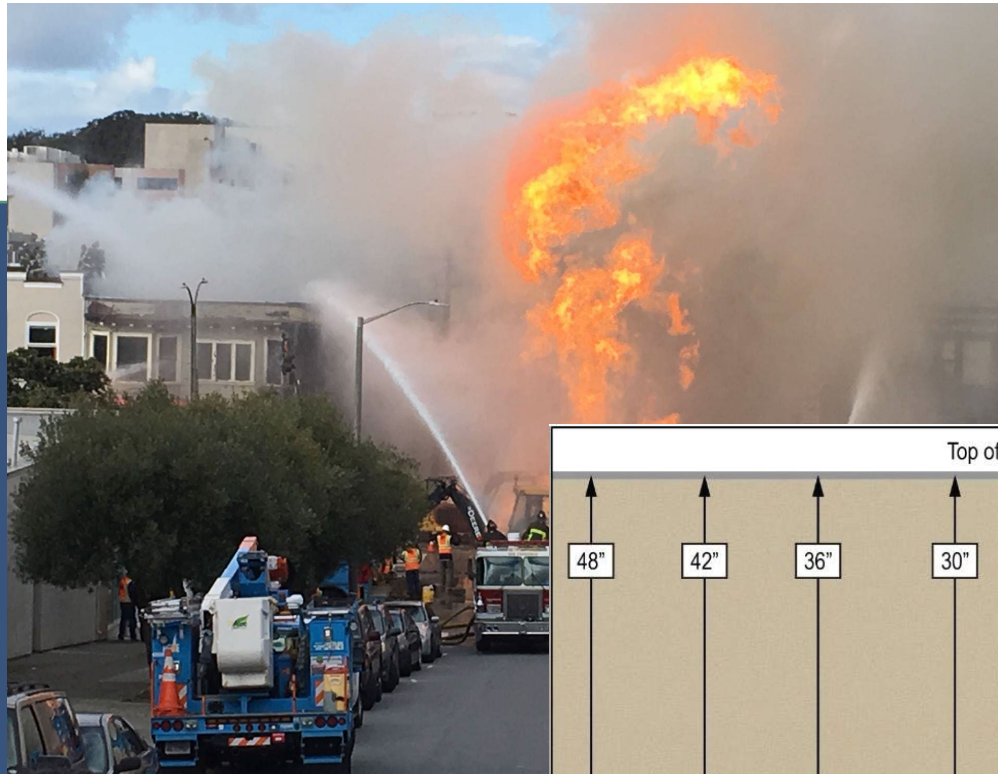
A mini excavator bucket struck the intersection of 2-inch and 4-inch natural gas mains, rupturing the lines and causing a fireball that engulfed nearby structures. The work was being performed by a subcontractor installing a fiber line in an urban area.

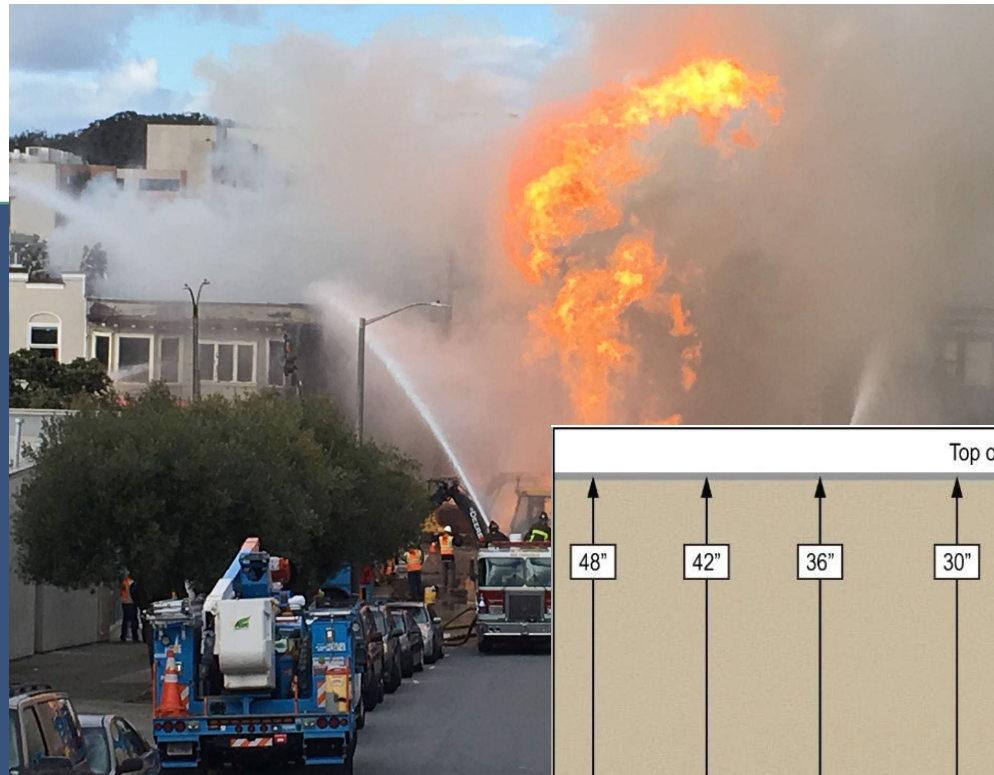
Design indicated no existing buried utilities. New fiber line design to be in the same location and depth as a gas pipeline main.

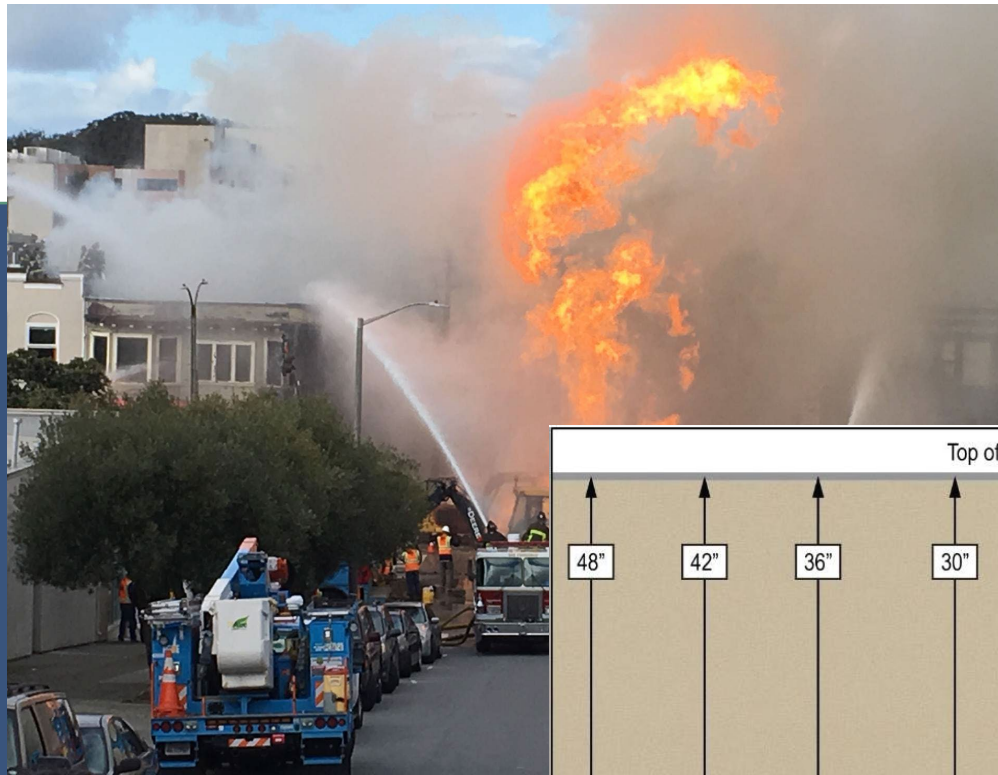
Subcontractor potholed both the 2" and the 4" gas lines, but not at their intersection, where a fusion-welded joint protruded upward six and a half inches.

Had the excavator considered buried facility intersections when determining where to pothole, they likely would have found the fusion weld appurtenance with hand tools and not struck it with an excavator bucket.

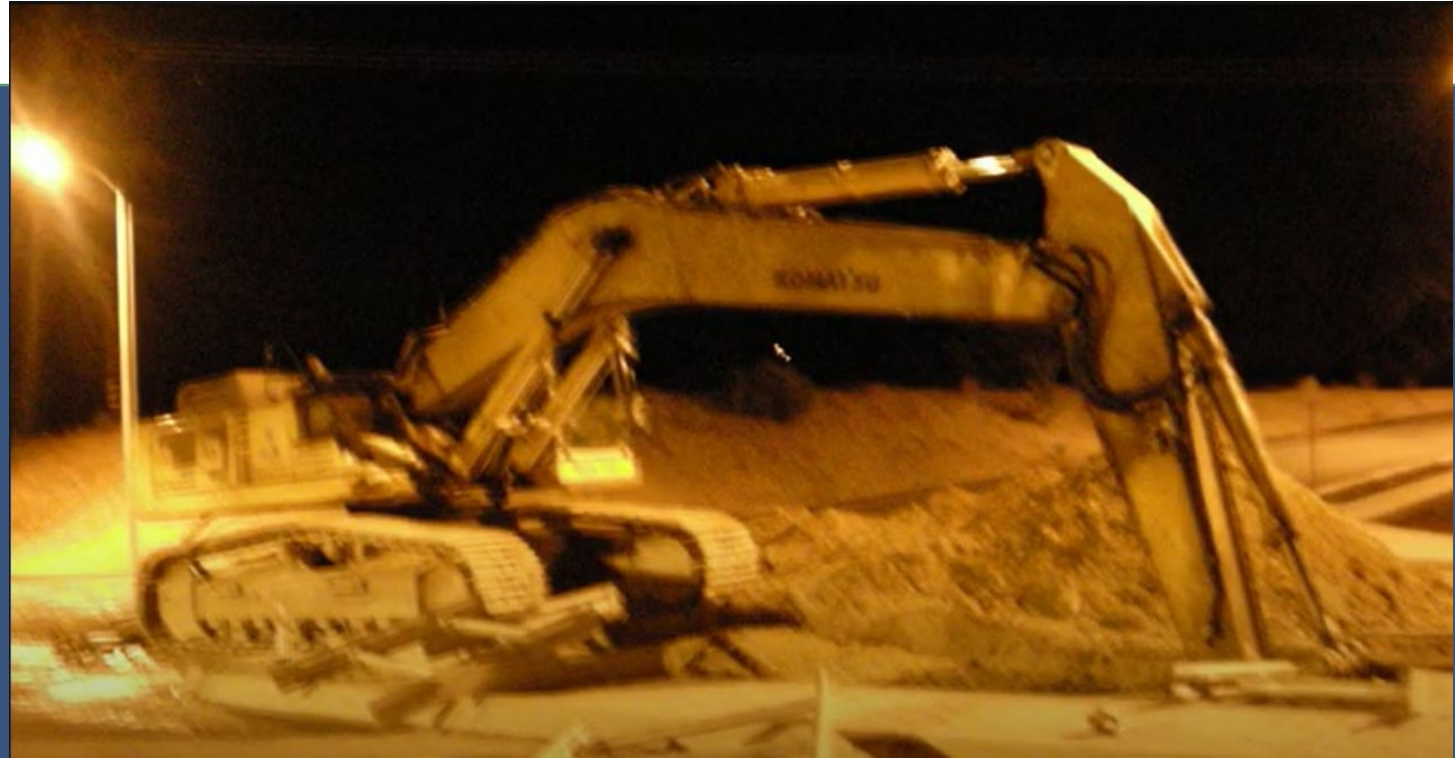
An excavator bucket struck an 8-inch city water line while installing a large diameter county water pipeline. The water flooded the empty pipeline while two workers were inside removing support struts, drowning them. The project inspector had thought that a water line was in the area, and work stopped briefly, but work continued after a brief discussion until the water line was struck.

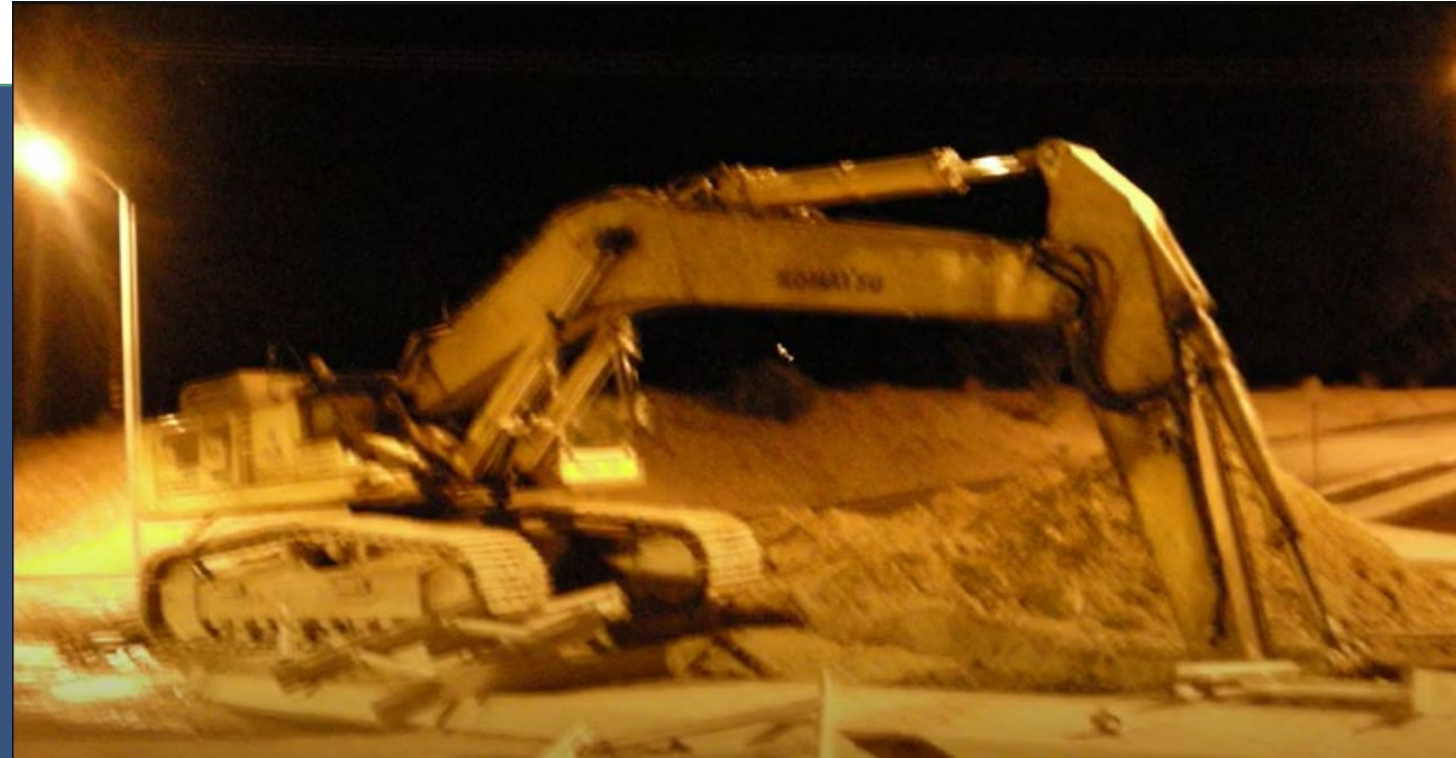
Ensuring potholing was performed on all facilities in the path of excavation prior to construction and recording location information in pothole logs may have provided workers a better understanding of where the facilities were located.

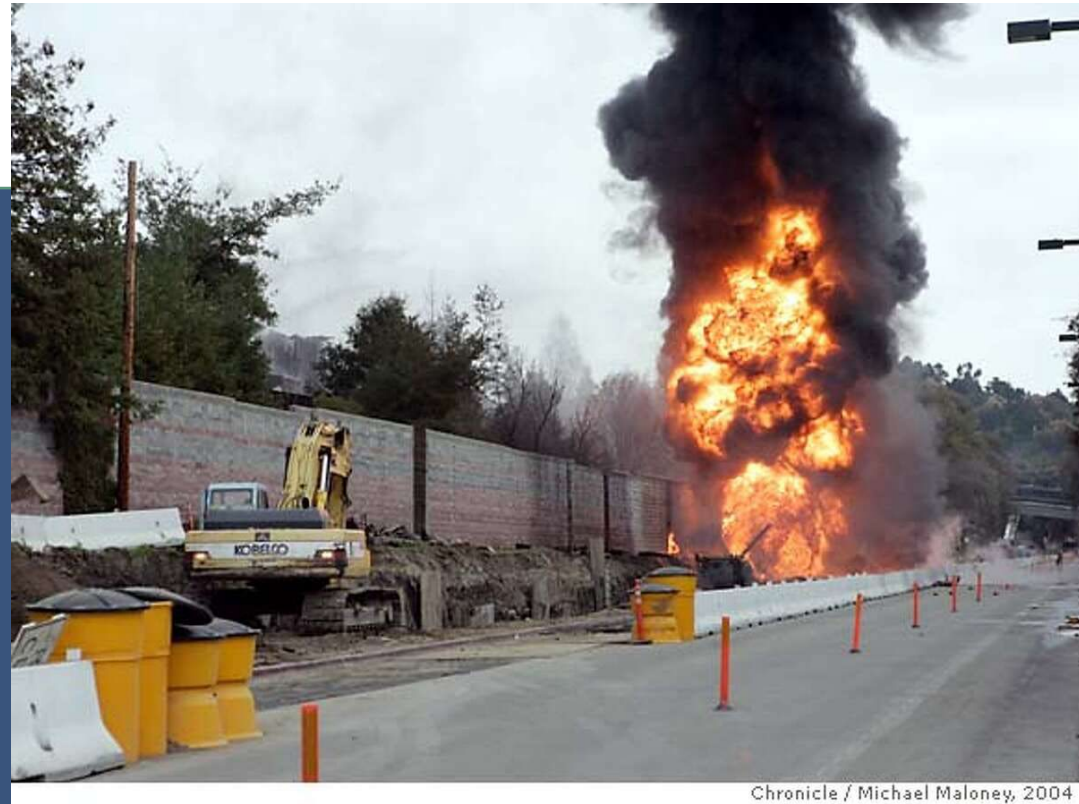
While digging a trench to install a large diameter waterline, an excavator bucket struck a 10-inch gasoline pipeline killing five and seriously injuring another four. The line had been marked as straight along a street, but it in fact had been installed with a jog to go around an oak tree. The oak tree had since been removed.

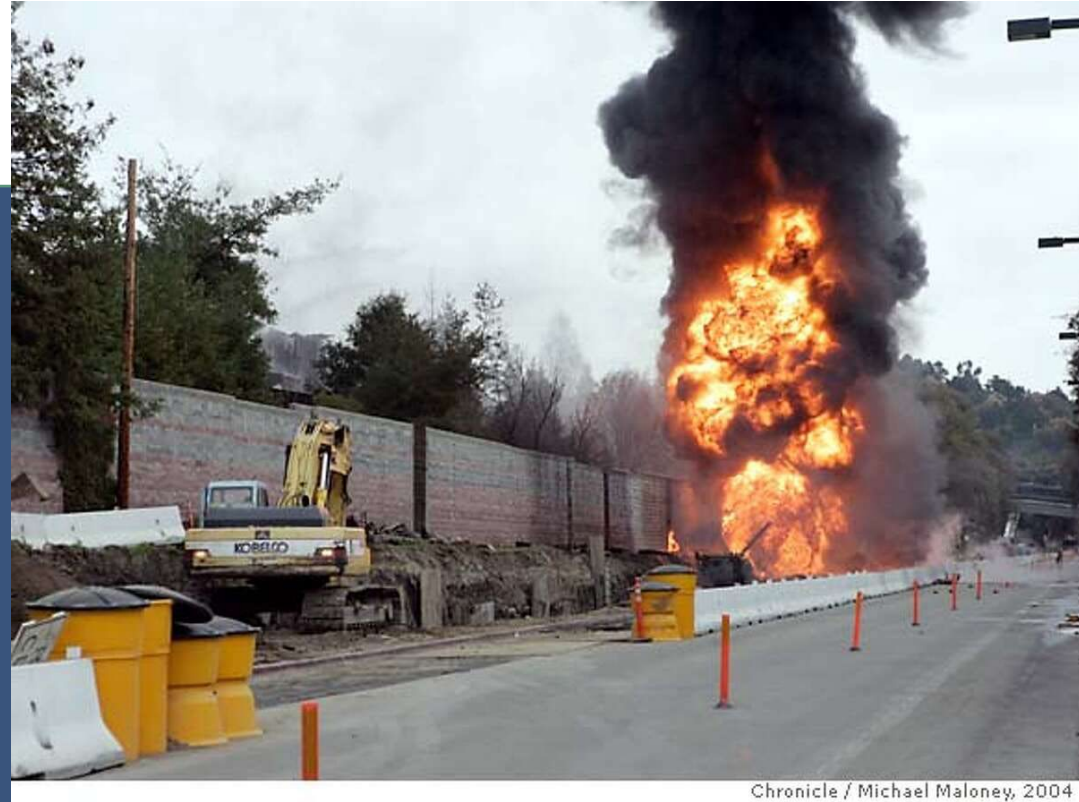
The petroleum pipeline company's line rider did not consult the maps when locating, which indicated the jog in the line.

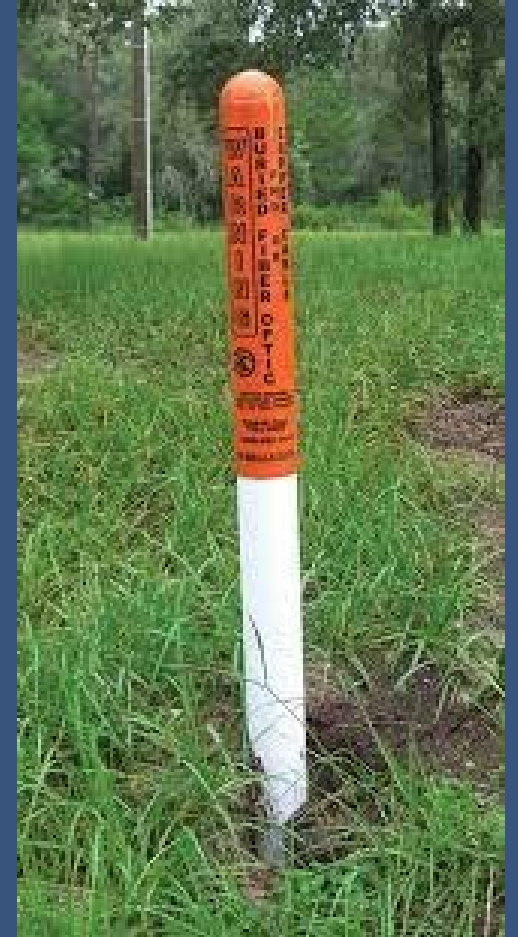
“...The excavator uses the response information provided by utility operators and reviews the site for surface indicators to confirm that all utility operators have identified their buried facilities...”

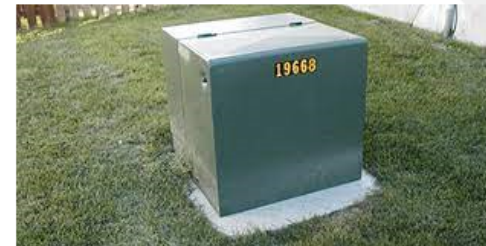
### 1.1 Pad-Mounted Transformer

Pad-mounted transformers are part of the electric distribution system that take distribution-level voltages and step the voltage down to lower voltages to serve homes and businesses. As such, pad-mounted transformers can be expected to have a 4-35 kilovolt input connected and one or more outputs in the hundreds of volts.
