**CALIFORNIA UNDERGROUND FACILITIES SAFE EXCAVATION BOARD
INVESTIGATION DIVISION
INVESTIGATION REPORT**

DATE: March 27, 2023
CASE No.: D230030002

Executive Summary:

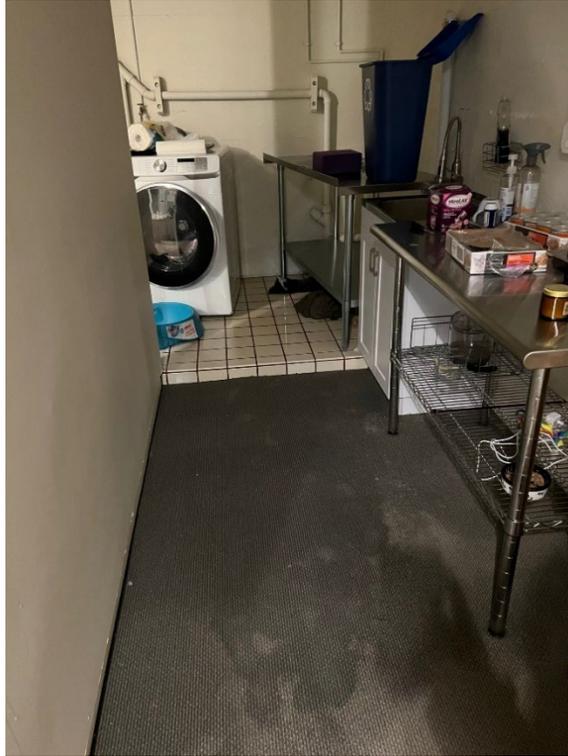
Photo 1: Image of water inside the home provided by the homeowner and Crest Landscape (Exh. 12.)

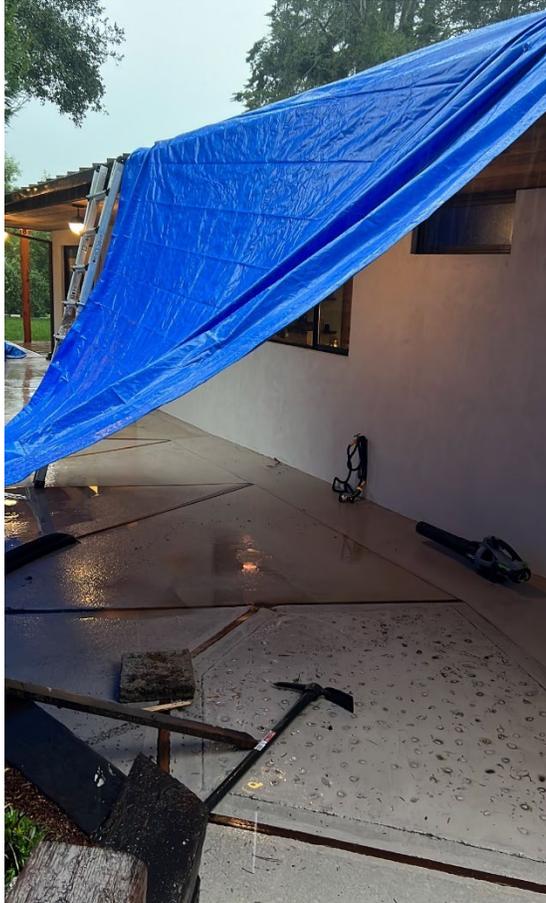
Josué Pablo of Crest Landscape stated that Crest Landscape employees used only shovels in digging to repair the drain and did not use the pick shown in Photo 2 (Exh. 7) in this report. He stated that the pick belonged to the owner of the residence, who took the photo before hiring Crest Landscape. (Exh. 8.)

Photo 2: Photo of the back yard provided by Crest Landscape. (Exh. 7)

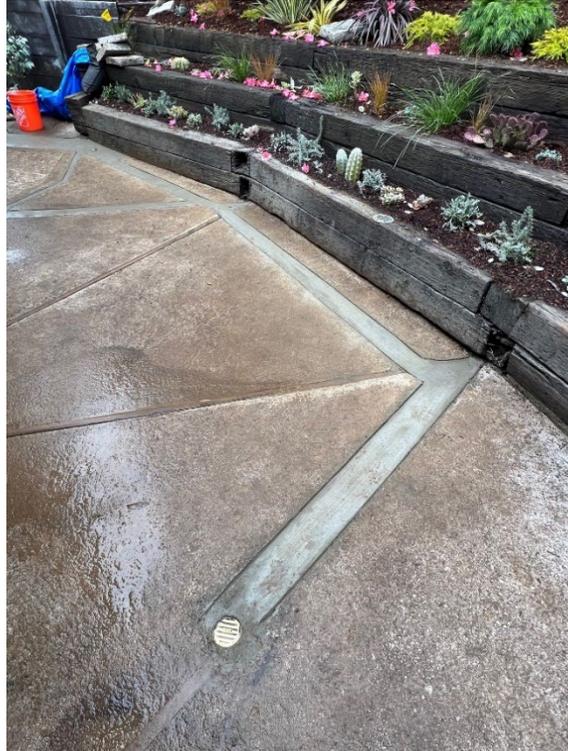
Photo 3: Photo of the back yard and drain area provided by Crest Landscape. (Exh. 11.)

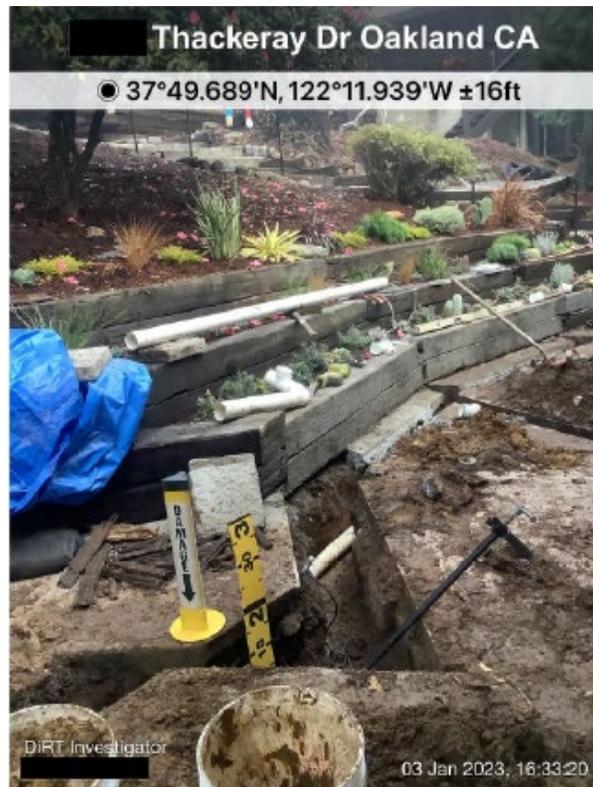
To replace the drain line that was clogged, Crest Landscaping employees used shovels to dig under pavement in the back yard, and a shovel cut a one-half-inch gas line at a depth of approximately 16 inches. (Exh. 6.)

Photo 4: Photo from the PG&E Investigation Report depicting the location and a measurement of the depth of the damaged facility. Redaction by PG&E. (Exh. 4.)

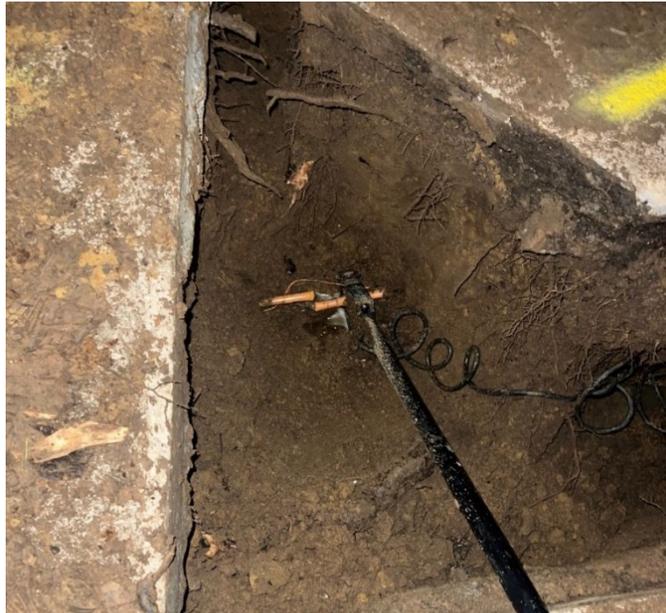
Photo 5: Photo of the damaged facility provided by Crest Landscape. (Exh. 10.)

As I walked the area I did not see any USA markings at the location. I checked the LM database and did not find any USA tickets for the location. I observed the damaged facility inside of a trench. The facility was approximately 20-inches below the grade. The facility was completely sliced; however, the tracing wire was not damaged.

Upon arrival I made contact with the PG&E GSR on scene. GSR advised me a 1/2-plastic gas service line had been struck causing damage and gas release. GSR was able to remove dirt around the damaged facility in order to squeeze it. GSR squeezed the facility stopping the flow of gas at approximately 1415 hours.

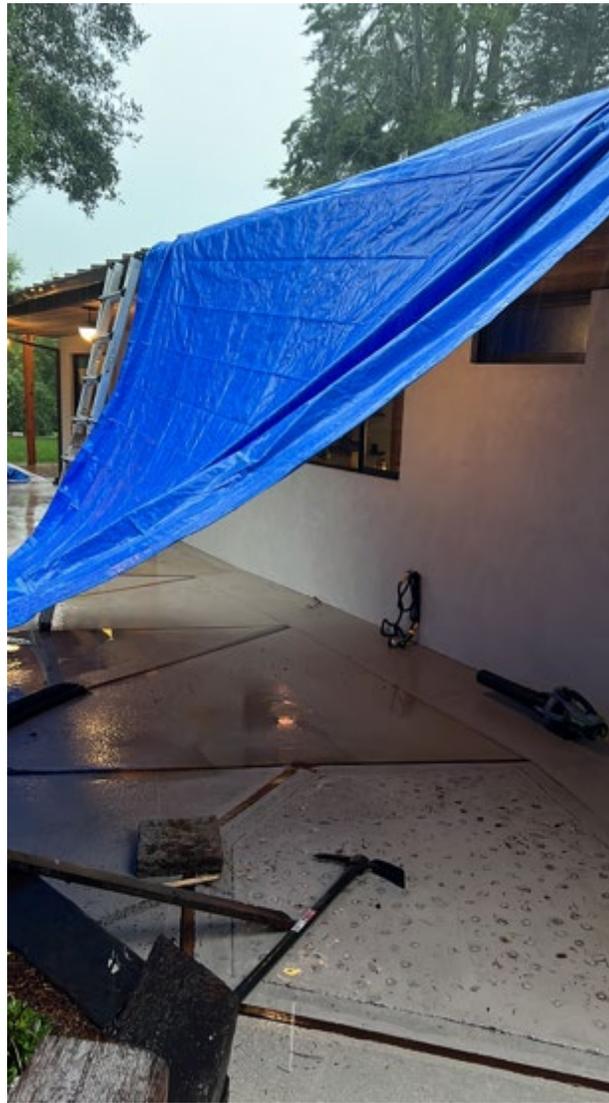
Photo for reference:

That picture it's a customers Photo before the incident. the tool in the ground its a customers tool . It's one of the picture he send it to me before you hire me, he was covering the area for water damage under his basement
