CALIFORNIA UNDERGROUND FACILITIES SAFE EXCAVATION BOARD

INVESTIGATION REPORT

Case No.: 23NTS0020

On November 9, 2023, at approximately 1:30 p.m., a licensed contractor, Rancho West Landscape, Inc., struck a Southern California Gas Company 2-inch yellow plastic natural gas line with a backhoe, resulting in damage to the gas line and release of natural gas.

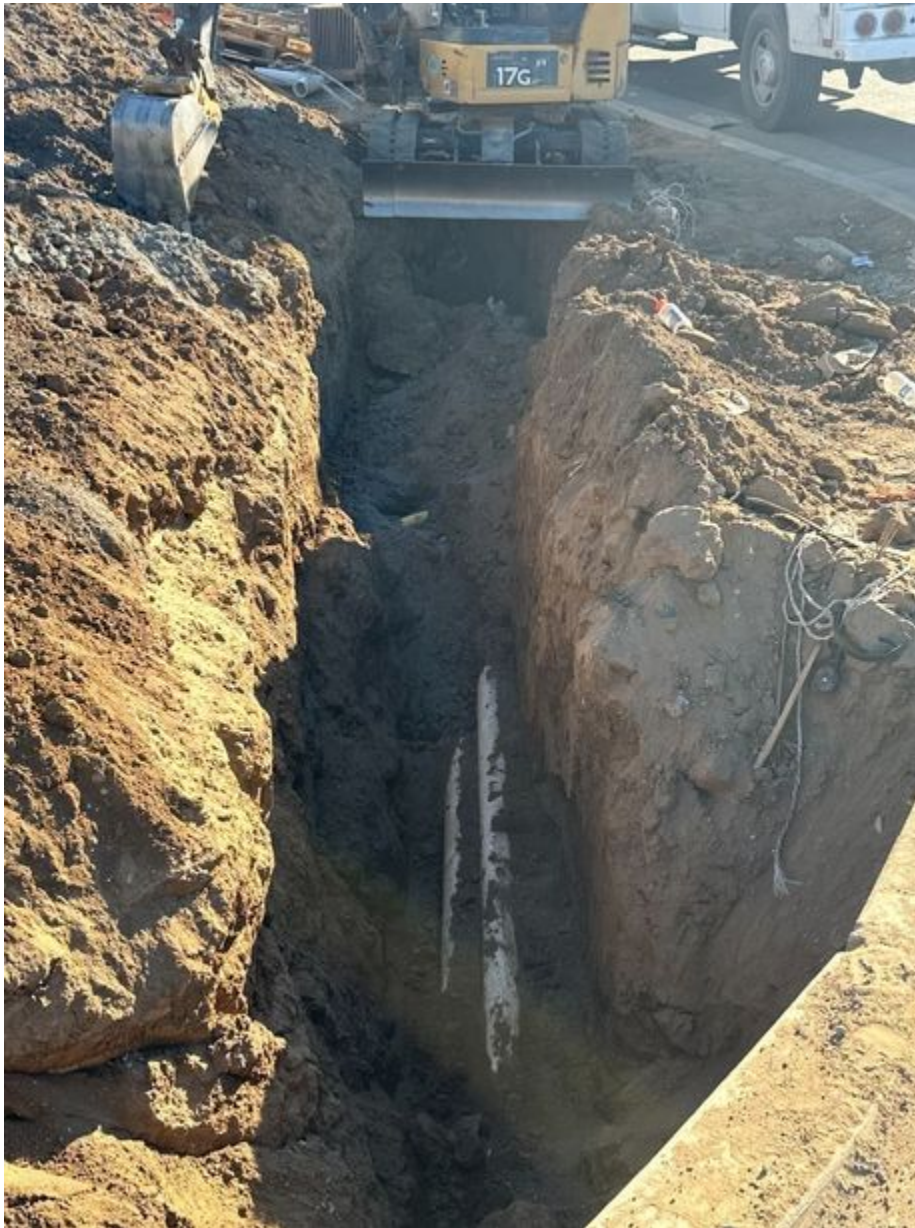
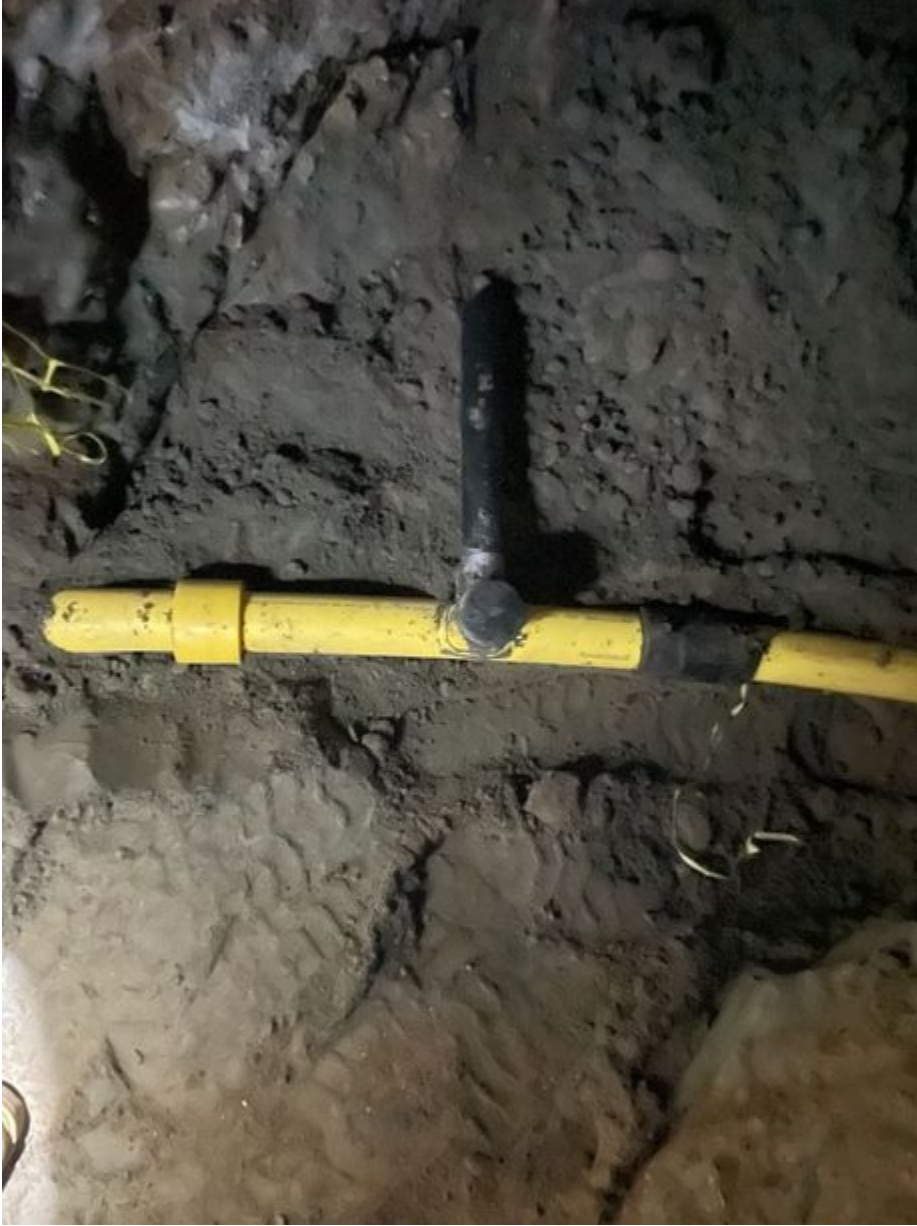
Upload photo of excavation location. The photo should be taken at a wide angle and include location identifiers such as buildings in the background, street signs, bridges, freeways, etc.:

Third-party working under without a current USA ticket trying to install irrigation and drainage hit the 2" plastic main.

And I noticed in the photo it looks like your team was trenching with the excavator across the utility. How does Rancho West usually perform potholing? And where did your team pothole to locate the facility prior to using the excavator? I see that the 811 procedures you provided include using hand tools to find the utility and that makes me wonder if the utility was where your team expected it to be.

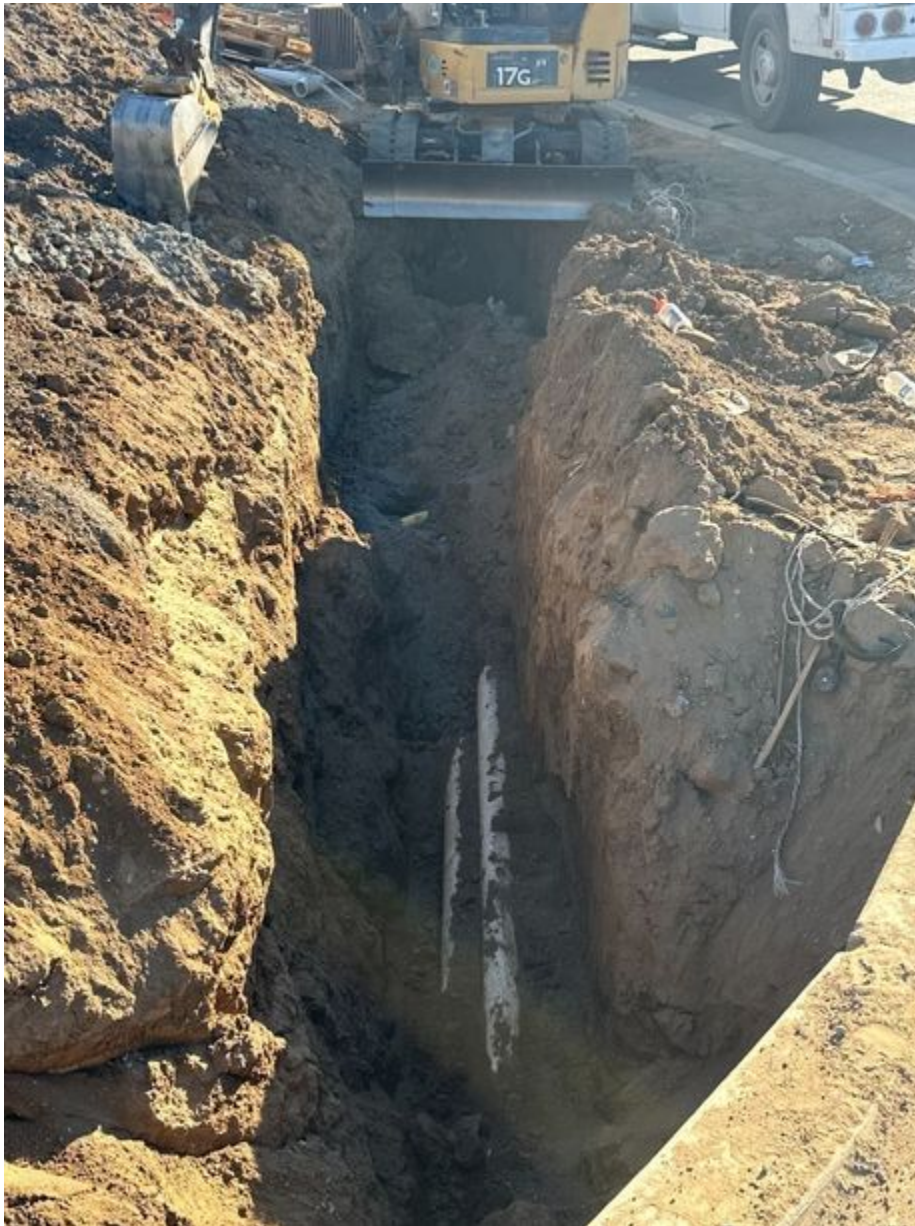
Upload photo depicting the damaged facility

Type of Facility damaged?
Natural Gas

Tool that caused the damage:
Backhoe
