NOTICE OF VIOLATION

INSPECTION REPORT

Electrical Corporation:	Bear Valley Electric Service, Inc. (BVES)
Report Number:	BVES_CAC15_20231101_1008
Inspector:	CAC15
WMP Year Inspected:	2023
Quarterly Data Report (QDR) Referenced:	Quarter 2 (Q2)
Inspection Selection:	Energy Safety viewed the contents of the Q2 QDR and performed an analysis that resulted in the selection of the WMP initiatives and locations referenced in this report.
Relevant WMP Initiative(s):	Clearance (2023 WMP initiative number 8.2.3.3)
Date of inspection:	November 1, 2023
City and/or County of Inspection:	Big Bear Lake, San Bernardino County
Inspection Purpose:	Assess the accuracy of Bear Valley Electric Service, Inc.'s QDR data, completeness of its work, compliance with WMP requirements, and compliance with its protocols.

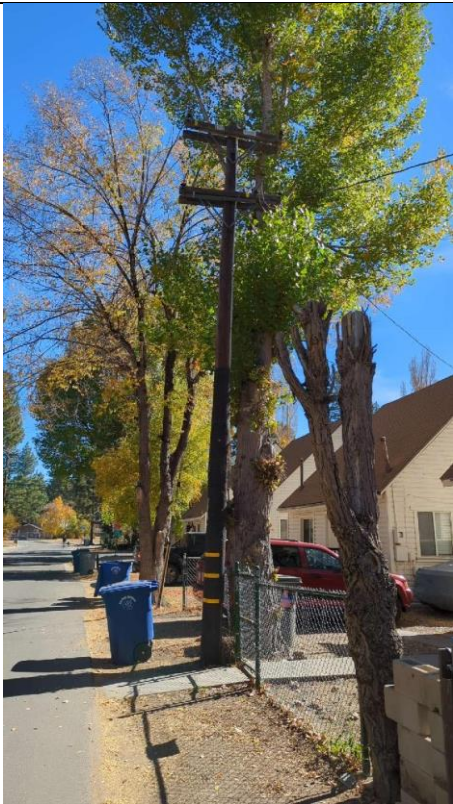
A photograph showing a utility pole on a residential street. The pole is dark and has several cross-arms. It is situated next to a sidewalk with blue recycling bins and a tree with green and yellowing leaves. A house with a brown roof is visible in the background.

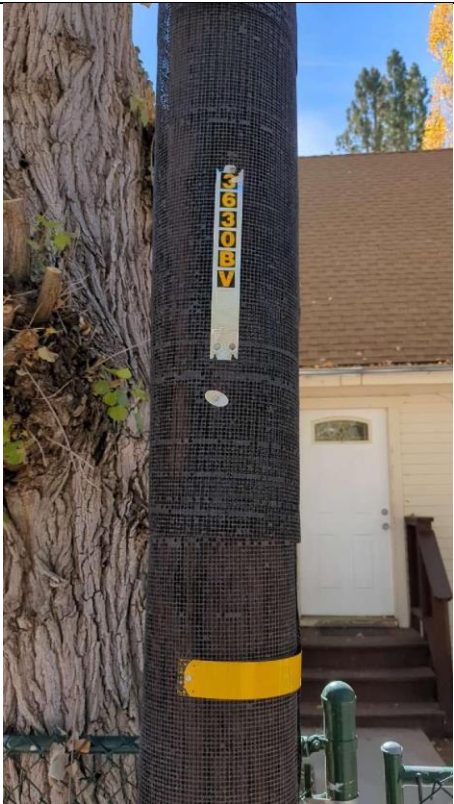
A close-up photograph of the utility pole. The pole is wrapped in a dark, textured mesh. A yellow band is visible around the pole. A white tag with the text '3630BV' is attached to the pole. The background shows a tree trunk and a house with a white door.
<p>Item4GImg1: Overall pole.</p>	<p>Item4GImg2: Pole ID.</p>

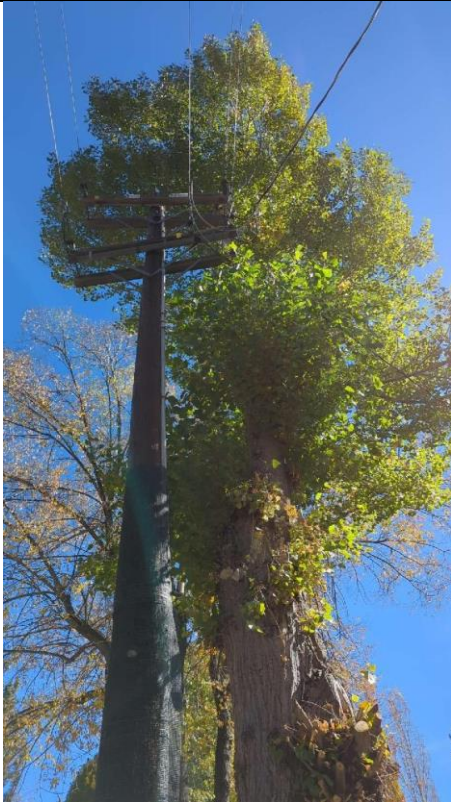
Near pole ID 3630BV at 41409 Park Avenue, Big Bear Lake, CA, 92315, USA, 34.2462367981346, -116.898800713462, the inspector observed vegetation growing within the 72-inch safe clearance distance under primary bare conductors. The inspector’s observation is documented in the Violation 1 photographs, which are attachments to this report. Photograph numbers Item4IA1Img1 and Item4IA1Img2 depict a tree growing approximately three feet under primary bare conductors.

1. The goal of Bear Valley Electric Service, Inc.’s Initiative 8.2.3.3 – Clearance is to proactively maintain vegetation so it does not contact electrical infrastructure, thereby preventing wildfires.
2. The tree is not in contact with bare conductor, but within Bear Valley Electric Service, Inc.’s minimum 72-inch safe clearance distance under bare conductors.
3. Bear Valley Electric Service, Inc.’s WMP clearance work was identified as complete at this location.

Item4IA1Img1: View of tree growing within three feet of bare conductors.

Energy Safety may prescribe a timeframe for resolution of a violation associated with the assigned risk category.² Within 30 days from the issuance date of this NOV, the electrical corporation must provide a response advising Energy Safety of corrective actions taken or planned to remedy the above identified violation(s) and prevent recurrence. Alternatively, the electrical corporation must advise Energy Safety that it

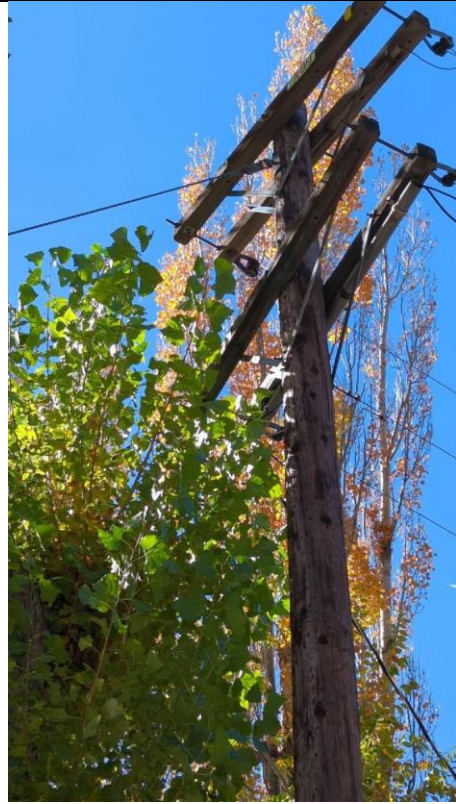
Item4IA1Img2: Secondary view of tree growing within six inches of crossarm and within three feet of bare conductors.
