NOTICE OF VIOLATION

INSPECTION REPORT

Electrical Corporation:	Bear Valley Electric Service, Inc. (BVES)
Report Number:	BVES_CAC15_20231025_1031
Inspector:	CAC15
WMP Year Inspected:	2023
Quarterly Data Report (QDR) Referenced:	Quarter 2 (Q2)
Inspection Selection:	Energy Safety viewed the contents of the Q2 QDR and performed an analysis that resulted in the selection of the WMP initiatives and locations referenced in this report.
Relevant WMP Initiative(s):	Clearance (2023 WMP initiative number 8.2.3.3)
Date of inspection:	October 25, 2023
City and/or County of Inspection:	Sugarloaf, San Bernardino County
Inspection Purpose:	Assess the accuracy of Bear Valley Electric Service, Inc.'s QDR data, completeness of its work, compliance with WMP requirements, and compliance with its protocols.

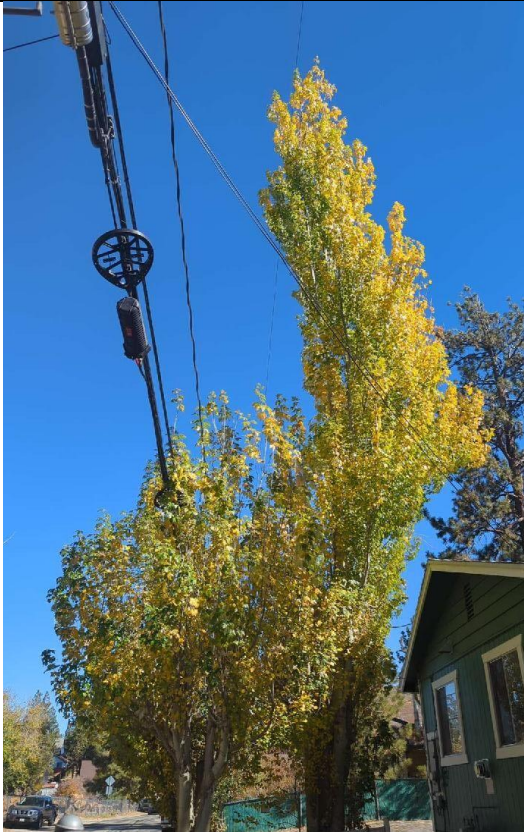
Near pole ID 1905 at 136 W Country Club Blvd, Big Bear City, CA, 92314, USA, coordinates 34.2617196240952, -116.847297778948, the inspector observed vegetation growing within the 72-inch safe clearance distance under primary bare conductors. The inspector's observation is documented in Violation 1 photographs, which are attachments to this report. Photograph numbers Item15IA1Img1 and Item15IA1Img2 depict a tree approximately one foot from primary bare conductors.

Item15IA1img1: View of tree growing within the 72-inch safe clearance distance of the conductor.

Energy Safety may prescribe a timeframe for resolution of a violation associated with the assigned risk category.² Within 30 days from the issuance date of this NOV, the electrical corporation must provide a response advising Energy Safety of corrective actions taken or planned to remedy the above identified violation(s) and prevent recurrence. Alternatively, the electrical corporation must advise Energy Safety that it

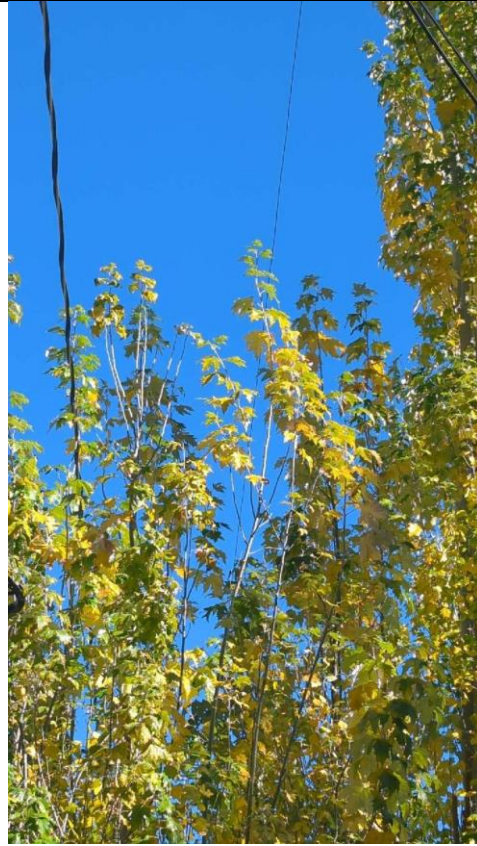
Item15IA1img2: Secondary view of tree growing within the 72-inch safe clearance distance of the conductor.
