NOTICE OF VIOLATION

INSPECTION REPORT

Electrical Corporation:	Pacific Gas and Electric Company (PG&E)
Report Number:	PGE_CAC18_20231129_0945
Inspector:	CAC18
WMP Year Inspected:	2023
Quarterly Data Report (QDR) Referenced:	Quarter 2 (Q2)
Inspection Selection:	Energy Safety viewed the contents of the Q2 QDR and performed an analysis that resulted in the selection of the WMP initiatives and locations referenced in this report.
Relevant WMP Initiative(s):	Pole Clearing (2023 WMP initiative number 8.2.3.1)
Date of inspection:	November 29, 2023
City and/or County of Inspection:	Willits, Mendocino County
Inspection Purpose:	Assess the accuracy of Pacific Gas and Electric Company’s QDR data, completeness of its work, compliance with WMP requirements, and compliance with its protocols.

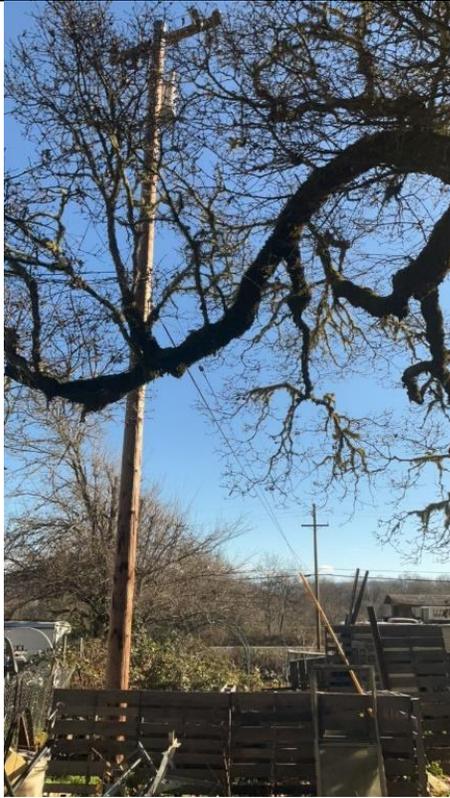
On pole ID 121593291 at 24438-24798 N Highway 101, Willits, CA, 95490, USA, 39.4337627600458, -123.358669737352, the inspector observed that pole clearing was not completed per protocol. The inspector's observation is documented in Violation 1 photographs, which are attached to this report. Photo numbers Item1GImg1, Item1GImg2, Item1GImg3, and Item1A1Img1 depict customer-owned wood pallets inside the pole's 10 ft firebreak radius.

1. The inspection point was reported as completed.
2. Customer-owned wooden pallets are inside the 10 ft. firebreak radius.
3. The pallets are made of wood, a flammable material.

Item1Gimg3: View of wood pallets in foreground within 10 ft firebreak radius of pole.

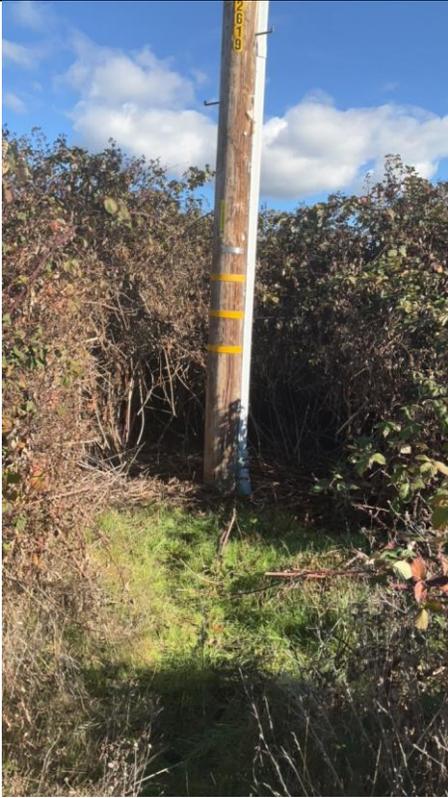
photographs, which are attachments to this report. Photo numbers Item3GImg1, Item3GImg2, Item3IA1Img2, and Item3IA1Img3 depict overgrown blackberry within the 10 ft firebreak radius.

1. Pacific Gas and Electric Company reported pole clearing was completed at this location.
2. Dense blackberry growth is inside the pole's 10 ft firebreak radius.
3. Blackberry bushes are a brush vegetation.
4. The vegetation density is moderate.

Item3IA1img2: Heavy blackberry growth within the 10 ft firebreak radius of pole.

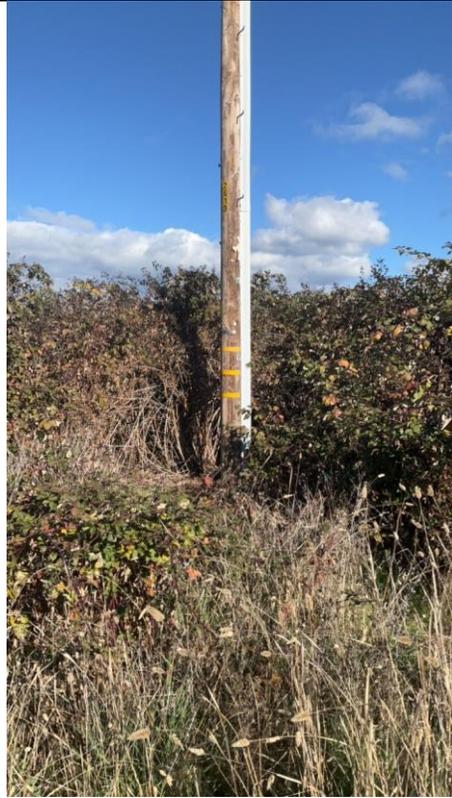
Item3IA1img3: Large angle view of heavy blackberry growth within the 10 ft firebreak radius of pole.
