**Subject**: Bear Valley Electric Service, Inc. Response to Notice of Violation- NOV\_BVES\_CAC14\_20231024\_0818 (No Written Hearing Requested)

## Notice of Violation: NOV\_BVES\_CAC14\_20231024\_0818

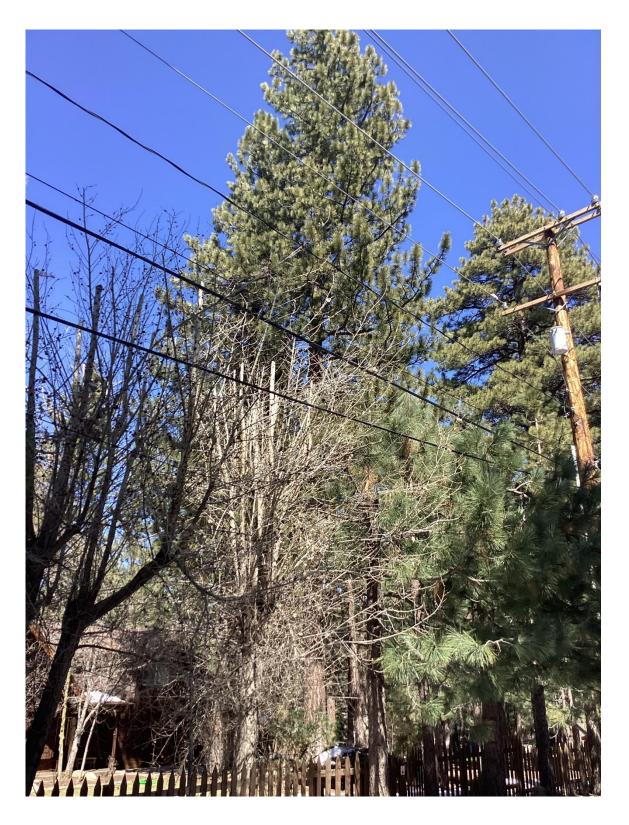
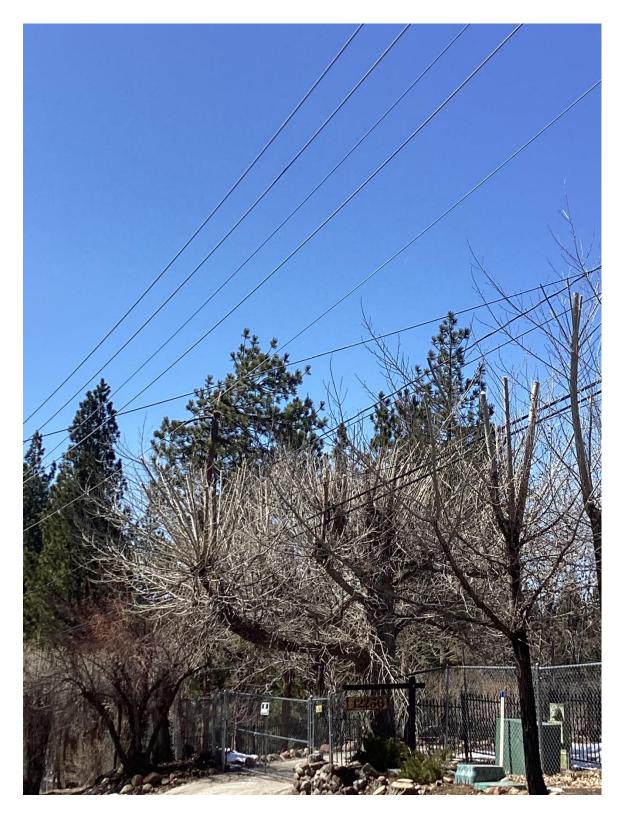
After Trimming on November 17, 2023

**Response:** This violation located near pole number 1300BV located at (Lat/Long: 34.2372390327414, -116.883346825071). was corrected on 11/17/2023 as part of BVES's routine vegetation management program. The tree was trimmed to approximately 12 feet from the primary conductors. Additionally, when this notice was sent to BVES on March 15, 2024, the lines were re-inspected for any additional growth. No additional action was needed. See photos below.
