April 4, 2024

Shaun Gahagan
Wildfire Mitigation Program Manager
San Diego Gas & Electric Company
8326 Century Park Court, CP32F
San Diego, CA 92123

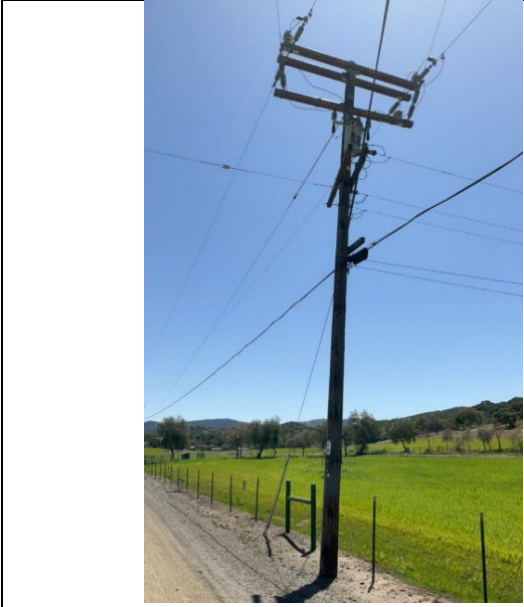
Item6G1mg1: Overall pole.
