Subject: Liberty's Response to Notice of Violation - NOV_LU_CAC18_20231025_0916

Finding: Failure to set the pole to protocol

Notice	Violation #	Structures
NOV_LU_CAC18_20231025_0916	Violation 1	275568

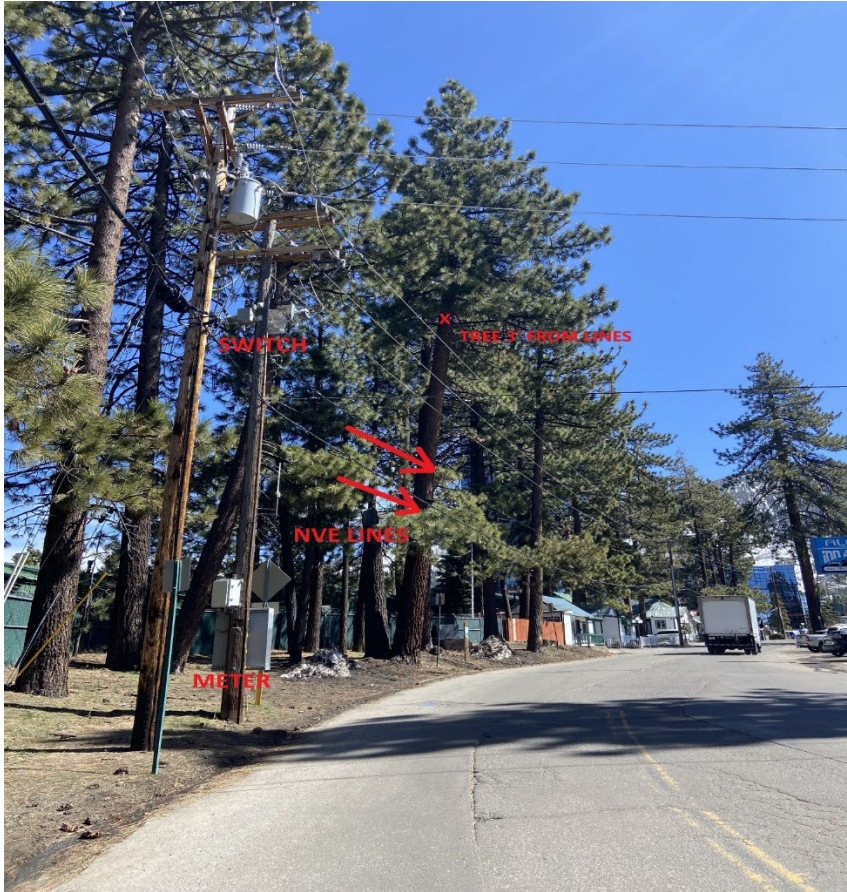
Summary of Energy Safety Finding:¹ Near pole ID 275568 at 920 Stateline Ave, South Lake Tahoe, CA, 96150, USA, 38.9609062307708, -119.944810162602, the Energy Safety inspector observed two Jeffrey pines within Liberty Utilities’ clearance distance of six feet. The inspector’s observations are documented in Violation 1 photographs. Item1GImg1, Item1GImg2, Item1IA1Img1, and Item1IA1Img2 depict a Jeffrey pine approximately three feet from primary conductors. Photograph numbers Item1IA1Img3 and Item1IA1Img4 depict a Jeffrey pine that is approximately five feet from primary conductors. The radial clearance requirement from these primary conductors (12kV-25kV) is six feet, and Liberty Utilities failed to trim back to 12-15 feet, per Liberty Utilities’ MAT shown in Table 8-23 above.

Response: The radial clearance requirement for vegetation to electrical conductors operating between 2,400 and 72,000 volts per General Order (GO) 95-Rule 35, and Public Resource Code (PRC) 4293 is 4-feet. The tree displayed in ‘Item1Iimg1’ and ‘Item1IA1Img2’ is not located near Liberty’s high voltage lines. East of the switch and meter, on Pole 275570, are NV Energy power lines. Liberty is not responsible for this tree or its clearance from the lines. No work is required by Liberty.

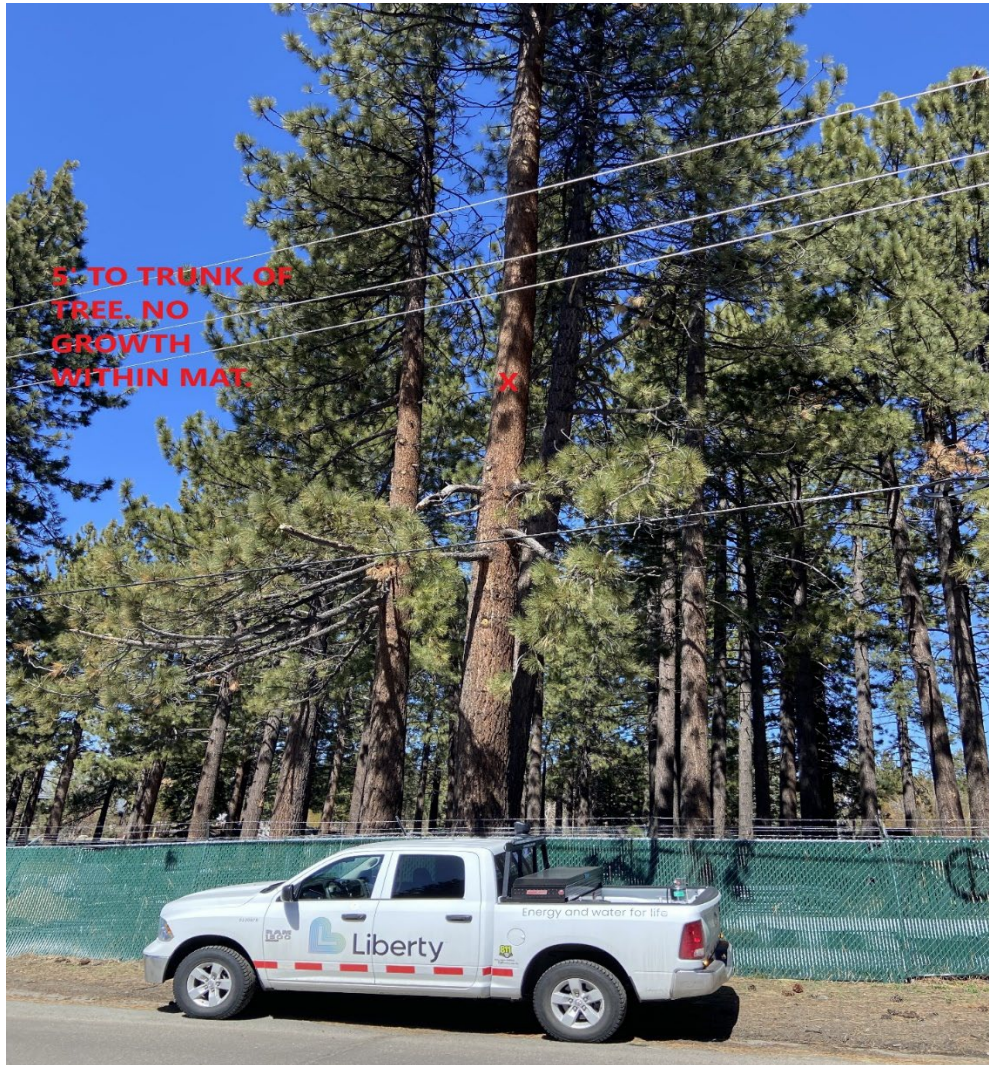
Regarding the tree displayed in 'Item1IA1Img3' and 'Item1IA1Img4,' no vegetation is within regulated clearance requirements. Bole wood is at 5' to conductors. There is no vegetative growth within Liberty maintenance action thresholds. No work is required by Liberty at this time.
