NOTICE OF VIOLATION

INSPECTION REPORT

Electrical Corporation:	Liberty Utilities (LU)
Report Number:	LU_CAC9_20221019_1218
Inspector:	CAC9
WMP Year Inspected:	2022
Quarterly Data Report (QDR) Referenced:	Quarter 3 and Quarter 4 (Q3 and Q4)
Inspection Selection:	Energy Safety viewed the contents of the Q3 and Q4 QDR and performed an analysis that resulted in the selection of the WMP initiatives and locations referenced in this report.
Relevant WMP Initiative(s):	Expulsion Fuse Replacement (2022 WMP initiative number 7.3.3.7)
Date of inspection:	October 19, 2023
City and/or County of Inspection:	Hinton, Nevada County
Inspection Purpose:	Assess the accuracy of Liberty Utilities' QDR data, completeness of its work, compliance with WMP requirements, and compliance with its protocols.

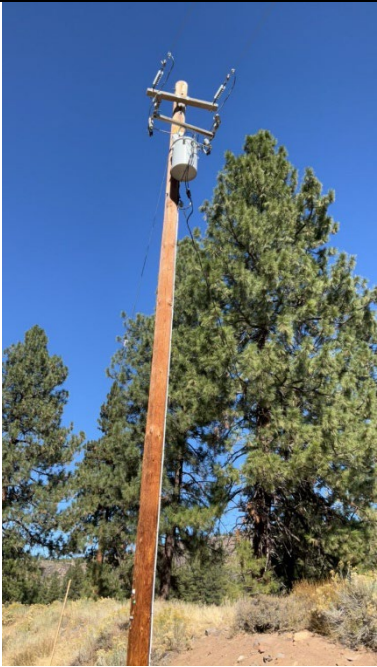
On pole ID 269464 at 10301 Hirschdale Rd, Hinton, CA 96161, USA, 39.3778635924797, -120.077769974398, the inspector observed a pair of expulsion fuses. The inspector's observation is documented in Violation 1 photographs, which are attachments to this report. Photo numbers Item1G1mg1, Item1G1mg2, and Item1IA11mg1 depict a pair of expulsion fuses instead of non-expulsion alternatives.

Item1Gimg1: Overall pole.

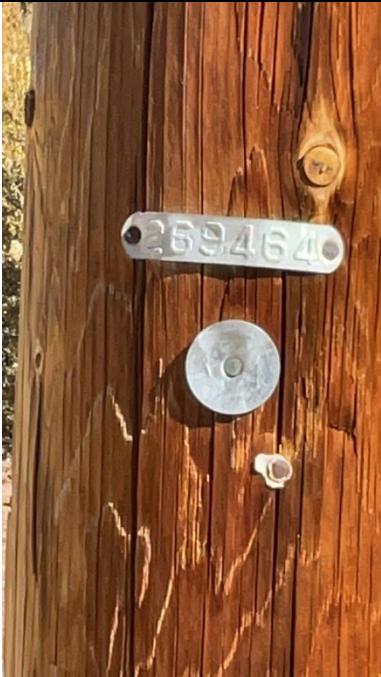
Item1Gimg2: Pole ID.

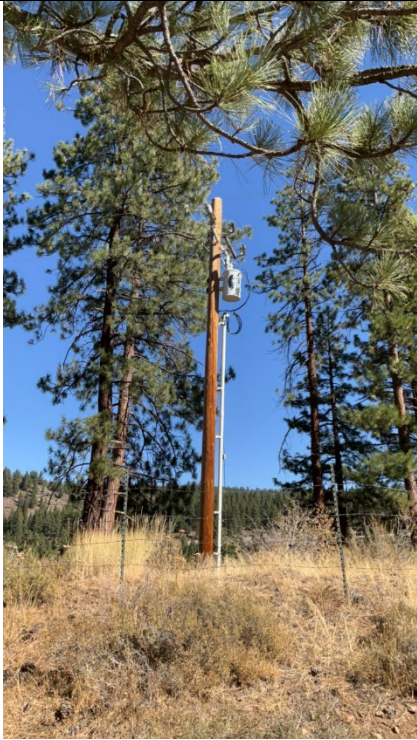
On pole ID 269462 at 10315 Hirschdale Rd, Hinton, CA 96161, USA, 39.3779225383708, -120.078023159941, the inspector observed a pair of expulsion fuses. The inspector's observation is documented in Violation 2 photographs, which are attachments to this report. Photo numbers Item2GImg1, Item2GImg2, and Item2GImg3 depict a pair of expulsion fuses instead of non-expulsion alternatives.

Item2GImg1: Overall pole.

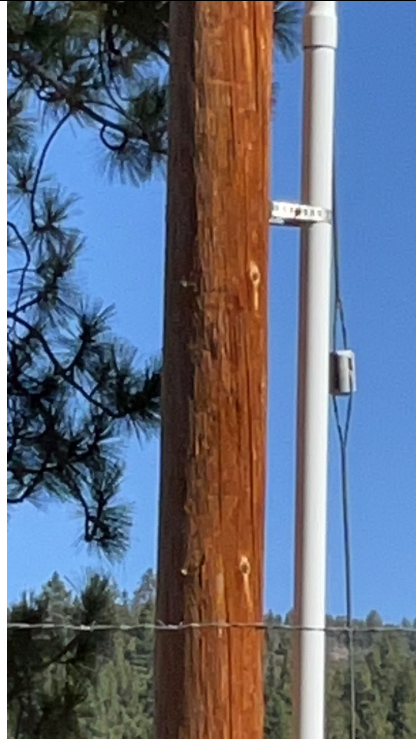
Item2GImg2: Pole ID not on the pole.

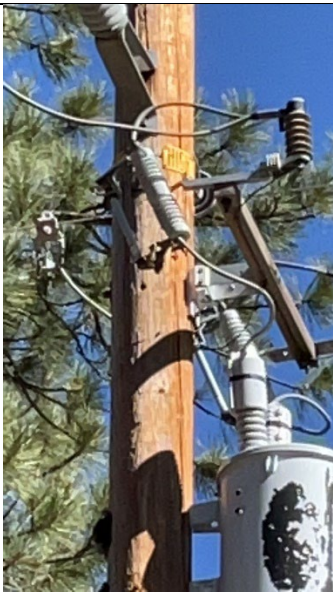
Energy Safety concludes that Violation 2 is Minor because of these facts:

1. Liberty Utilities' WMP initiative number 7.3.3.7 - Expulsion Fuse Replacement work was reported as complete at this location.
2. Expulsion fuses were observed.
3. Non-expulsion fuses were not observed.

Item2GImg3: Close-up view of expulsion fuses.
