**CALIFORNIA UNDERGROUND FACILITIES SAFE EXCAVATION BOARD
INVESTIGATION DIVISION
INVESTIGATION REPORT**

DATE: May 14, 2024
CASE No.: 23NTS00002

On July 10, 2023, ARM Construction excavated without first contacting the regional notification center and, with a shovel, damaged a half-inch natural gas plastic service line operated by the Southern California Gas Company. After damaging the line, ARM Construction contacted the regional notification center and the Southern California Gas Company but did not call 911.

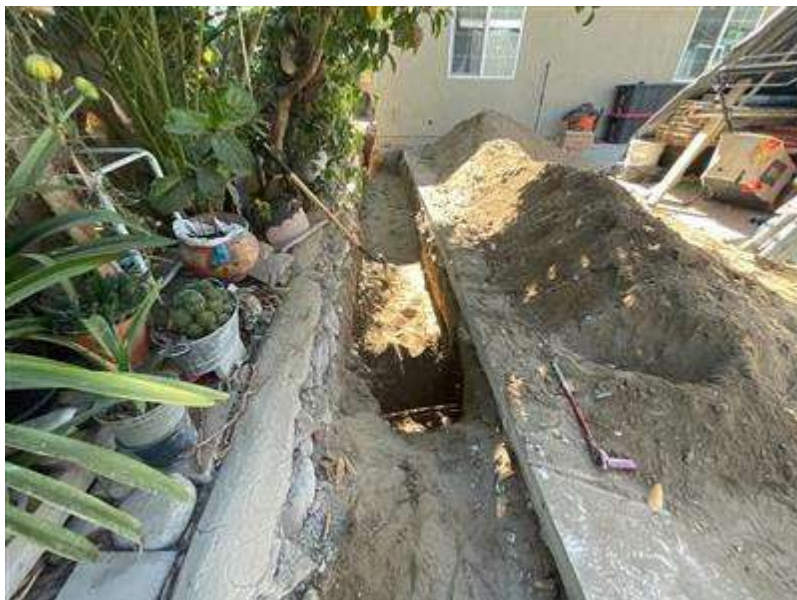
Photo 1 provided by Southern California Gas Company depicts the backyard jobsite. (Exh. 1.)

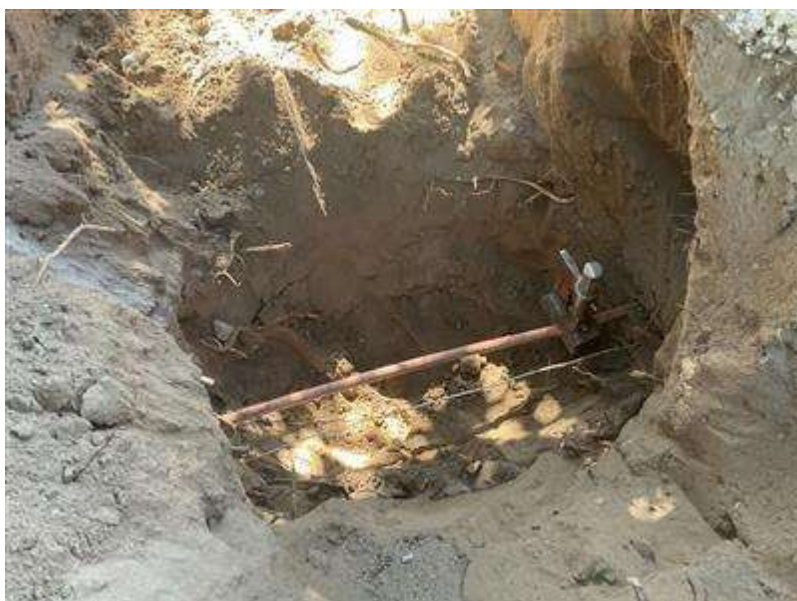
Regarding the excavation and damage to the natural gas line, Supervisor Medina explained in his interview that Robert Morfin, the sole excavator at the jobsite, was using a shovel to dig the backyard trench. Morfin, cutting through tree roots with a shovel, cut natural gas line approximately halfway through causing a leak. There were no explosions or injuries. (Exh. 2.)

Photo 2 provided by Southern California Gas Company depicts the half-inch natural gas line. (Exh. 1.)

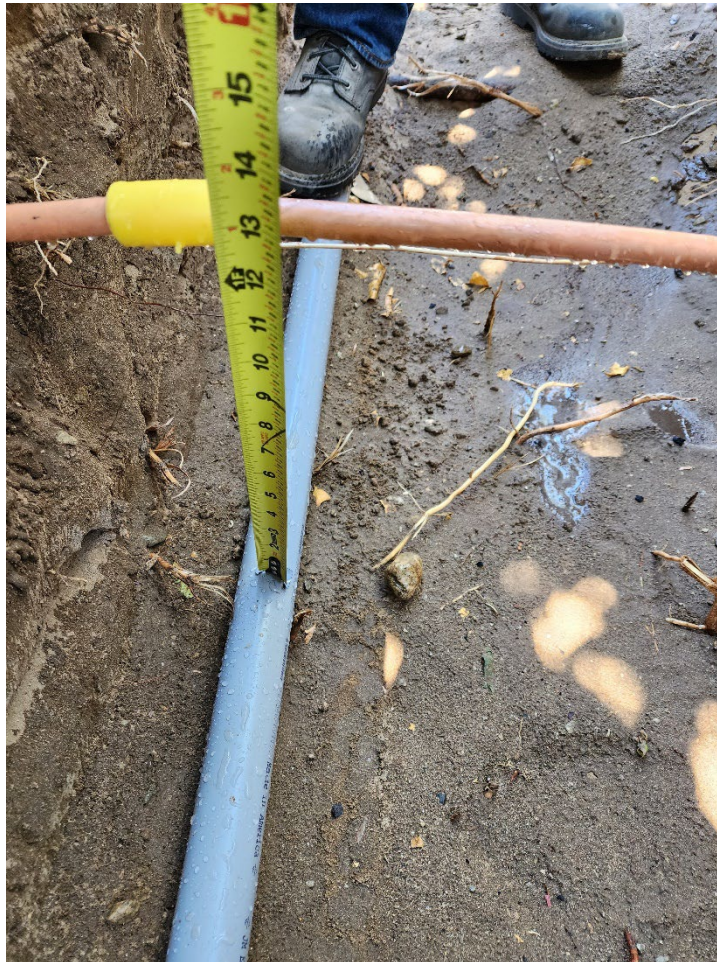
Photo 3 provided by ARM Construction depicts the half-inch natural gas line. (Exh. 4.)

On July 27, 2023, you sent me a brief email that said, "I only have the repair' with an attachment of a picture of a trench, 2 lines and a measuring stick.

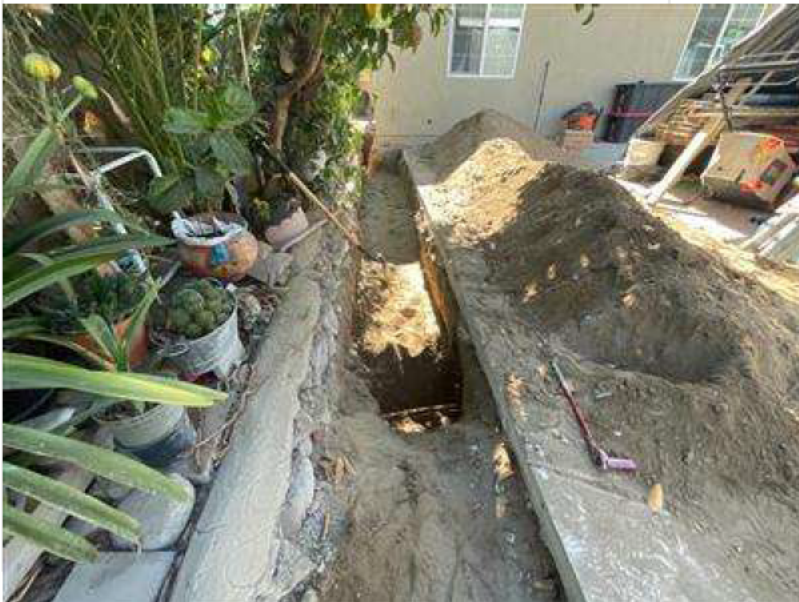
Contractor hit 1/2" plastic service with a shovel. They did not have a valid USA ticket. They requested a USA ticket after the fact. The damage occurred on the left side of the house. It was a branch service that was hit, going to the neighbors house.
