## NOTICE OF VIOLATION

# INSPECTION REPORT

Electrical Corporation:	San Diego Gas & Electric Company
Report Number:	SDGE_YLO_20240606_0812
Inspector:	Yana Loginova
WMP Year Inspected:	2023
Quarterly Data Report (QDR) Referenced:	Quarter 3 & 4 (Q3) (Q4)
Inspection Selection:	Energy Safety viewed the contents of the Q3 & Q4 QDR and performed an analysis that resulted in the selection of the WMP initiatives and locations referenced in this report.
Relevant WMP Initiative(s):	Avian Protection Program (2023 WMP initiative number 8.1.2.10.1, WMP.972)
Date of inspection:	June 6, 2024
City and/or County of Inspection:	Fallbrook, San Diego County
Inspection Purpose:	Assess the accuracy of San Diego Gas & Electric Company’s QDR data, completeness of its work, compliance with WMP requirements, and compliance with its protocols.

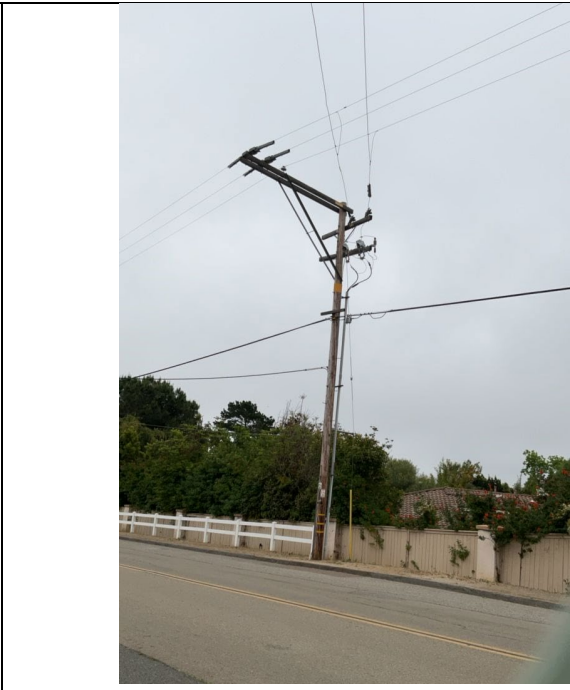
Energy Safety arrived at the pole ID P218236 at 887 Hillcrest Ter, Fallbrook, CA, 92028, USA, 33.3911329330061, -117.232570455604, and observed that one of the avian protection covers was missing. The inspector's observation is documented in Violation 1 photographs, which are attachments to this report. Photo number Item1IA1Img1 depicts that the avian protection cover is not covering clamps and instead it is loose and displaced.

Item1GImg2: Overall Pole

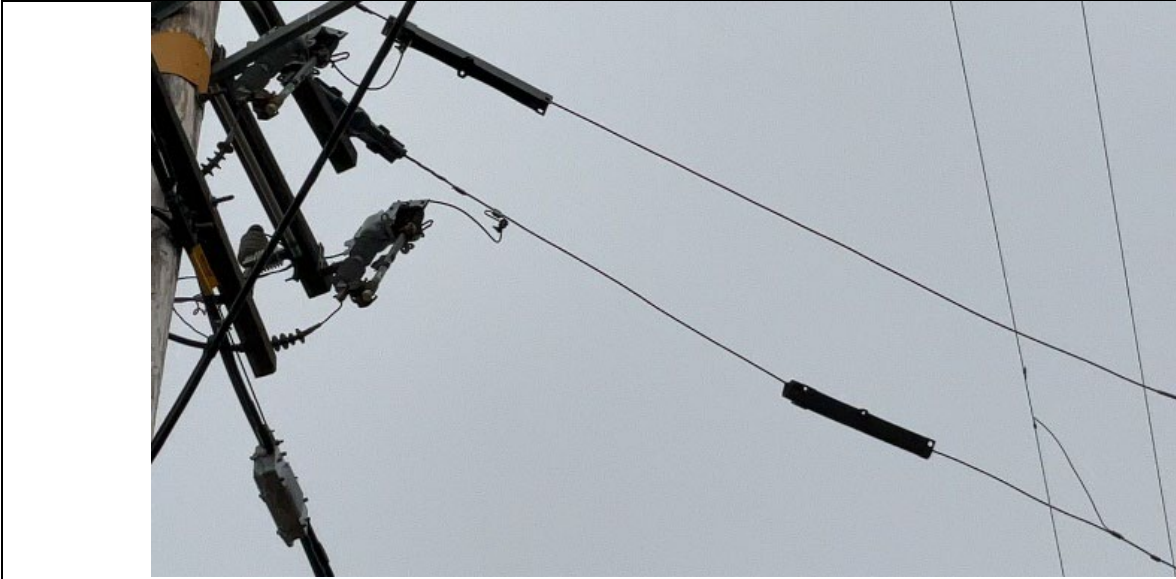
1. The reported location provided by SDG&E indicated that work on the Avian Protection Program (WMP.972, 2023 WMP Initiative 8.1.2.10.1) was reported as completed.
2. The avian protection cover was missing on one side.

Item1IA1Img1: Dislodged avian protection cover

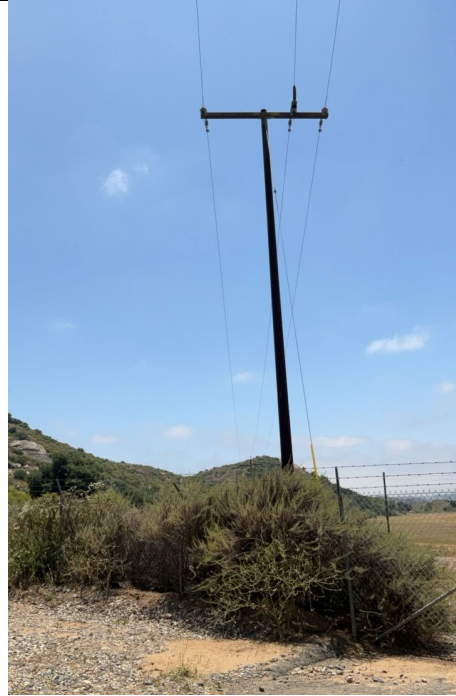
Energy Safety arrived at the pole ID P252330 at 4000-4098 Via San Thomas, Fallbrook, CA, 92028, USA, 33.3178905263497, -117.165591809892, and observed that the avian cover was missing from one side. The inspector's observation is documented in Violation 2 photographs, which are attachments to this report. Photo

numbers Item5G1mg2, and Item5IA11mg1 depict that only one side has the avian protection cover and the avian protection cover is missing from the other side.

**Item5GImg2:** Overall pole

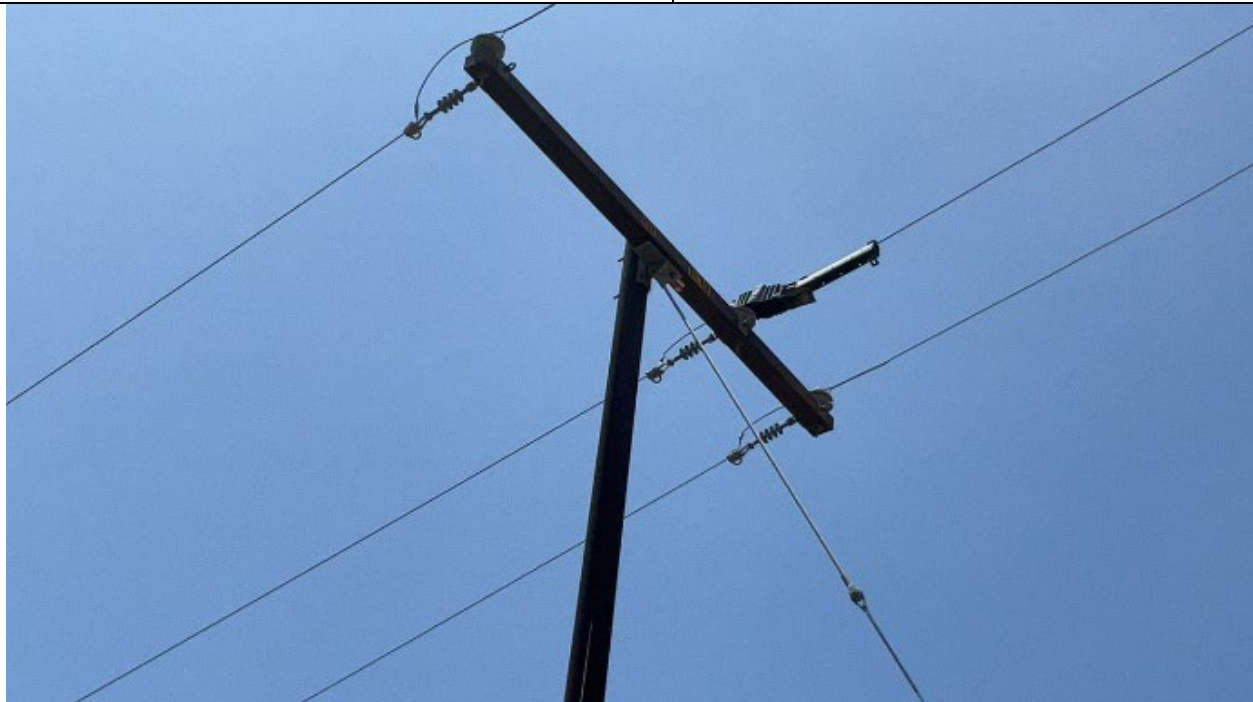
1. The reported location provided by SDG&E indicated that work on the Avian Protection Program (WMP.972, 2023 WMP Initiative 8.1.2.10.1) was reported as completed.
2. The avian protection cover was partially missing.

**Item5IA1Img1:** Missing avian protection cover on one side
